# Fire Risk Assessment

**18-22**

**New Hope Road,  
Smethwick,  
B66 3TY**

**Date Completed: 02/07/2026**

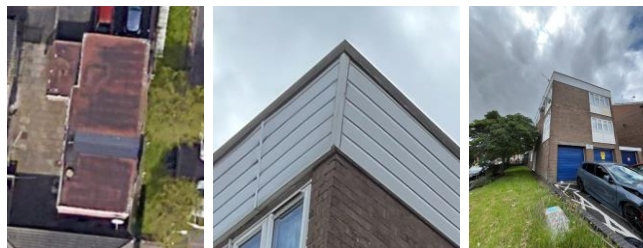
The low-rise three-storey block was built in 1968 using traditional brick cavity and concrete construction. The building has a flat bitumen-felt roof with uPVC fascia boards fitted around the roofline.

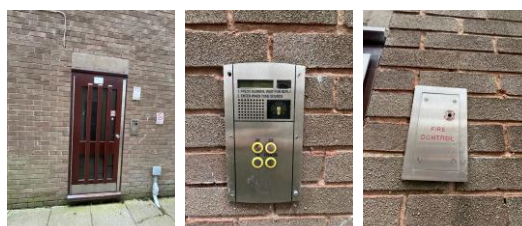
The building is a detached residential block positioned at the end of the row. Access is provided via New Hope Road and Priory Close. The entrance/exit door is of timber construction with glazed panel insets. Entrance access is controlled by a fob system, flat call button, and fire-service drop key.

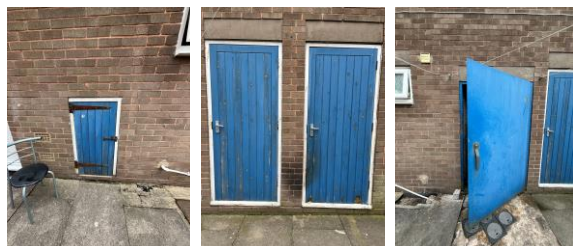
Adjacent to the bin storeroom, within the same wall, there are three individual storage rooms allocated to specific flats, accessible only by the respective residents. Also located within this wall is the entrance door to the ground-floor flat. This rear area forms part of a secure courtyard, enclosed with metal railings and gated access.

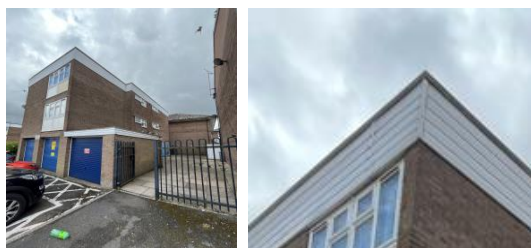
- 1) The external surface of the building is predominantly brick structure. The building has a flat bitumen-felt roof with uPVC fascia boards fitted around the roofline, timber fascia boards around the single garage.

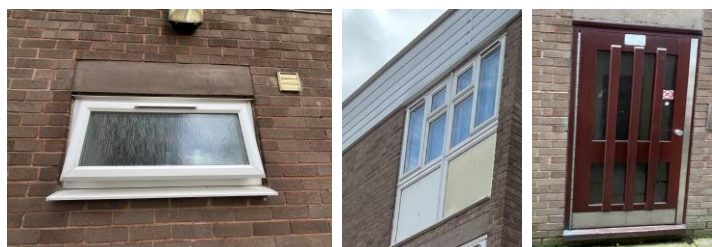
- 2) uPVC double-glazed units have been installed in each flat and within the communal stairway, most of the large units have spandrel panels fitted on the lower sections of the units. The entrance doors are a timber construction with glazed panels.

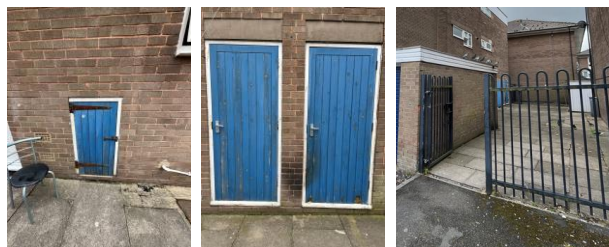
- 5) Adjacent to the bin storeroom, within the same wall, there are three individual storage rooms allocated to specific flats, accessible only by the respective residents. Also located within this wall is the entrance door to the ground-floor flat. This rear area forms part of a secure courtyard, enclosed with metal railings and gated access.

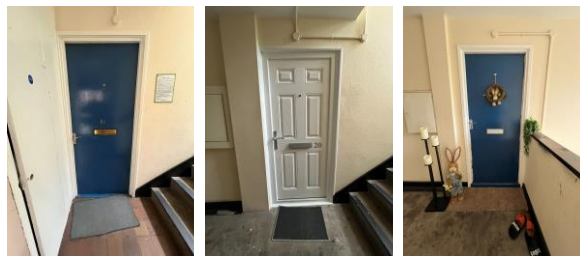
- 1) Each property is fitted with a minimum of an LD3 detection system within the flat. See Section 8
- 2) All corridors are of adequate width (at least 1050mm) and will be maintained clear to that width as a minimum
- 3) None of the corridors that form part of the means of escape are dead ends.
- 4) Majority of the flats within the block are fitted with timber notional doors, with one flat having a composite FD30s door fitted.

Access was attempted to a sample of the properties as part of the risk assessment to ensure that the flat entrance doors have not been tampered with by residents. It is recommended that the two flats currently fitted with notional timber doors are upgraded to composite FD30S fire-resisting doors during future refurbishment works.

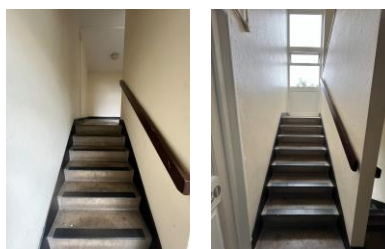
- 9) The flooring and stairway within this property are concrete construction.

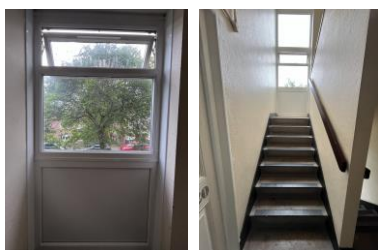
- 10) Automatic smoke ventilation is not employed. Windows fitted on the stairwell are fitted with manual openers; the windows will assist in additional lighting and any ventilation required.

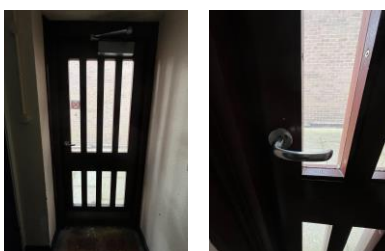
- 11) The final exit door is operated using a levered handle to egress the building and are also fitted with automatic closing devices that are checked on a regular basis by caretaking teams as part of their checks. Defective closing devices are replaced either by the Caretaking Team(s) or the in-house repairs team(s). The final exit doors have door entry systems installed. These systems are designed to fail safe i.e. door unlocked in the event of a power failure. This prevents residents being locked in or out of the building.

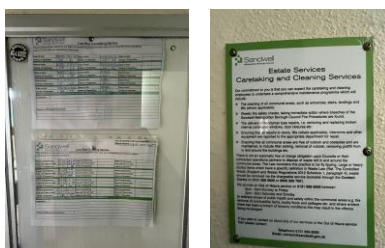
- 12) Communal areas are kept free of flammable items. The communal areas are checked on a regular basis by Caretaking / Cleaning teams 365 days per year and all items of rubbish are immediately removed. There is also an out of hour's service that allows combustible items of furniture / rubbish to be removed.

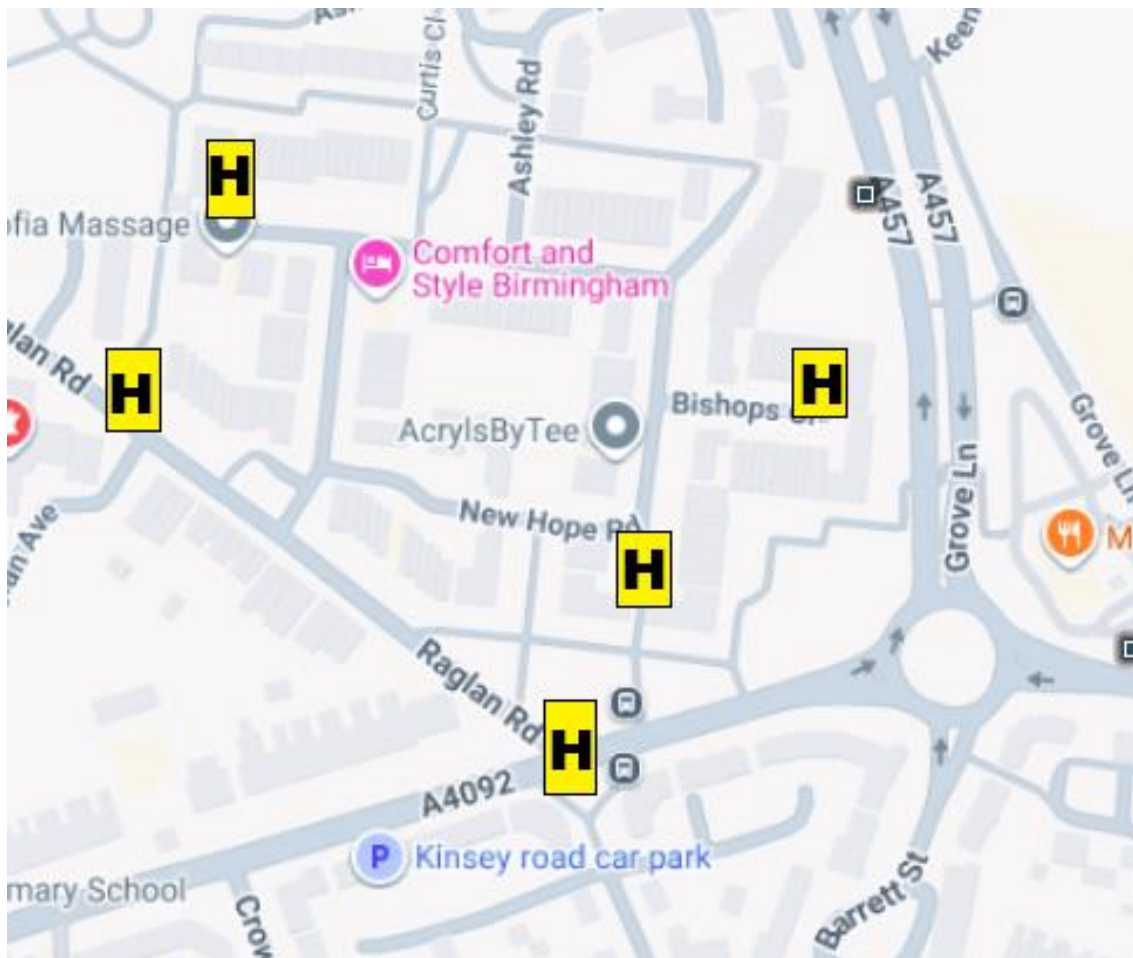
- 1) There is no firefighting equipment on this premises.
- 2) Nearest fire hydrant is indicated within the attached plan. Information from <https://dataservices.riscauthority.co.uk/map/index>

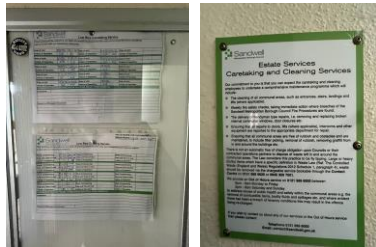
- 1) There is a regular Cleaning Service to the premises.

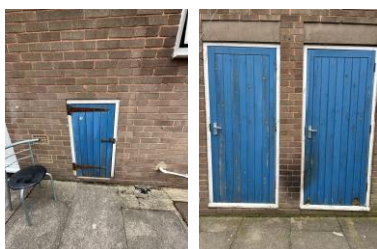
- 3) Residents should not store flammable liquids or gas cylinders on site.
- 4) No Flammable liquids stored on site by Caretakers / Cleaners.
- 5) There are three individual storage rooms allocated to specific flats, accessible only by the respective residents. Also located within this wall is the entrance door to the ground-floor flat. This rear area forms part of a secure courtyard, enclosed by metal railings with gated access.
