# Fire Risk Assessment

## Scribbans Place 50-64

**Durban Road,  
Smethwick, B66 3SG**

**Date Completed: 08/06/2026**

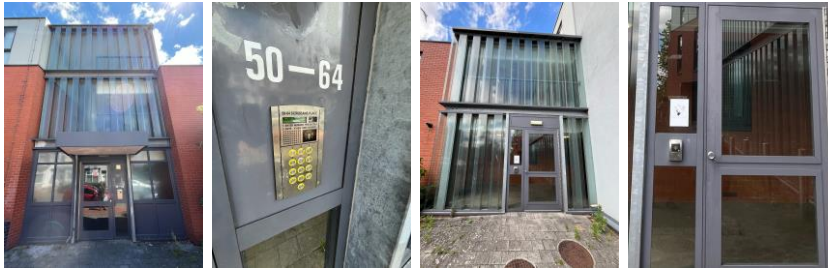
Door access control to the front and rear

Firefighter's switch is only present at the front entrance

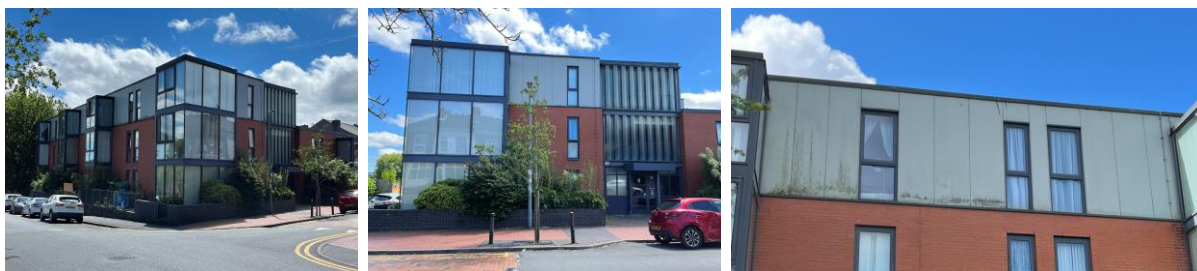
Front elevation and Eternit Fibre Cement Boarding.

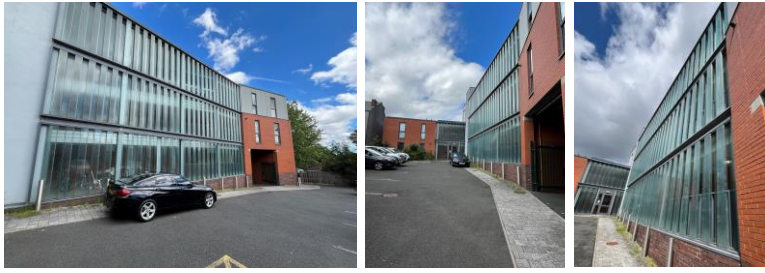
Rear elevation with staggered glass columns

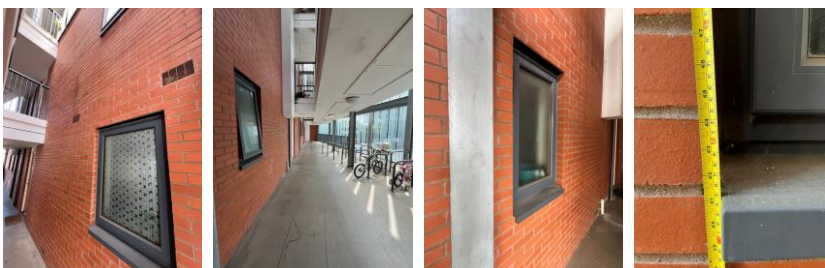
- 1) The primary means of escape proceeds via a partially open-sided, atrium-style lobby featuring a semi-glazed roof and full-height, staggered glass columns on three elevations that provide a significant level of continuous natural ventilation. While existing flat windows opening into this communal space are openable, the risk of fire and smoke logging to escaping occupants is currently deemed sufficiently mitigated due to the high window threshold heights, the substantial natural airflow, the adequate width of the escape route, the nominal FD30S fire door protection, and the building's 'Stay Put Unless' strategy. However, to further enhance compartmentation and long-term safety, consideration should be given to replacing these openable flat windows with fixed, fire-rated glazing units as part of any future building refurbishment programme.

Flat windows opening onto communal areas

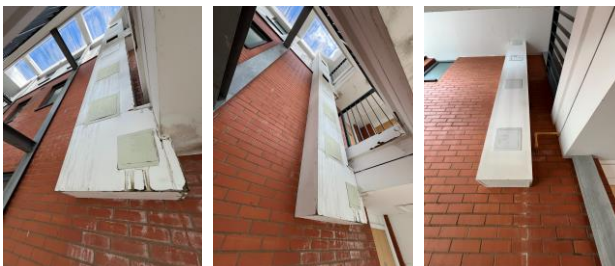
- 7) There are 3 soil stack service ducts installed on the internal walls with the means of escape, these are constructed out of timber with plastic inspection panels to the front.

- 8) It was noted that there are a few plastic inspection panels missing of the soil stacks. The ducts are not required to be fire stopped; however, it is recommended that the inspection panels are to be replaced as part of a routine maintenance.

- 11) Inspection panels to the soil service stacks are to be replaced as part of routine maintenance. Email has been sent to repairs on the 23/06/2026.

Inspection panels to the soil service stacks are to be replaced as part of routine maintenance. *Email has been sent to repairs on the 23/06/2026.*

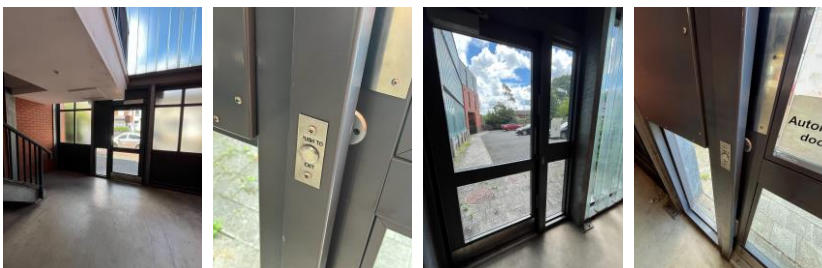
- 14) The final exit doors to have a door entry system installed. This system is designed to fail safe i.e. door unlocked in the event of a power failure. This prevents residents from being locked in or out of the building.

Front and rear final exit doors with failsafe exit.

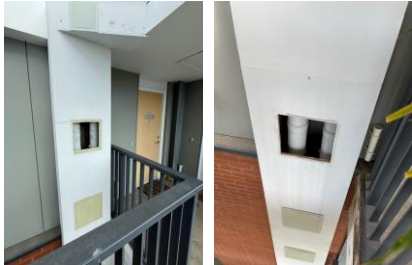
- 12) Cladding to the external wall facing on to the communal corridor for flat 64 has bowed and come apart from its supporting structure compromising the compartmentation between communal area and flat. *Email sent to Responsive Repairs on 23/06/2026*

Cladding to the internal wall on flat 64 has bowed and come apart from its supporting structure. *Email sent to responsive Repairs on the 23/06/2026*
