Fire Risk Assessment

Bearwood Road 200-238

Church Gardens 1-20, 29-48, 53-72

**Smethwick,
B66 & B67**

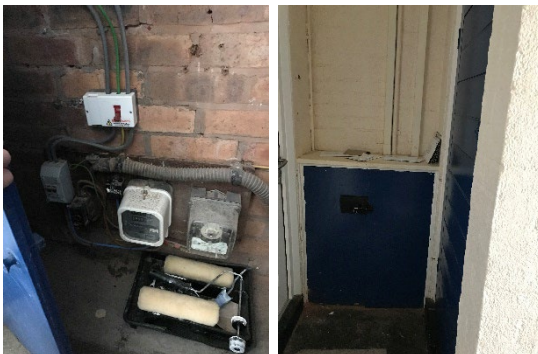
- 11) Residents meter cupboards are timber storage units located outside each maisonette within the communal areas.

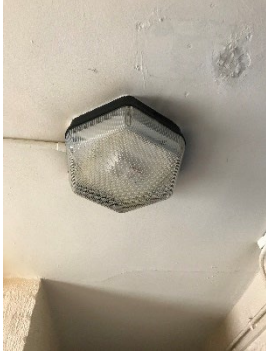
27) conventional lighting was present along the means of escape.

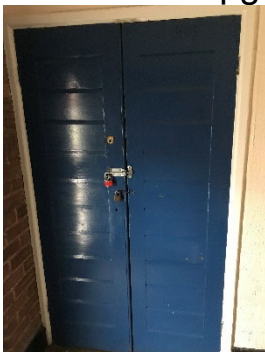
- 4) All communal fire doors are subject to an annual check by the Fire Safety Rapid Response Team.
- 5) Residents have access to communal cupboards along the means of escape. These are not fire rated doors and consideration should be taken to upgrade these with future improvements to the blocks.

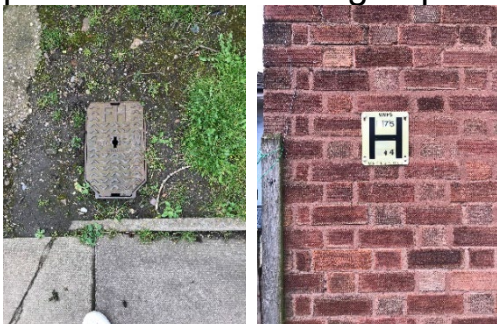
- 1) The Premises have no firefighting provisions.
- 2) Note there is Fire Hydrants located near the blocks and signage is posted on the building depicting the location.

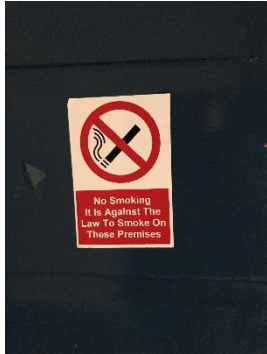
- 1) Smoking is prohibited within any communal parts of the building in line with Smoke Free England legislation. With signs displayed in communal areas.

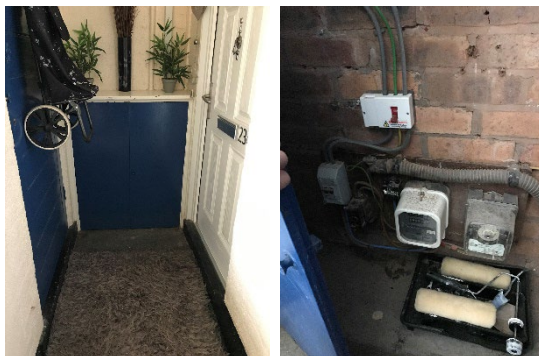
- 2) Hot working is not normally carried out. If essential maintenance requires the use of hot work processes, then corporate policies and procedures are to be followed.
- 3) Portable electrical equipment used as part of the Caretaking / Cleaning regime is subject to annual PAT Testing. This information is held by the Estate Services Manager Bryan Low.
- 4) **The fixed electrical installation shall be tested every 5 years. It was noted that the last inspection at Bearwood road was completed in 2012 and is now out of date, the inspection dates for church gardens were all the same being conducted on the 05/12/2019.**
- 5) Residents have meter cupboards located outside their dwellings stored within timber.
