# Fire Risk Assessment

## Priory Close 5 - 9

**Priory Close,  
Smethwick  
B66 3SL**

**Date Completed:** June 2026

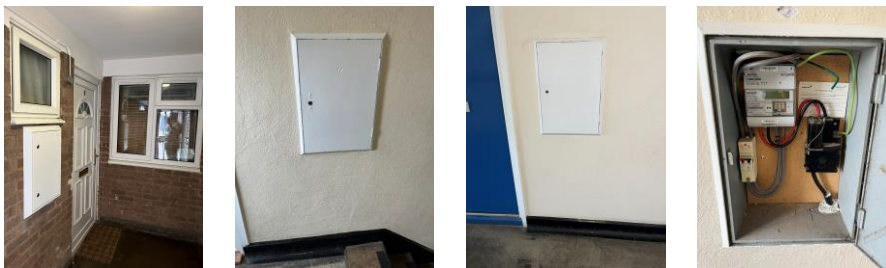
- 18) Ground floor flat 5 has UPVC window units that face into the communal hallway of the block, Recommendation on any future refurbishment of the block these are to be removed and replaced with sufficient fire resistance to maintain complete compartmentation between the flat and of the communal area. **See observations.**
