Fire Risk Assessment

1 - 3

**Curtis Close,
Smethwick,
B66 2RE**

Date Completed: 20/05/2026

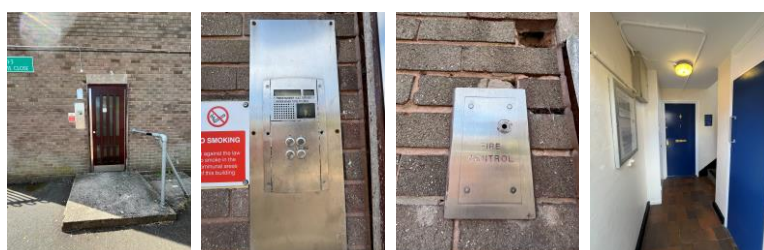
Safety/security light installed at each side of the building, no light was present at the entrance side of the building. This is to be recommended for a future install.

Entrance Door light: It is recommended that a light is installed adjacent to the entrance door to assist with safety and security in this area.

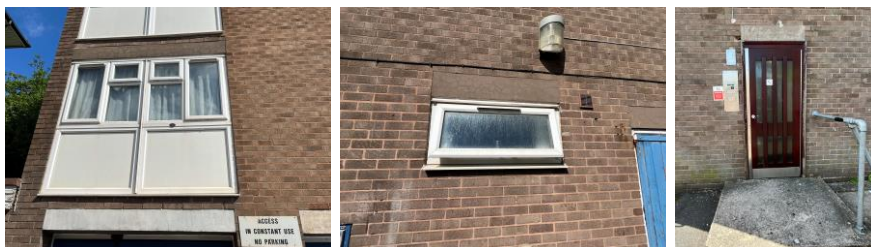
- 2) uPVC double-glazed units have been installed in each flat and one at the top of the communal stairway. A security/safety light is fitted within the courtyards; installation of a light is recommended for next to the entrance door. The entrance door is timber construction with glazed panels.

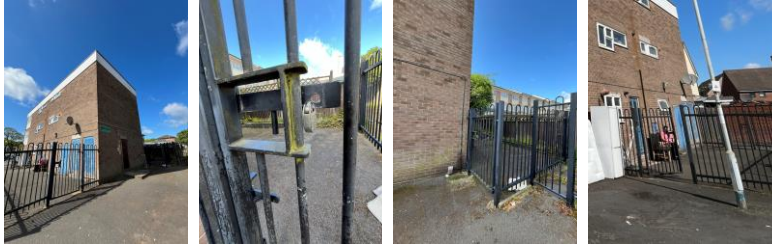
- 3) The two courtyards, located on adjacent sides of the building, are secured by metal railings. One courtyard was locked with a padlock at the time of inspection. The other courtyard was unsecured and provided access to the storage cupboards, the bin room, and a secondary entrance to Flat 1.

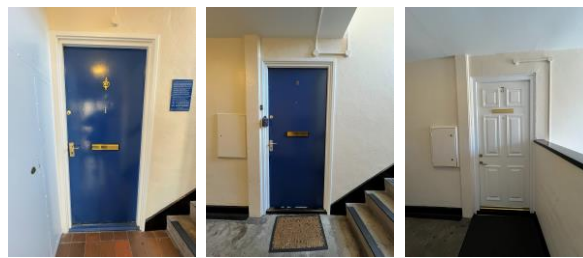
Access was gained to Flat 1. The entrance door has an excessive threshold gap, and the drop hinges do not allow the door to self-close. This is a leasehold property.

- 1) Each property is fitted with a minimum of an LD3 detection system within the flat. See Section 8
- 2) All corridors are of adequate width (at least 1050mm) and will be maintained clear to that width as a minimum
- 3) None of the corridors that form part of the means of escape are dead ends.
- 4) Two flats within the block are fitted with timber notional doors, the other flat has a composite FD30 door fitted.

a) Flat 1 (Leaseholder): The entrance door to Flat 1 is non-compliant, lacking a self-closing device and presenting an excessive threshold gap. A compliant drop-down fire seal should be installed, or the door replaced to achieve the required fire-resisting standard.

Question/ Ref No	Required Action	Supporting photograph	Priority	Timescale and Person Responsible	Date Completed
7/5a	Flat 1: New door required due to no self closer and an excessive threshold gap. Repair if not renewing the door	 	P3	Within 3-6 months Leasehold Manager

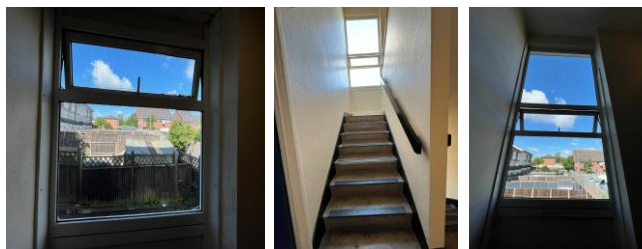
9) Automatic smoke ventilation is not employed. Windows fitted on the stairwell are fitted with manual openers; the windows will assist in additional lighting and any ventilation required.

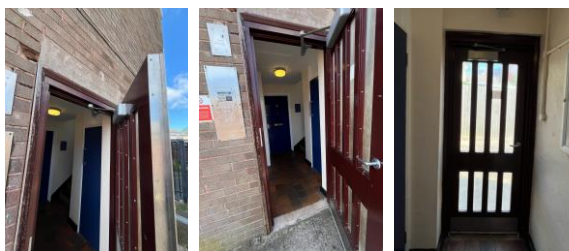
11) The final exit doors are operated using a handle to egress the building and are also fitted with automatic closing devices that are checked on a regular basis by caretaking teams as part of their checks. Defective closing devices are replaced either by the Caretaking Team(s) or the in-house repairs team(s). The final exit doors have door entry systems installed. These systems are designed to fail safe i.e. door unlocked in the event of a power failure. This prevents residents being locked in or out of the building.

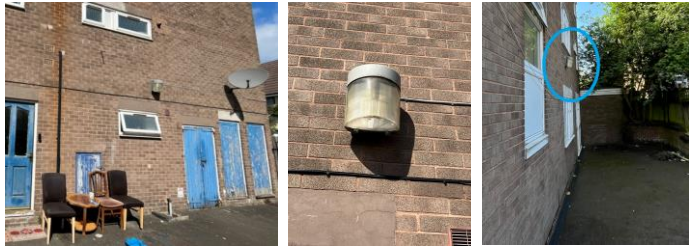
- 1) Regular checks are undertaken by Caretakers / Cleaning Team(s) 365 days per year which helps reduce the risk of arson.
- 2) Access to the premises is by means of a fob, individual flat call point and by using a fire fighters drop key.
- 3) Sides of the building within the courtyards are covered by external lighting, lighting is required at the premises entrance door for safety and security.

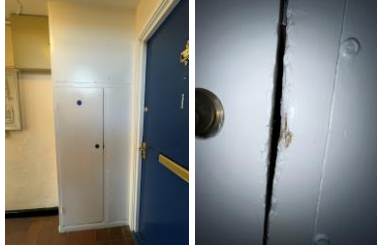
7/10	<p>Adjacent Flat 1: Reduce the gap on the service-cupboard door using appropriate fire-stopping and fire-rated door furniture.</p>

10) **In the communal ground-floor area adjacent to Flat 1, there is a service cupboard. Access to this cupboard was not available at the time of the fire risk assessment; therefore, no observations can be made regarding any internal conditions or potential hazards. The cupboard door has a substantial gap along the closing edge, which requires appropriate fire-stopping to restore its fire-resisting performance. *Fire Door Keep Shut* signage is present on the door.**
