# Fire Risk Assessment

## Manifoldia Grange

**Coyne Road, West Bromwich,  
B70 7JU**

**Date Completed:** 21<sup>st</sup> January 2026

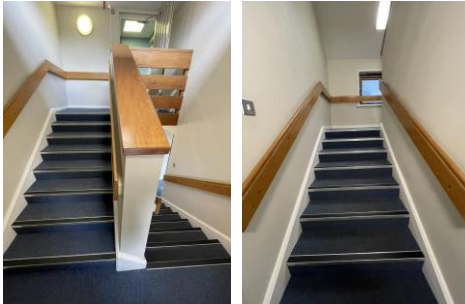
- 1) The site has four staircases that provide a means of escape, these are approximately 1040mm in width.

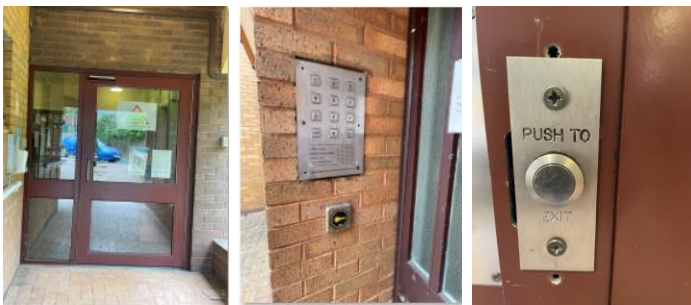
- 10) There are three final exits from the central building (offices / meeting room) therefore occupants have can escape in three of directions.
- 11) The main entrance / final exit door to the central building (office) has a door entry system installed. This system is designed to fail safe i.e. door unlocked in the event of a power failure. This prevents occupants from being locked in or out of the building.

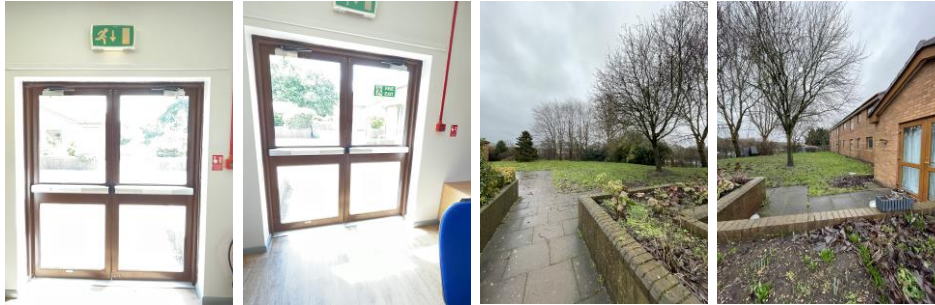
- 12) The remaining two exits are within the former lounge and dining room which is now an open plan office/meeting facility. These exit doors to the rear garden are 1420mm wide, push bar operated and lead to the rear garden. Although the garden is enclosed, there is a final exit gate to escape from the area to a place of ultimate safety.

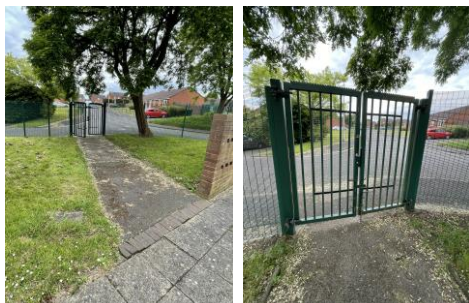
- 15) The final exit door adjacent flat 28 leads into an enclosed garden area with perimeter fencing and double gates. The gates are equipped with a thumb turn lock allowing for easy access to the street.

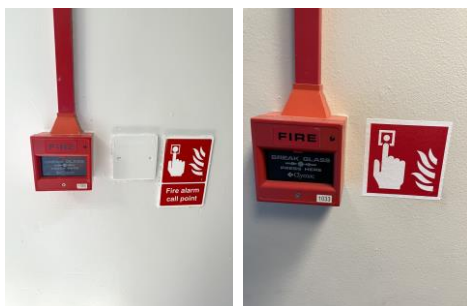
- 3) Fire Alarm Call Points are strategically located within the premises, including beside the rear exit doors of flats 2, 3, 11, 23, 24, 32.

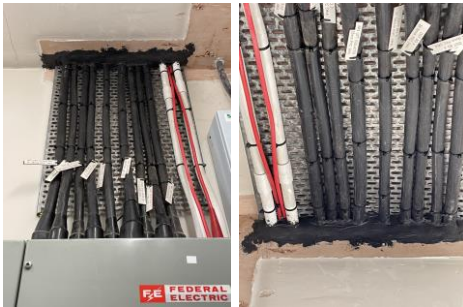
- 1) The building is designed to provide as a minimum 1-hour vertical fire resistance and 30 minutes horizontal fire resistance.
- 2) A variety of methods / materials have been used to achieve fire-stopping including intumescent sponge, mastic and Fire batt.
- 3) There is evidence of some good fire stopping at the premises, examples such as the service cupboard where the main electrics are located on the ground floor outside the main office.

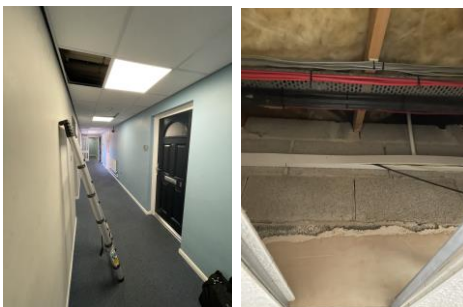
- 4) During this FRA survey ceiling tiles were removed in communal corridors to confirm compartmentation between flats, corridors, means of escape corridors and above communal fire doors.

- 5) **Lifting ceiling tiles identified that compartmentation needs to be improved, these areas are located on the first floor means of escape.**

- 6) **In isolated areas where fire resisting sponge has been used to seal voids, these should be replaced with another suitable fire resisting material. i.e., buttered fire batt.**

- 7) **Based on the findings at Manifoldia Grange it is recommended that a full compartmentation survey of the building is undertaken. This should be carried out at the earliest opportunity.**
- 8) Once this work has been completed the premises will have sufficient compartmentation to limit the travel and effect of smoke and flame in event of a fire.
- 9) There is a boiler house to the central building which is accessed externally from the front car park area. It has sufficient compartmentation extending from the boiler house up into the roof void (accessed via a ceiling hatch).

| 10/06 | In isolated areas where fire resisting sponge has been used to seal voids, these should be replaced with another suitable fire resisting material. i.e., buttered fire batt. | | P3 | Within 3-6 Months Fire Rapid Response | |

| 10/07 | Based on the findings at Manifoldia Grange it is recommended that a full compartmentation survey. An approved contractor should carry out this assessment. | | P3 | Within 3-6 Months Asset Management | |

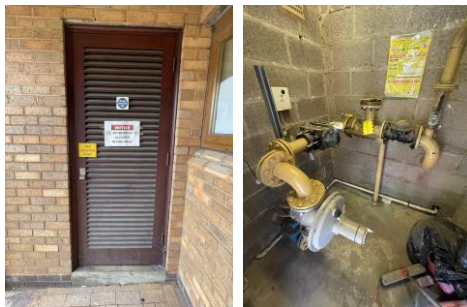
- 9) Gas appliances and pipework (where installed) are subject to annual testing and certification. This cyclical contract is managed by the in-house Gas Team. The incoming gas supply and isolation point is located within a dedicated external cupboard adjacent the main entrance to the building.

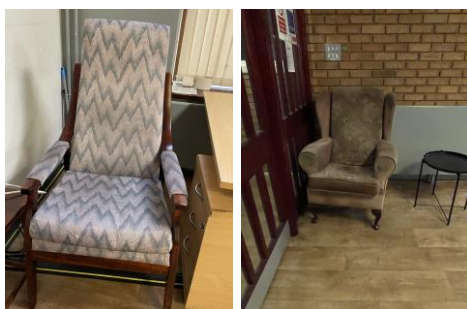
- 10) Soft furnishings in the open plan office should be maintained to ensure they are compliant with British Standard 7176 & the Furniture and Furnishings (Fire Safety) Regulations 1988/1989, 1993 and 2010.

Should any damage, rips or tears of fabric occur, the chairs should be removed from service.
