Fire Risk Assessment

**Maisonettes 231 - 243
St Marks Road,
Tipton,
DY4 0SZ.**

Date Completed: 18/07/2024.

Officer: A Jones Fire Risk Assessor.

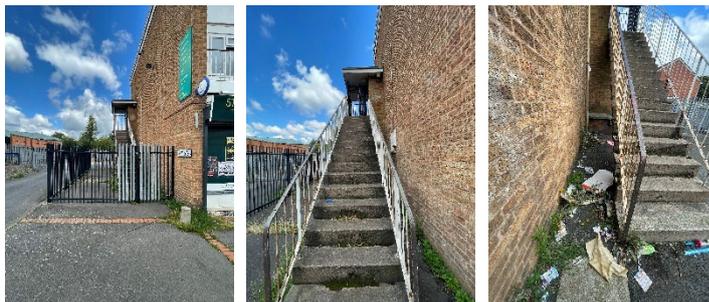
The residential dwellings are accessed from St Marks Road via two external concrete stairways accessed from either end of the premise.

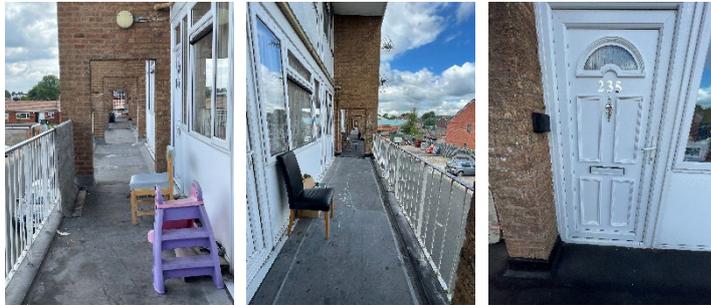
Maisonettes have UPVC double glazed window frames and UPVC frontage leading onto an open deck access. Each dwelling has its own independent front door directly off this deck access.

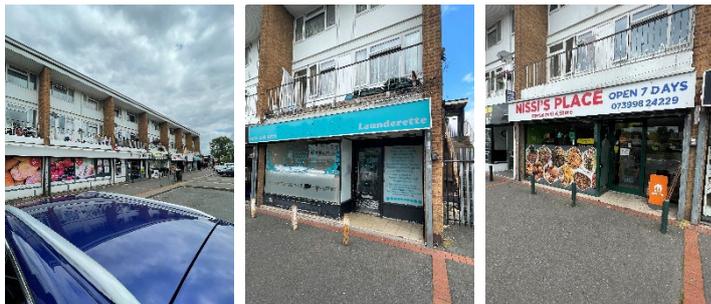
Each Maisonette has individual balcony area to front of the building, the balcony is accessed from individual first-floor door.

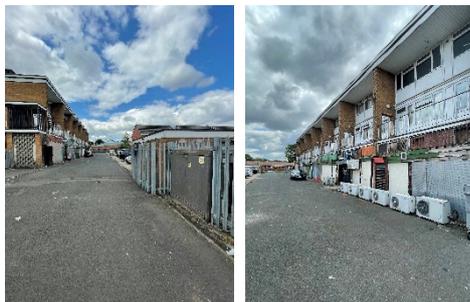
The secured rear area is occupied by commercial premises located on the ground floor. Gates to access the rear area are located in Strathmore Road.

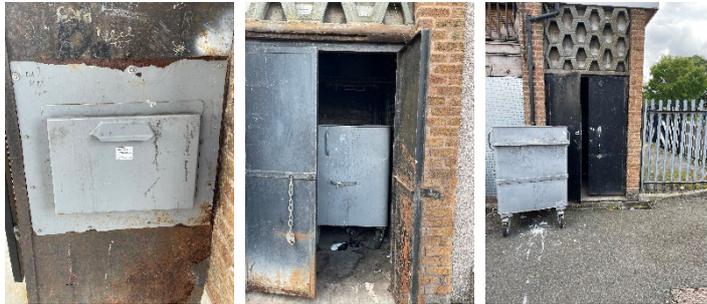
Residents use refuse chutes at first floor level to dispose of any rubbish. All refuse is collected at frequent intervals by the local authority.

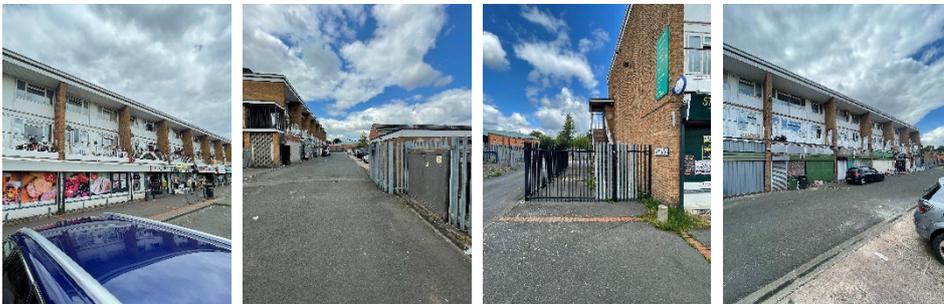
- 1) The external envelope of the premise is predominantly traditional brick, concrete construction, UPVC double glazed window frames surmounted by a flat bitumen roof.
