Fire Risk Assessment

Birchcroft

**Windmill Lane,
Smethwick, B66 3LN**

Date Completed: 13/08/2025

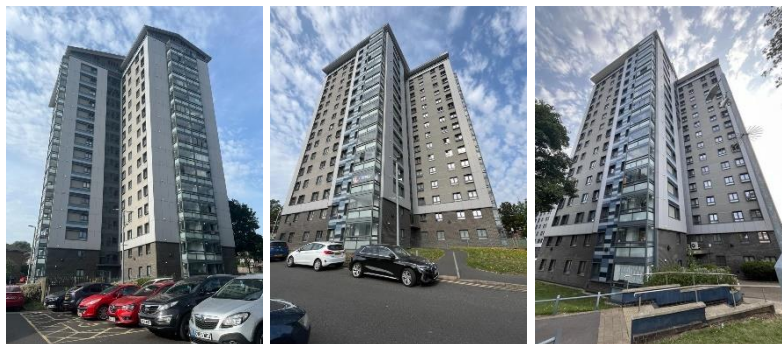
This high-rise block was constructed in 1966. The height of the block is 37.6 metres. In 2016, a comprehensive refurbishment was undertaken, upgrading the external wall system across all elevations. Additionally, a new pitched roof with an aluminium standing seam PIR core covering and a solar PV system was installed. Other improvements included replacement windows and balcony doors, glazed balcony enclosures, new front entrance porches, landscaping enhancements, and additional parking provisions.

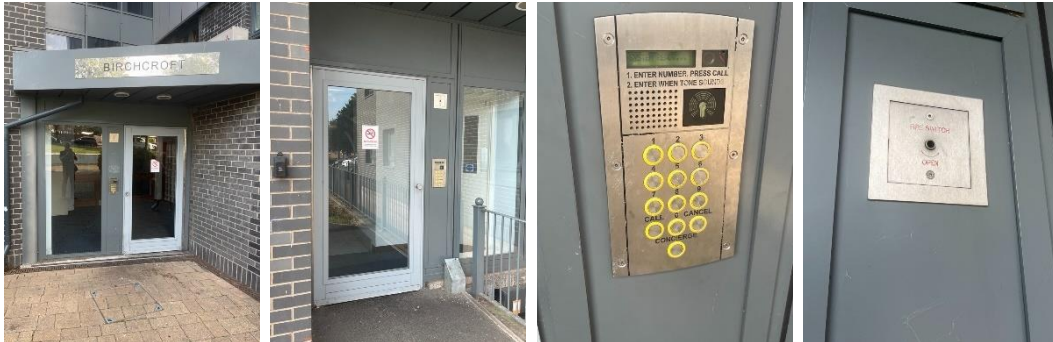
The block has a main entrance to the front elevation and a further entrance / exit located to the rear. The main entrance has a door entry system, both entrances have a fob reader and a firefighters drop key box installed.

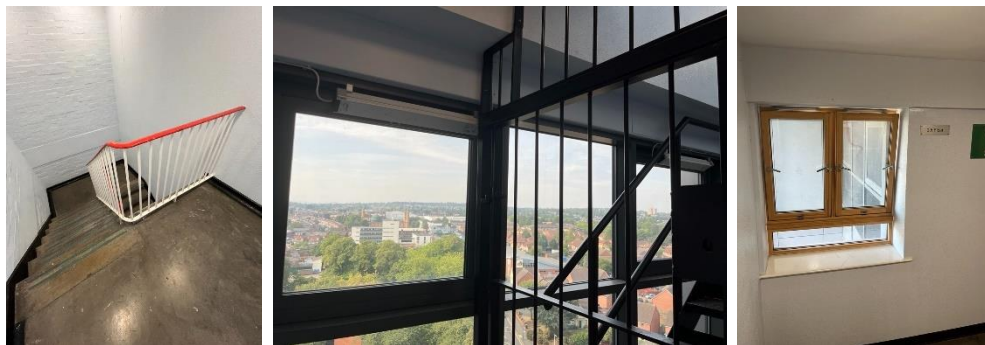
There is a single staircase which provides a sufficient means of escape. The stairwell is ventilated by AOV vents at the top of the stairwell and has openable windows on some floors.

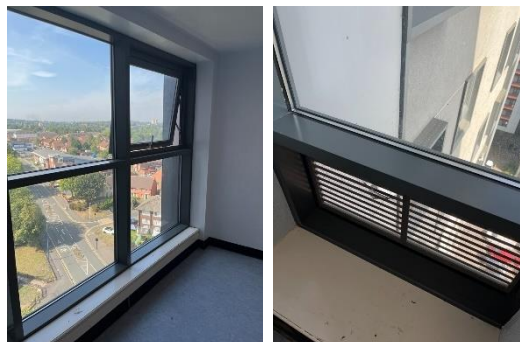
The communal corridors have natural ventilation by openable windows (the smaller left-hand flat lobbies have no ventilation). The bin chute area on each floor has natural ventilation by means of a louvered vent.

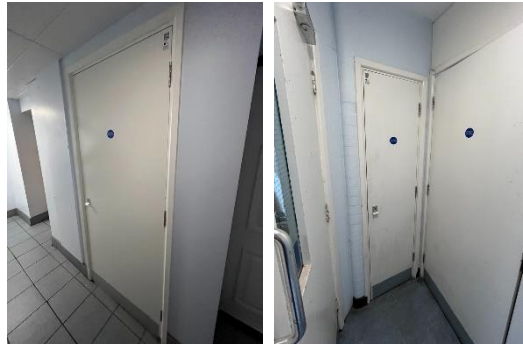
There are service cupboards on all floors for electrics, water and communications, locked with a suited 54 key.

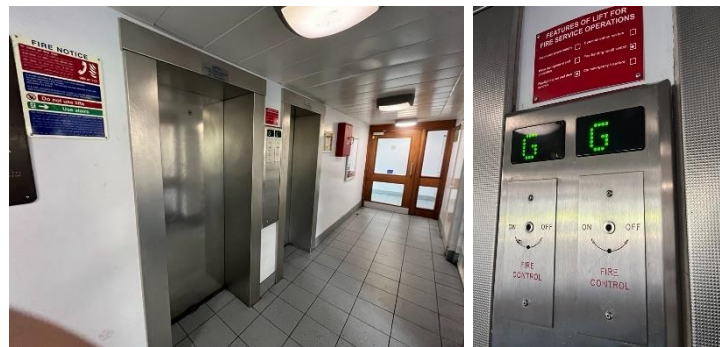
There are two lift cars that serve alternate floors, the capacity for each lift is 8 persons or 630kg. The lifts have a firefighter control facility.

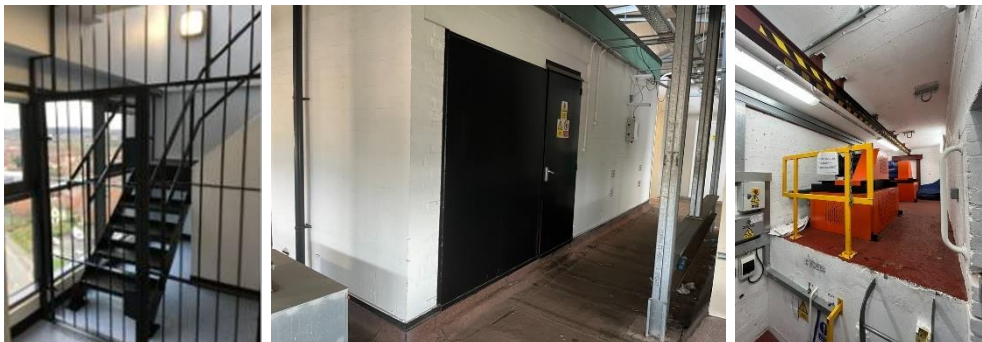
The lift motor room is located within the roof void. Access to the lift motor room is via a steel gate secured with a suited 54 lock. Then utilise the metal stairs leading from the 14th floor, then through a full height door (secured with suited 54 locks) into roof space.

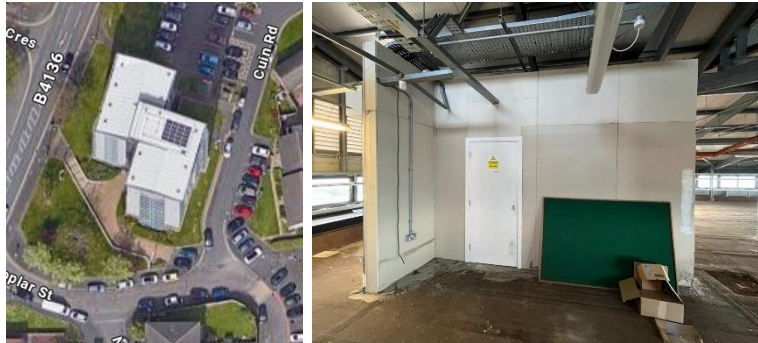
The block is fitted with a solar photovoltaic system on the roof. The roof void houses the PV system electrical switchgear.

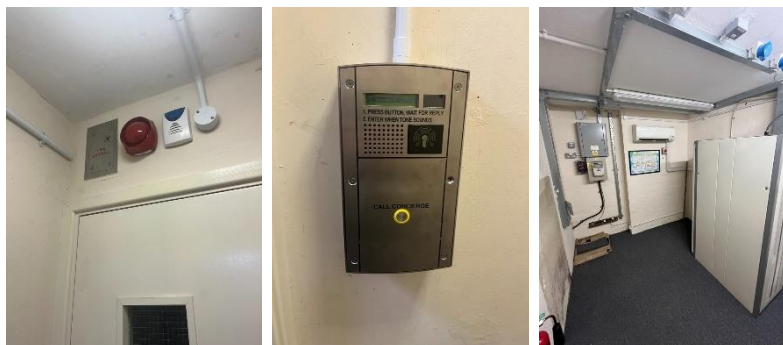
The ground floor of the block contains a CCTV/server room which is accessed from the main entrance lobby. Access is gained to the room via the firefighters drop key or by contacting the concierge. The server room has its own fire alarm panel / system.

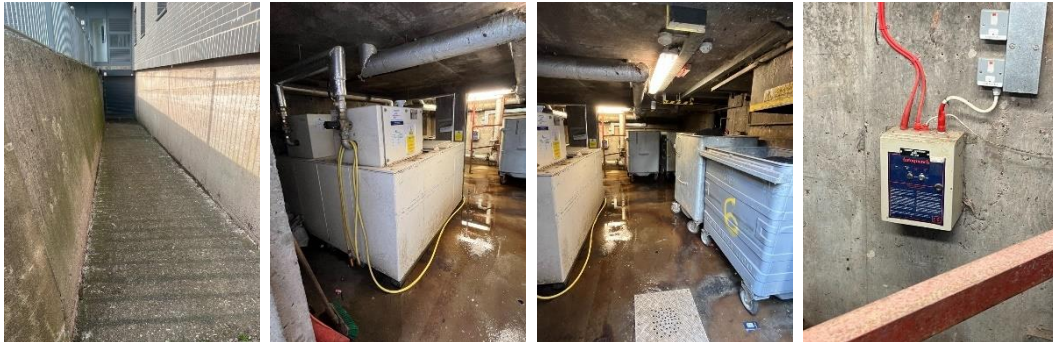
The bin store is in a small lower ground room, accessed from the rear of the block, down a ramp. This compartment contains the bin room, the control panel for the bin store deluge system and the water pumps.

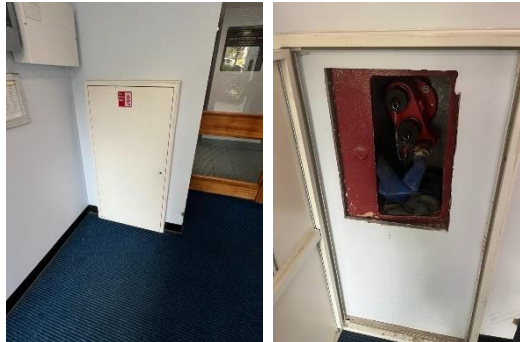
The dry riser inlet is located within the ground floor lobby, inside a cupboard secured with a budget lock.

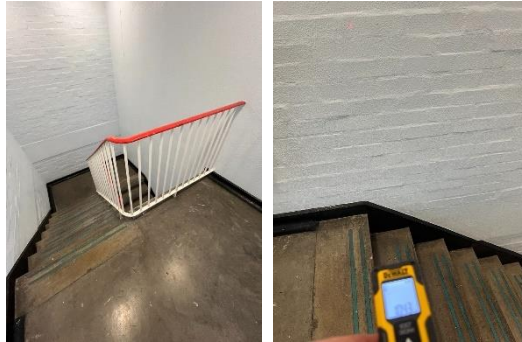
- 1) The site has a single staircase that provides a means of escape and is 1050mm in width.

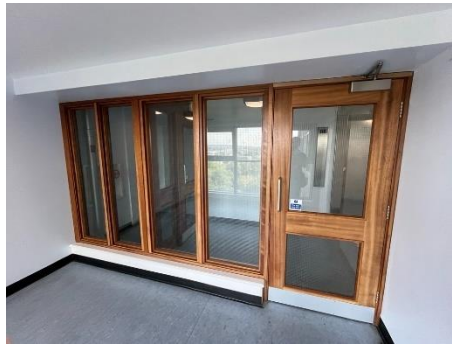
- 4) The means of escape are protected to prevent the spread of fire and smoke.
- 5) The communal landing / staircases are protected by use of self-closing FD30s fire doors with vision panels & intumescent strips / cold smoke seals.

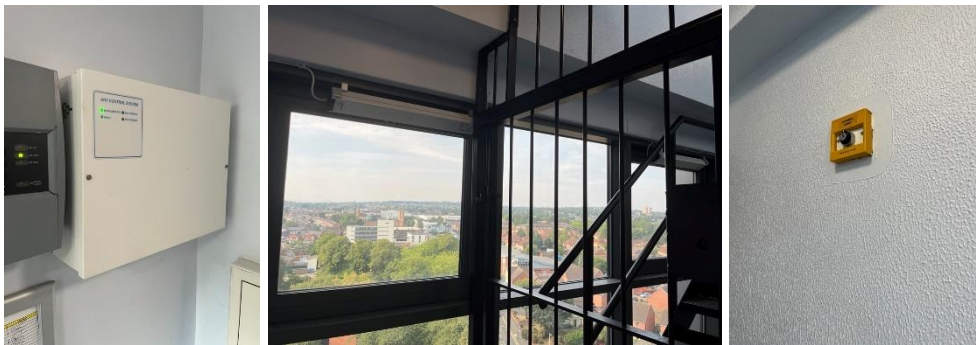
- 9) Automatic smoke ventilation is employed. This is tested, inspected and maintained by a competent procured contractor in accordance with BS7346. The frequency for the maintenance checks is twice per year (April and October) of each calendar year.
- 10) Automatic smoke ventilation is installed to the two windows at the head of the staircase on the 14th floor. The controls and repeater panel are in the ground floor lobby. A further reset switch is located at the top of the stairs on the 14th floor.

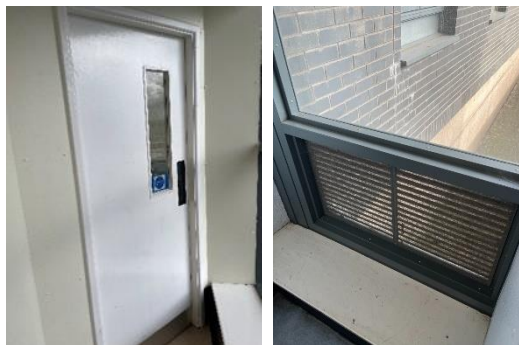
- 11) The chute room doors on each floor are FD30s fire doors with combined intumescent strips & cold smoke seals and overhead self-closing devices. The chute room on each floor has louvres to provide natural ventilation.

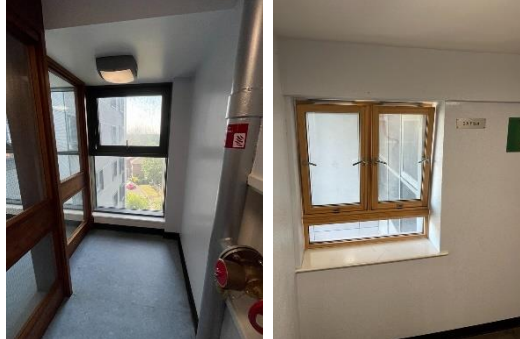
- 12) Communal windows can only be opened with the use of a key or by operating the automatic smoke vents. The timber windows to the staircase do not require a key.

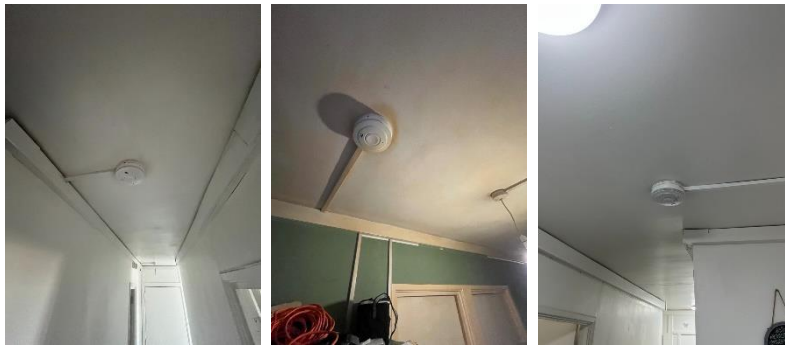
- 1) Early warning is limited to hard wire or battery smoke alarms within each of the resident's flats. The equipment is subjected to a cyclical test.
- 2) Based on the sample of properties assessed during the fire risk assessment, residents confirmed that smoke alarms are installed to an LD1 and LD2 Standard. Flats assessed were: -

Flats; 90 LD1, 85 LD2, 83 LD2, 77 LD2, 71 LD1, 65 LD2, 64 LD1, 60 LD2, 42 LD2.

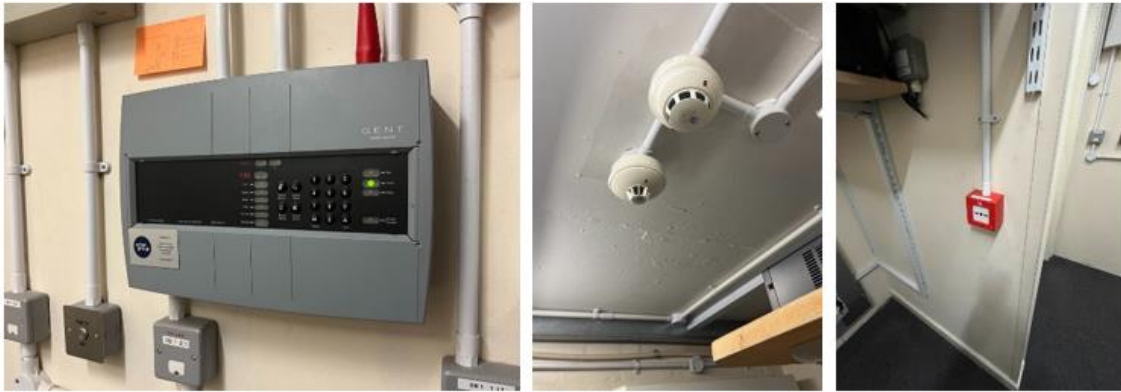
- 8) The CCTV/server room is equipped with an automatic fire alarm system. The system protects the server room only and incorporates smoke detection and a break glass call point.

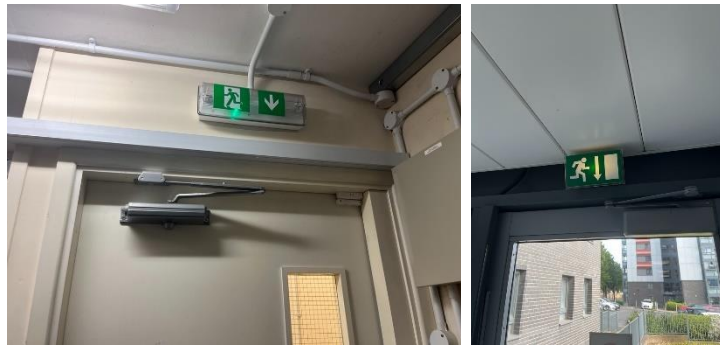
- 1) The premises has a sufficient emergency / escape lighting system in accordance with BS 5266 and has test points strategically located.

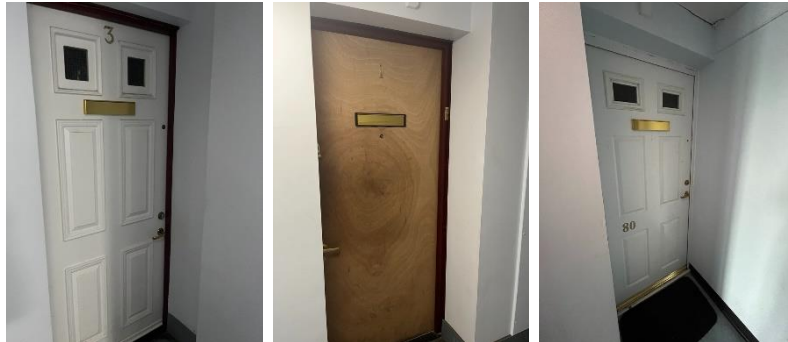
- 10) Individual flat doors are nominal FD30s timber doors or FD30s rated composite doors sets manufactured by: Permadoor or IG.

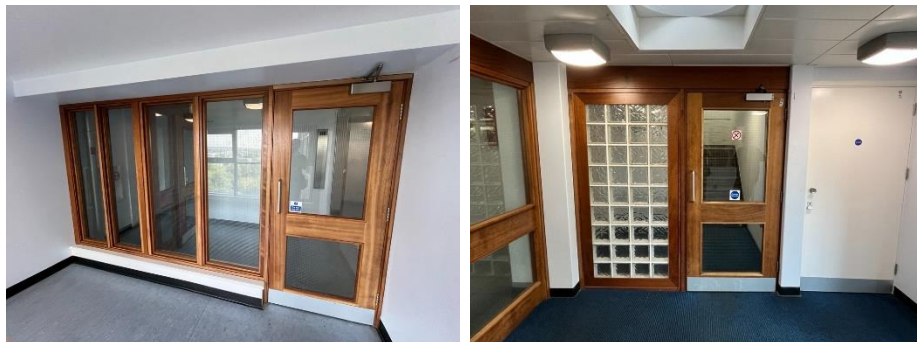
- 11) The corridors / staircases are protected by use of self-closing FD30s fire doors with combined intumescent strips / cold smoke seals and vision panels consisting of Georgian wired glazing.

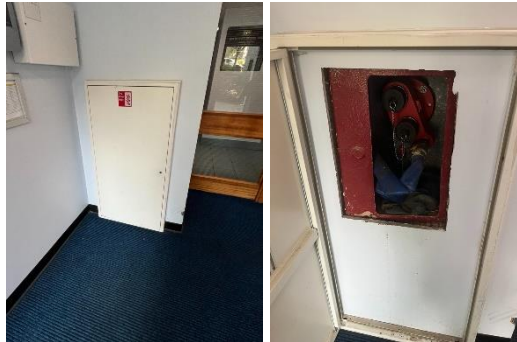
- 1) The dry riser inlet is located within the ground floor lobby, inside a cupboard secured with a budget lock.

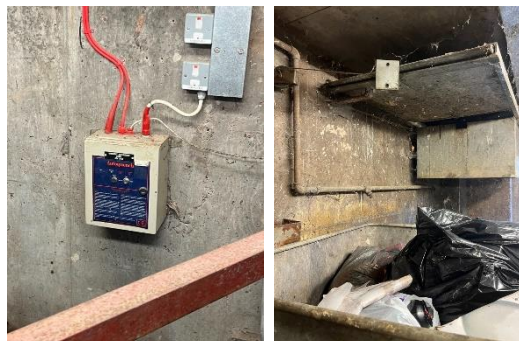
7) A fire suppression system is fitted in the bin room.

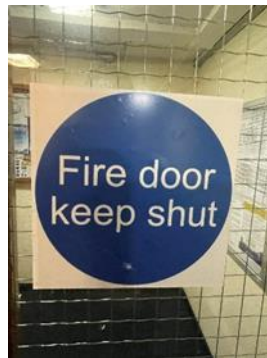
- 1) Fire doors display “Fire Door Keep Shut” where appropriate.

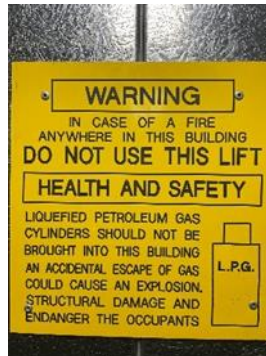
- 4) Yellow LPG warning signs are displayed within the lift cars.

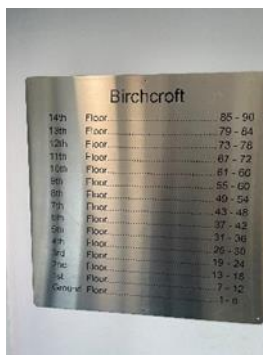
- 6) Signage illustrating the floor location of each flat is fitted to the ground floor lobby wall.

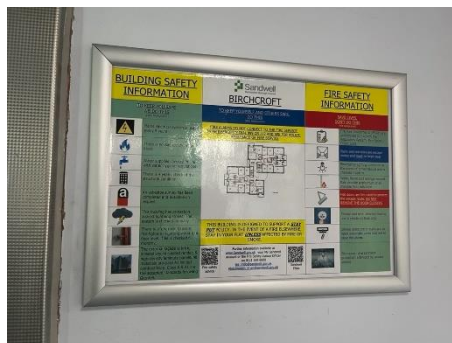
- 1) All Caretaking / Cleaning Employees have undertaken fire safety training. This includes use of bespoke 'Fire Safety in High / Low Rise Flatted Accommodation' Video.
- 2) All employees are encouraged to complete 'In the line of fire' training on an annual basis.
- 3) Caretaking Teams are not currently trained in the effective use of fire extinguishers. The only extinguishers are located within the lift motor room. Caretaking Teams are not expected to tackle fires in this area.
- 4) Building safety and evacuation notices are displayed in common areas and lift cars.

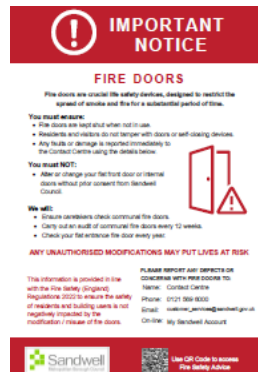
- 6) Fire safety has been provided as part of tenancy pack. This includes information about Fire Doors.

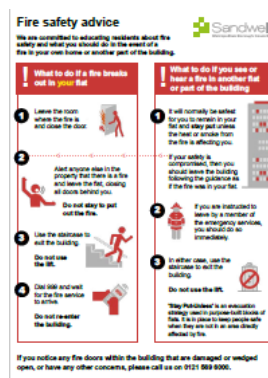
- 7) Information regarding the Stay Put unless fire evacuation strategy is provided to residents.
