# Fire Risk Assessment

## Birchcroft

**Windmill Lane,  
Smethwick, B66 3LN**

**Date Completed: 13/08/2025**

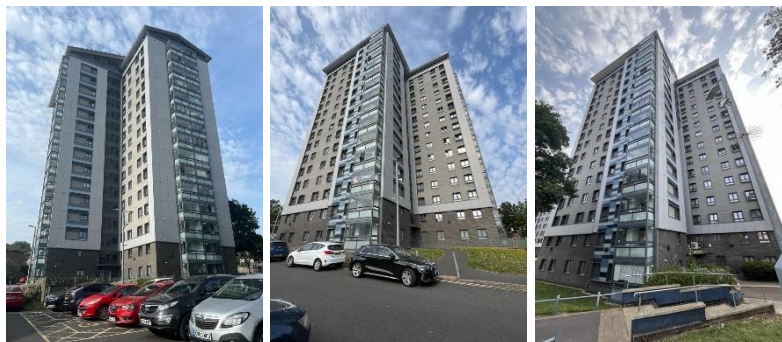
This type 1 fire risk assessment encompasses Birchcroft. This high-rise block was constructed in 1966. The height of the block is 37.6 metres. In 2016, a comprehensive refurbishment was undertaken, upgrading the external wall system across all elevations. Additionally, a new pitched roof with an aluminium standing seam PIR core covering and a solar PV system was installed. Other improvements included replacement windows and balcony doors, glazed balcony enclosures, new front entrance porches, landscaping enhancements, and additional parking provisions.

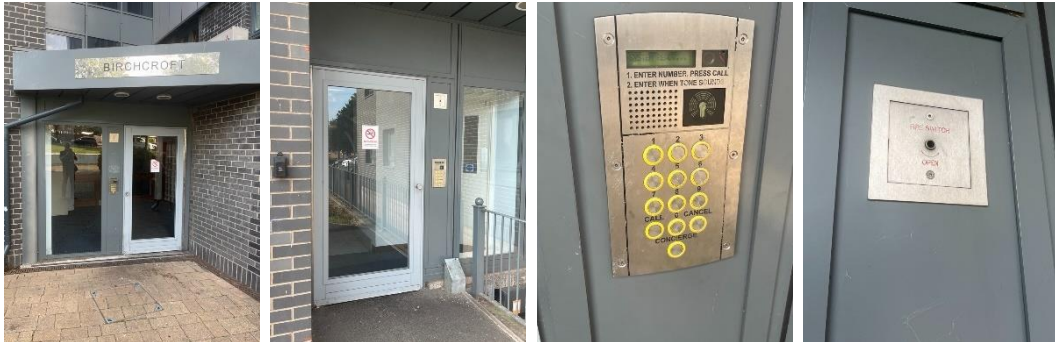
The block has a main entrance to the front elevation and a further entrance / exit located to the rear. The main entrance has a door entry system, both entrances have a fob reader and a firefighters drop key box installed.

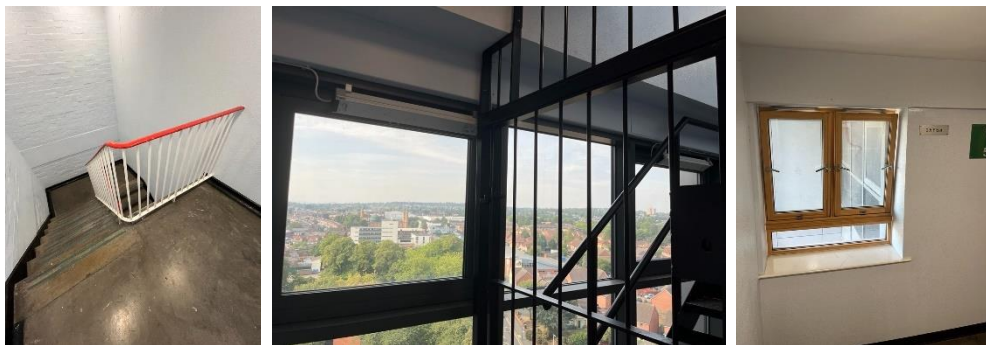
There is a single staircase which provides a sufficient means of escape. The stairwell is ventilated by AOV vents at the top of the stairwell and has openable windows on some floors.

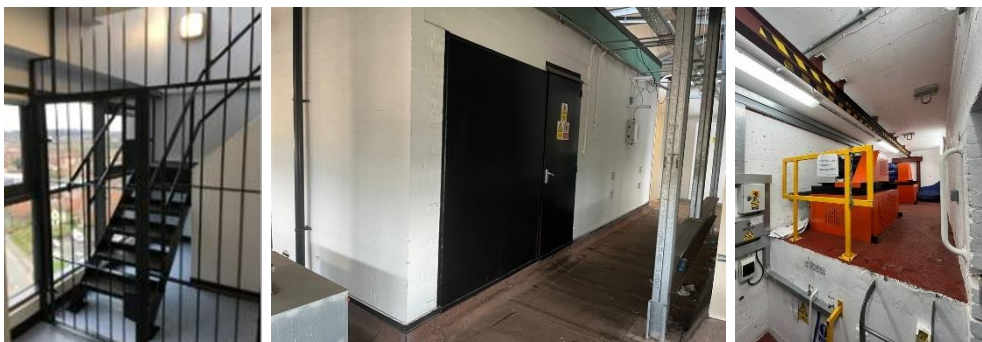
The lift motor room is located within the roof void. Access to the lift motor room is via a steel gate secured with a suited 54 lock. Then utilise the metal stairs leading from the 14th floor, then through a full height door (secured with suited 54 locks) into roof space.

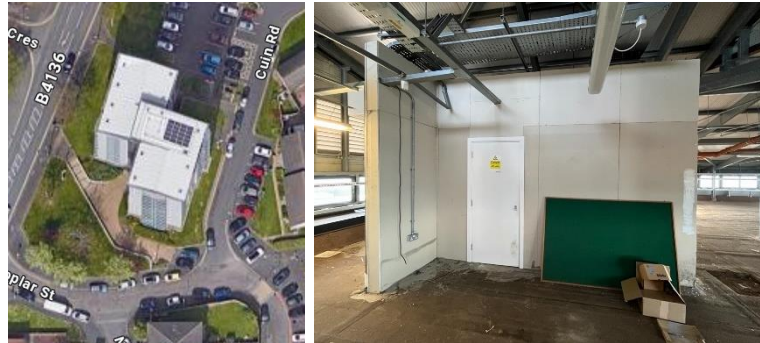
The block is fitted with a solar photovoltaic system on the roof. The roof void houses the PV system electrical switchgear.

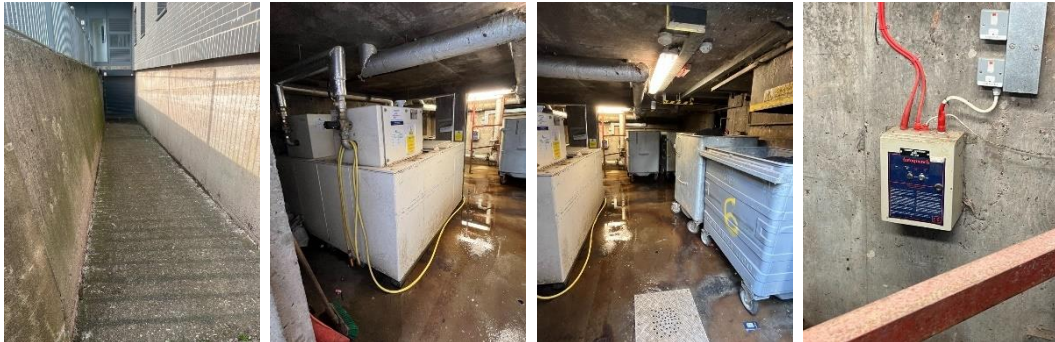
The bin store is in a small lower ground room, accessed from the rear of the block, down a ramp. This compartment contains the bin room, the control panel for the bin store deluge system and the water pumps.

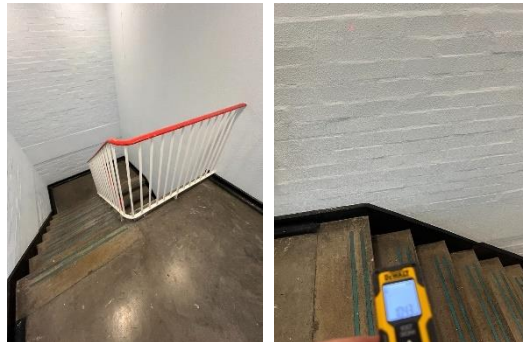
- 1) The site has a single staircase that provides a means of escape and is 1050mm in width.

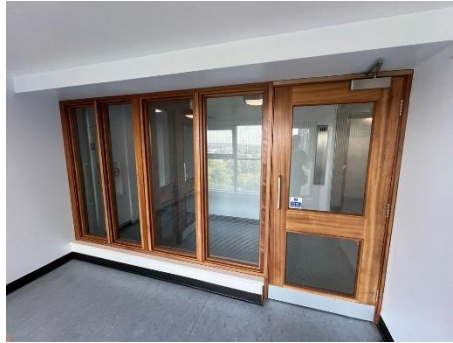
- 4) The means of escape are protected to prevent the spread of fire and smoke.
- 5) The communal landing / staircases are protected by use of self-closing FD30s fire doors with vision panels & intumescent strips / cold smoke seals.

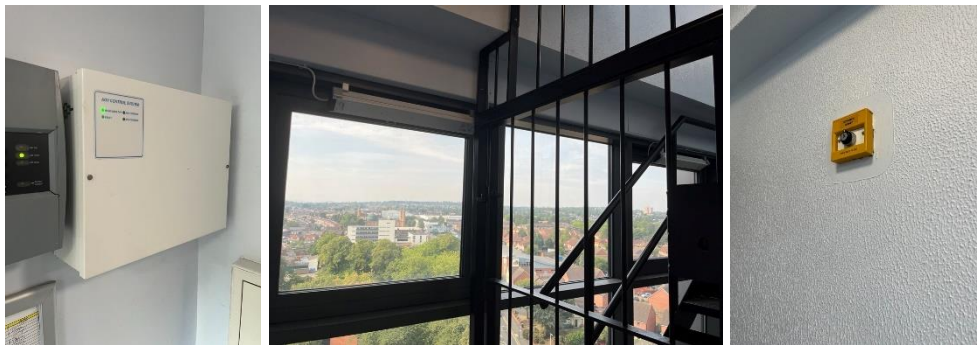
- 9) Automatic smoke ventilation is employed. This is tested, inspected and maintained by a competent procured contractor in accordance with BS7346. The frequency for the maintenance checks is twice per year (April and October) of each calendar year.
- 10) Automatic smoke ventilation is installed to the two windows at the head of the staircase on the 14<sup>th</sup> floor. The controls and repeater panel are in the ground floor lobby. A further reset switch is located at the top of the stairs on the 14<sup>th</sup> floor.

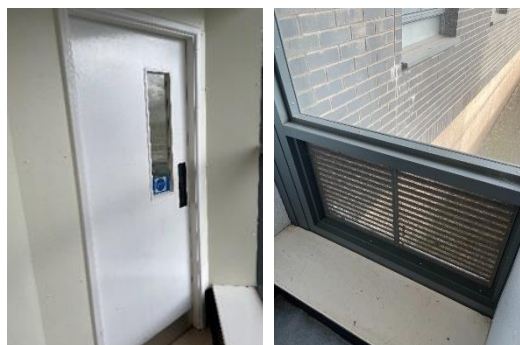
- 11) The chute room doors on each floor are FD30s fire doors with combined intumescent strips & cold smoke seals and overhead self-closing devices. The chute room on each floor has louvres to provide natural ventilation.

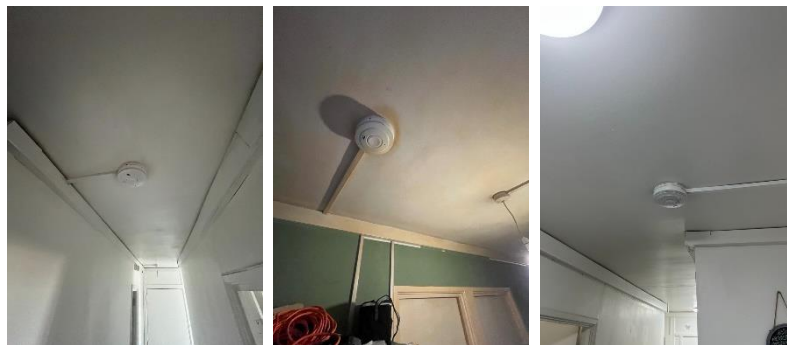
- 1) Early warning is limited to hard wire or battery smoke alarms within each of the resident's flats. The equipment is subjected to a cyclical test.
- 2) Based on the sample of properties assessed during the fire risk assessment, residents confirmed that smoke alarms are installed to an LD1 and LD2 Standard. Flats assessed were: -

Flats; 90 LD1, 85 LD2, 83 LD2, 77 LD2, 71 LD1, 65 LD2, 64 LD1, 60 LD2, 42 LD2.

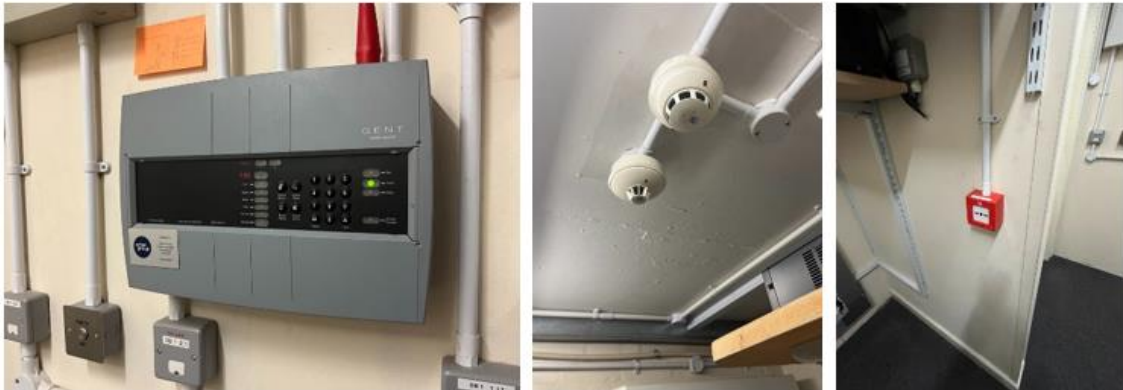
- 8) The CCTV/server room is equipped with an automatic fire alarm system. The system protects the server room only and incorporates smoke detection and a break glass call point.

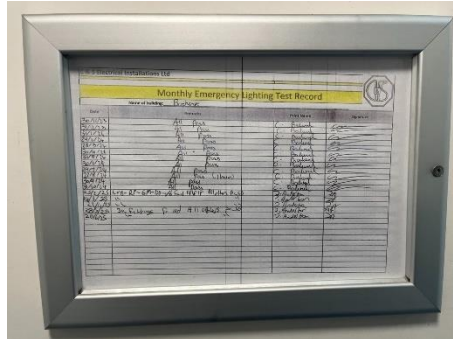
- 4) All installed equipment is checked and tested on a monthly basis by Sandwell MBC in house electrical team or approved contractor, in accordance with current standards.

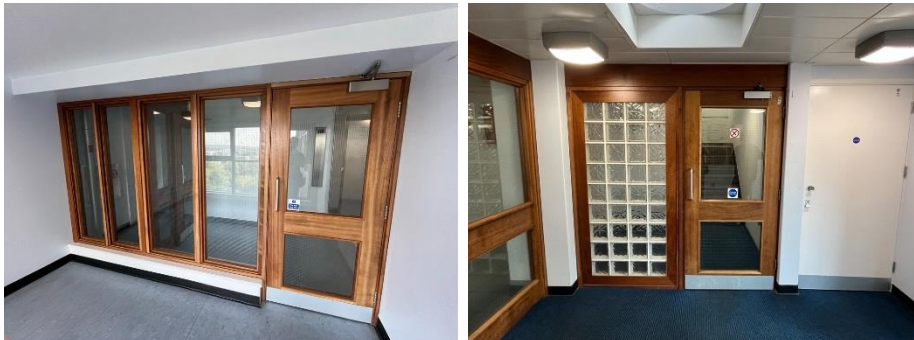
- 11) The corridors / staircases are protected by use of self-closing FD30s fire doors with combined intumescent strips / cold smoke seals and vision panels consisting of Georgian wired glazing.

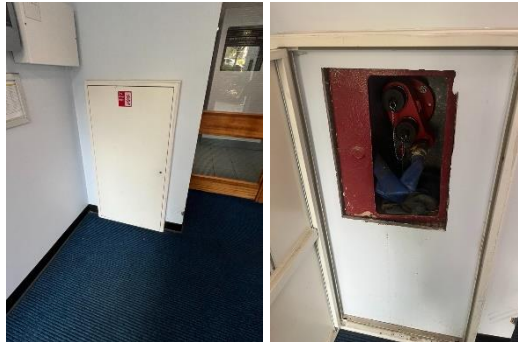
- 1) The dry riser inlet is located within the ground floor lobby, inside a cupboard secured with a budget lock.

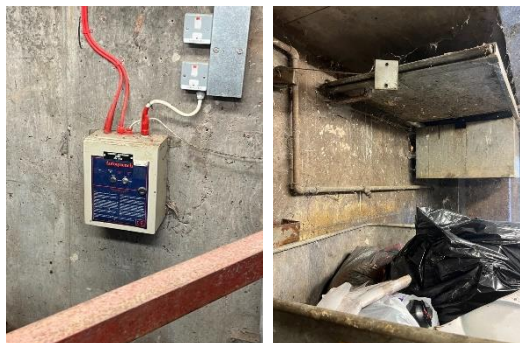
7) A fire suppression system is fitted in the bin room.

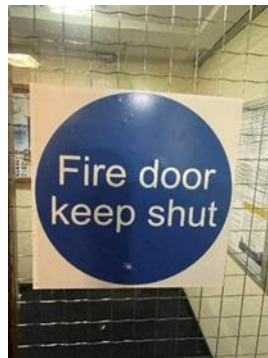
- 1) Fire doors display “Fire Door Keep Shut” where appropriate.

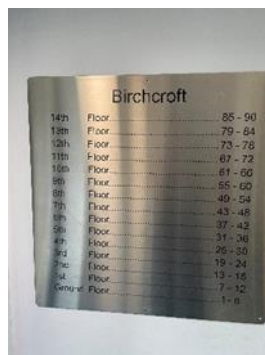
- 6) Signage illustrating the floor location of each flat is fitted to the ground floor lobby wall.

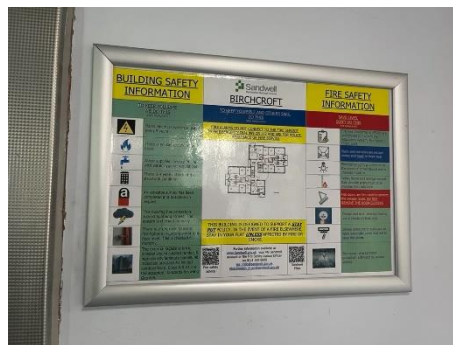
- 1) All Caretaking / Cleaning Employees have undertaken fire safety training. This includes use of bespoke 'Fire Safety in High / Low Rise Flatted Accommodation' Video.
- 2) All employees are encouraged to complete 'In the line of fire' training on an annual basis.
- 3) Caretaking Teams are not currently trained in the effective use of fire extinguishers. The only extinguishers are located within the lift motor room. Caretaking Teams are not expected to tackle fires in this area.
- 4) Building safety and evacuation notices are displayed in common areas and lift cars.
