# Fire Risk Assessment

## Elmcroft

**Windmill Lane,  
Smethwick, B66 3JN**

**Date Completed: 05/08/2025**

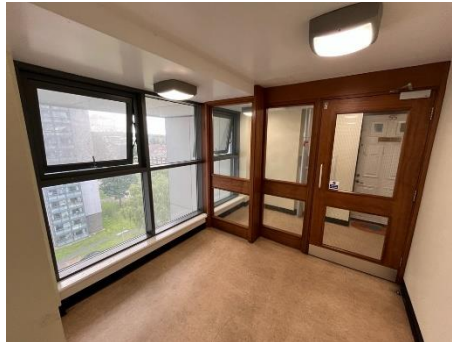
- 4) The means of escape are protected to prevent the spread of fire and smoke.
- 5) The communal landing / staircases are protected by use of self-closing FD30s fire doors with vision panels & intumescent strips / cold smoke seals.

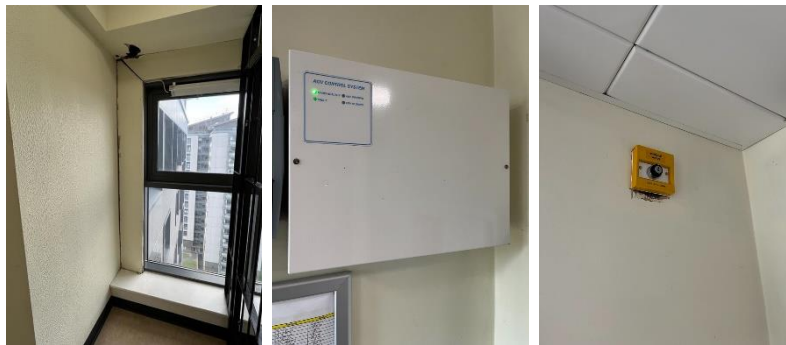
- 9) Automatic smoke ventilation is employed. This is tested, inspected and maintained by a competent procured contractor in accordance with BS7346. The frequency for the maintenance checks is twice per year (April and October) of each calendar year.
- 10) Automatic smoke ventilation is installed to the two windows at the head of the staircase on the 14<sup>th</sup> floor. The controls and repeater panel are in the ground floor lobby. A further reset switch is located at the top of the stairs on the 14<sup>th</sup> floor.

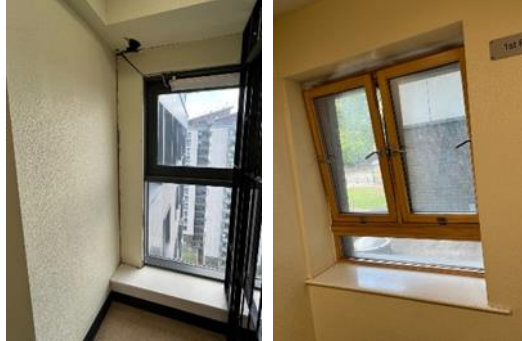
- 13) The stairwell lobby windows on floors 13 and 10 have chipboard panels covering the frames. Presumably these chipboard panels cover damage to the windows. This damage should be repaired, and the chipboard should be removed. See Action 07/13.

Question/ Ref No	Required Action	Supporting photograph	Priority	Timescale and Person Responsible	Date Completed
07/13	The stairwell lobby windows on floors 13 and 10 have chipboard panels covering the frames. Presumably these chipboard panels cover damage to the windows. This damage should be repaired, and the chipboard should be removed.

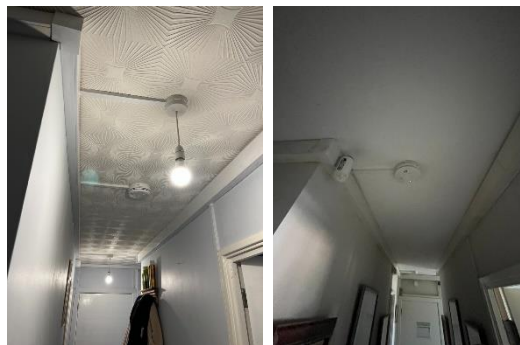
- 1) Early warning is limited to hard wire or battery smoke alarms within each of the resident's flats. The equipment is subjected to a cyclical test.
- 2) Based on the sample of properties assessed during the fire risk assessment, residents confirmed that smoke alarms are installed to an LD1 and LD2 Standard. Flats assessed were: -

Flats; 90 LD2, 84 LD2, 58 LD2, 49 LD1, 45 LD2, 29 LD2, 21 LD2, 16 LD2.

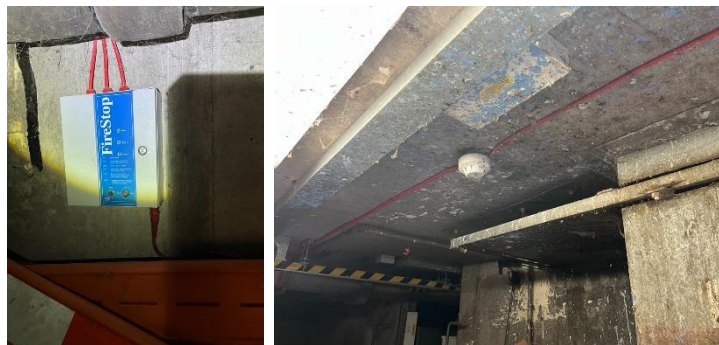
- 7) A fire suppression system is provided in the refuse chute bin store; the control panel is also located within. An approved contractor maintains the system. The frequency for the maintenance checks is twice per year (April and October) of each calendar year.

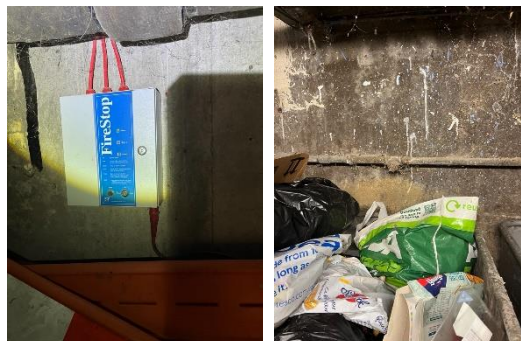
7) A fire suppression system is fitted in the bin room.
