Fire Risk Assessment

Elmcroft

**Windmill Lane,
Smethwick, B66 3JN**

Date Completed: 05/08/2025

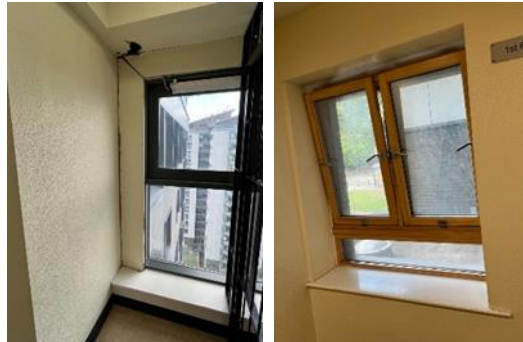
- 12) Communal windows can only be opened with the use of a key or by operating the automatic smoke vents. The timber windows to the staircase do not require a key.
