Fire Risk Assessment

Nelson House

**1 – 34 Nelson House,
Upper Church Lane,
Tipton,
DY4 9PW.**

Date Completed: 01/10/2025

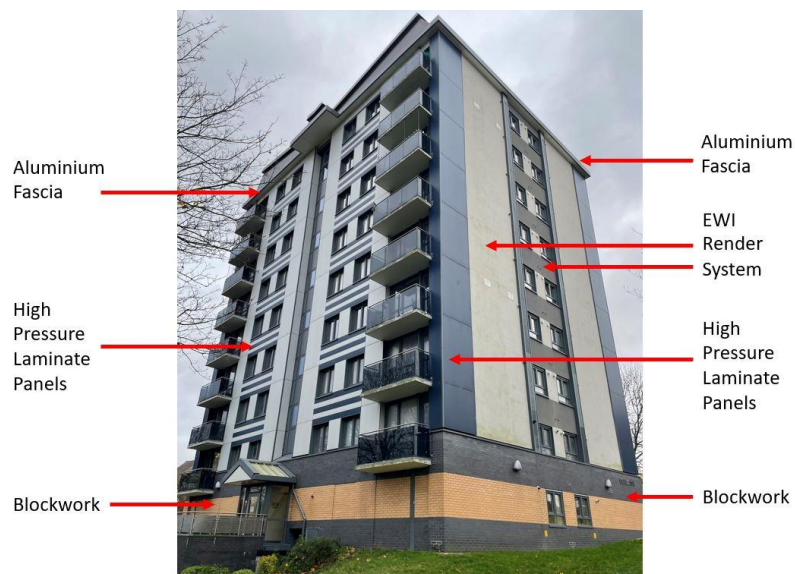
- 1) Nelson House has 4 separate areas of cladding consisting of;
 - Blockwork ground to first floor consisting of Ibstock Staffordshire Smooth Blue & Cheddar Golden brick slips.
 - Baucalad high pressure laminate panels manufactured by Euro Clad LTD 1st – 8th floors. Fire classification B-s2-d0
 - Wetherby EWI render system to the gable ends (fire classification A2) – 1st – 8th floors.
 - 2mm thick aluminium fasciae.
- 2) Mineral wool manufactured by Rockwool (classification A1) has been used to insulate the external wall system.
- 3) The pitched roof is a steel framed construction with aluminium standing seam with mineral wool core.
- 4) Entrance doors to the building are powder coated aluminium units.

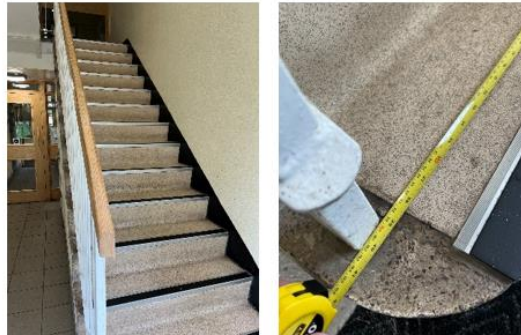
- 1) The site has a single staircase that provides a means of escape and is 1000mm in width.

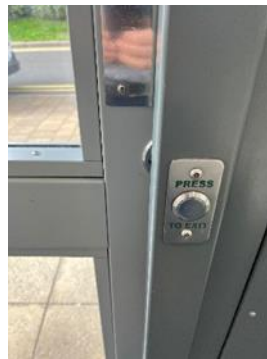
- 9) **The fire exit doors from the two residents' storage shed areas require the internal key locks to be replaced with thumb twist locks. This will prevent the chance of persons becoming accidentally locked in these corridors in the event of an emergency. A total of three locks require changing, two in the righthand side and one in the lefthand side. See Action 7/9**

Question/ Ref No	Required Action	Supporting photograph	Priority	Timescale and Person Responsible	Date Completed
7/9	The fire exit doors from the two residents' storage shed areas required the internal key locks to be replaced with thumb twist locks (on the inside). A total of three locks require changing, two in the righthand side and one in the lefthand side.

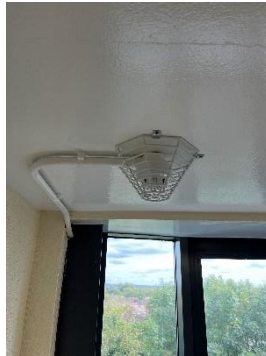
- 4) Smoke detectors linked to the Automatic Opening Vents have been installed. The vents will automatically open when smoke has been detected.

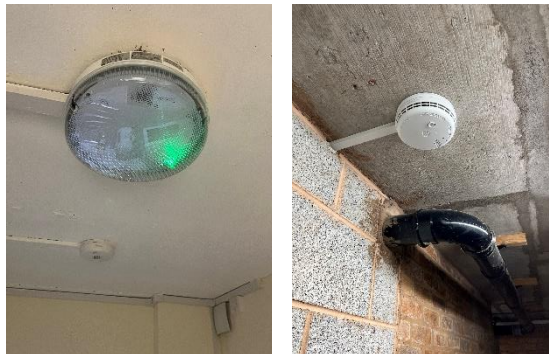
- 5) Smoke detection is present in the ground floor welfare room and residents' storage cupboard corridor, presumably to warn an occupant of the corridor that there is a fire in the welfare room.

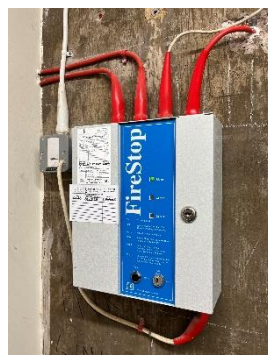
- 6) A sprinkler or deluge system is provided to the refuse chute bin store. An approved contractor maintains the system. The frequency for the maintenance checks is twice per year (April and October) of each calendar year. The control panel for the system is in the caretaker's area which is off the ground floor lift lobby.

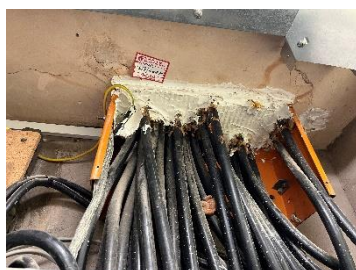
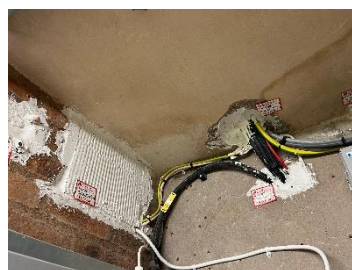
- 1) The building is designed to provide as a minimum 1-hour vertical fire resistance and 1-hour horizontal fire resistance around flats stairwells and lift shafts. All doors are 30-minute fire resistant with cold smoke seals, including those in 1-hour rated walls.
- 2) The premise has sufficient compartmentation to limit the travel and effect of smoke and flame in event of a fire (however note the action below in 4). Whilst the existing fire stopping is fit for purpose, there is a cyclical programme to ensure fire stopping as not been compromised by third parties and where applicable enhance the fire stopping.
- 3) A variety of methods / materials have been used to achieve fire-stopping including Rockwool and intumescent pillows.

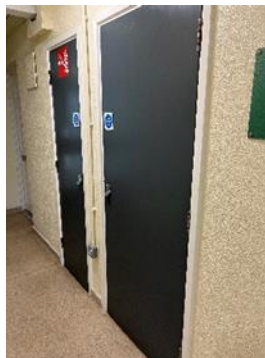
- 5) All communal doors are fitted with automatic closing devices that are checked on a regular basis by Caretaking Teams as part of their checks. Defective closing devices are replaced either by the Caretaking Team(s) or the in-house repairs team(s).
- 6) Electrical service cupboards have FD30s rated doors, secured with a suited lock.

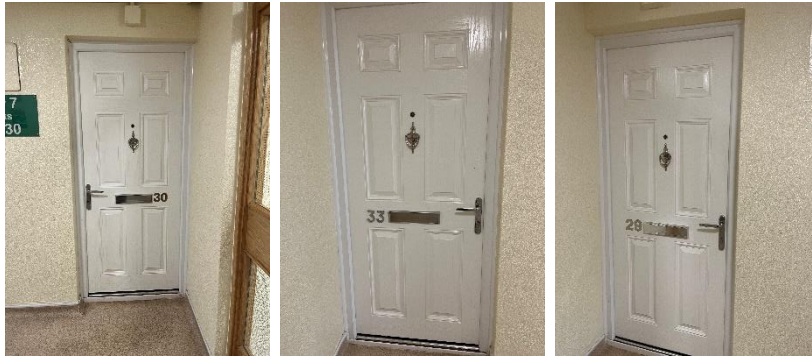
- 8) Individual flat doors are FD30s rated composite doors sets manufactured by IG doors.

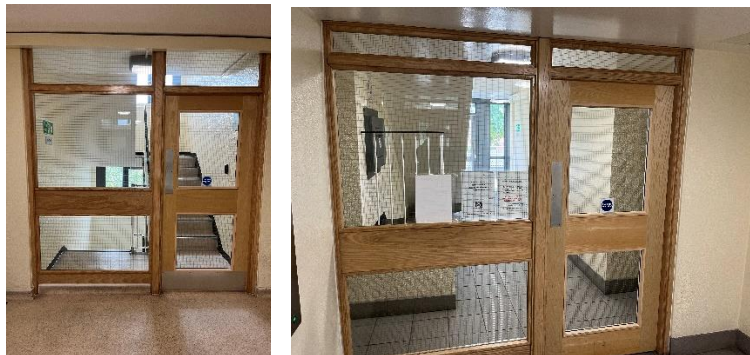
- 9) The corridors / staircases are protected by use of self-closing FD30s fire doors with combined intumescent strips / cold smoke seals and vision panels consisting of Georgian wired glazing.

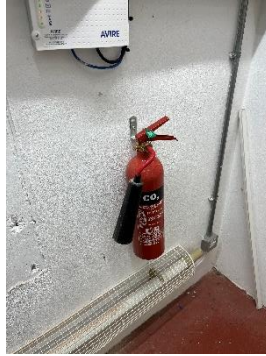
- 5) A portable fire extinguisher (CO2) is provided in the lift motor room. Maintenance contracts are in place for servicing the extinguisher. The frequency for the maintenance checks is once (October) of each calendar year. At the time of the assessment, this extinguisher had no 'how to use' signage. An email has been sent to the Team Leader Fire Safety and Facilities to request suitable signage.

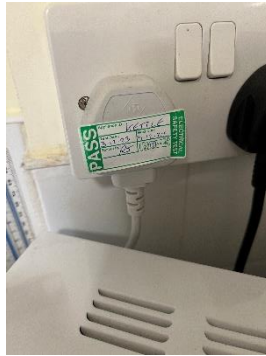
- 4) Portable electrical equipment used as part of the Caretaking / Cleaning regime is subject to annual PAT Testing. This information is held by the Estate Services Manager. A sampled appliance had an expired test label. An email to the Estate Services Manager was sent requesting a new test.
