# **Fire Risk Assessment**

## **Howard Street**

**Flats 1 - 12 – 19 - 30**  
**Howard Street.**  
**Tipton,**  
**DY4 8UF.**

**Date Completed: 08/11/2024.**

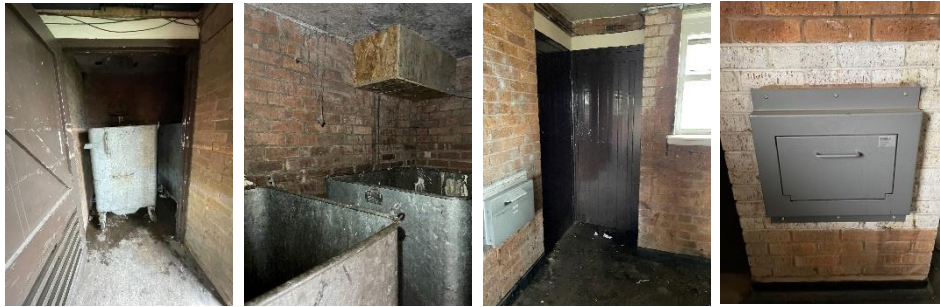
To dispose of rubbish, residents utilise waste containers secured behind a timber door on the ground floor and a waste chute on the first floor.

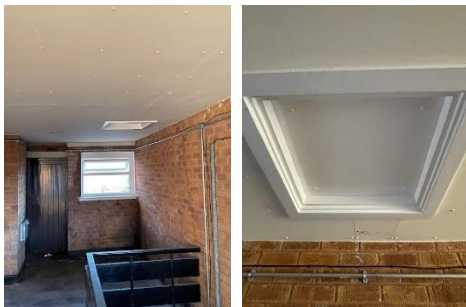
There is an access panel to the communal roof space on the first floor landing area, this space was not accessed at the time of the assessment.

A resident confirmed that access to other areas of the roof space is gained through individual flats. Therefore, an inspection of the roof void was not undertaken at the time of the fire risk assessment.

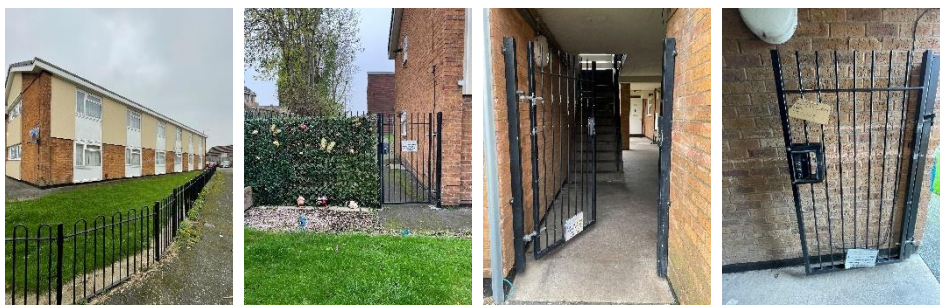
The front elevation has a steel security access gate, this is used to access individual flats.

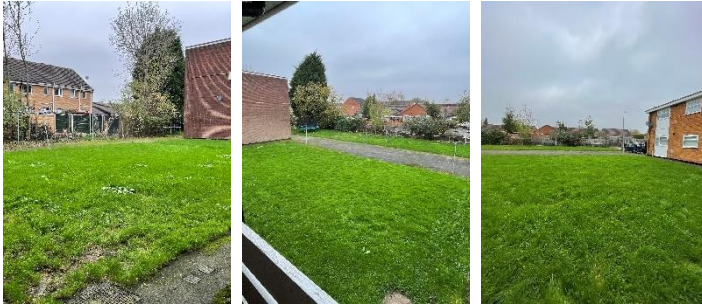
The rear garden is secured by a combination of wooden and metal fencing, there is an access gate fitted to enable easy access for residents.

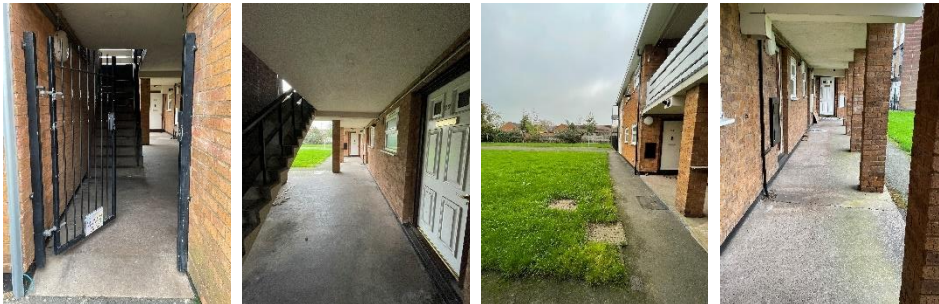
- 4) Access is gained to all flats from the ground floor using the main access gate at the front elevation of the building. The rear of the building is open plan with deck access on the first floor.

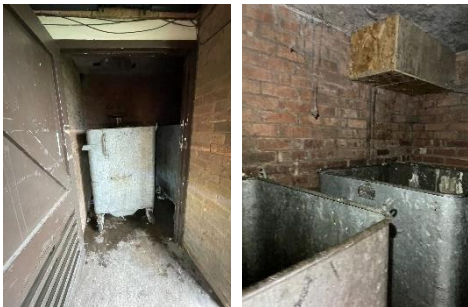
- 1) The building has a concrete staircase that provides the means of escape, the staircase provides a 980mm width as a minimum. All open deck corridors are of adequate width (at least 1500mm) and should be maintained clear to that width as a minimum.
- 2) In an emergency, persons are able to escape from their flats and crouch below windowsills of neighbouring flats. Floor to Windowsill height is approximately 1100mm.
- 3) The bin room is accessible at ground floor level adjacent to the staircase. The timber door to the bin room should be upgraded to certified to FD30's fire rated as part of future planned works.

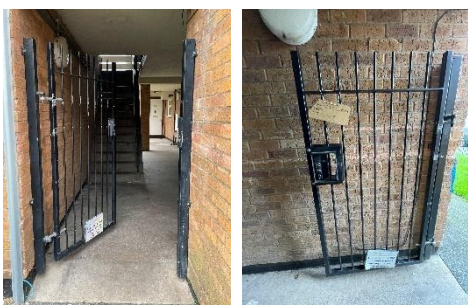
- 4) There are steel security gates that have combination locks to secure the building. These can be opened from inside without the use of a key.
