Fire Risk Assessment

Kynaston House

**Rydding Lane, Millfields,
B71 2HD**

Date Completed: 02/01/2026

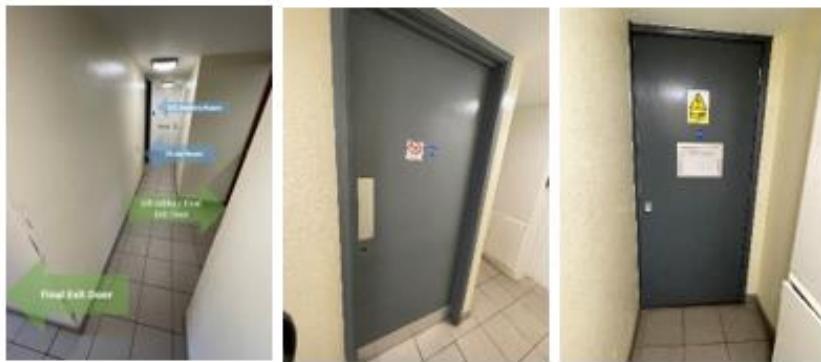
- 2) All corridors are of adequate width (at least 1050mm) and will be maintained clear to that width as a minimum.
- 3) The maximum travel distance from the furthest flat to the protected stair is 6 metres.
- 4) The communal corridor providing a means of escape for flat 44 (ground floor) is 820mm in width and 3.5 meters in length to the nearest place of relative safety (lift lobby). This corridor contains a chute room with an FD60s self-closing door and a service cupboard housing the central battery system for the emergency lighting which is secured with an FD60s locked door (suited 54 key mortice lock). The risk is sufficiently mitigated to maintain an acceptable means of escape for flat 44. The flat has as secondary means of escape via the rear door.

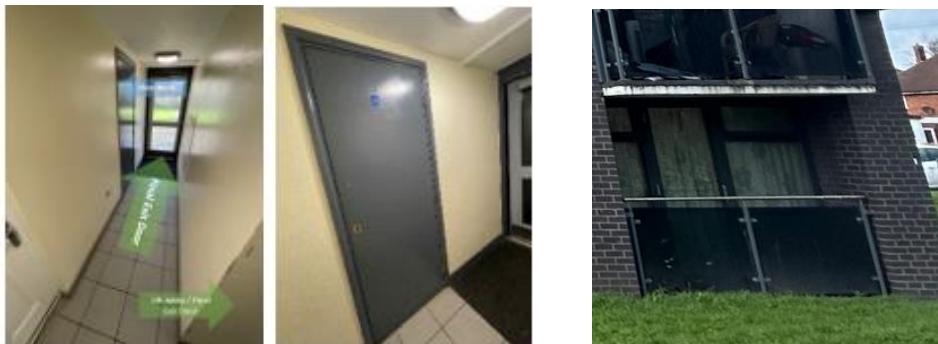
5) Flat 43 also shares the corridor mentioned above however, occupants don't have to pass the chute room or E/L battery store to escape. There is an electrical service cupboard adjacent the rear exit door. The risk is also sufficiently mitigated because the service door is a locked FD60s (suited 54 key mortice lock) and means of escape is possible in two directions. This flat also has a secondary means of escape via its rear door.

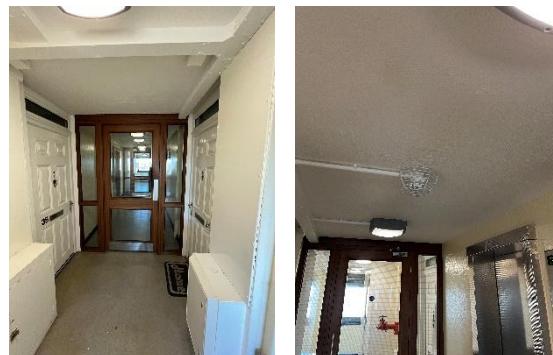
8) Corridor access dead ends are 5.5m, these are separated with the use of full height timber nominal FD30s doors and have an automatic opening vent.

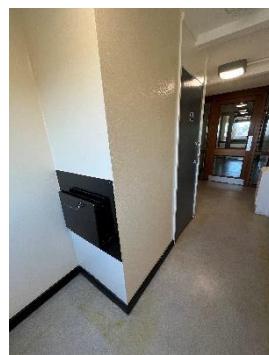
12) Chute hoppers are located within the flat entrance lobbies / dead corridors on the rear facing side of the building. The hoppers are not contained in cupboards which is acceptable because they have intumescent strips, there is an automatic chute closure plate and there is a fire suppression system installed in the bin store. Additionally, there is an AOV adjacent on floors 1 – 10.

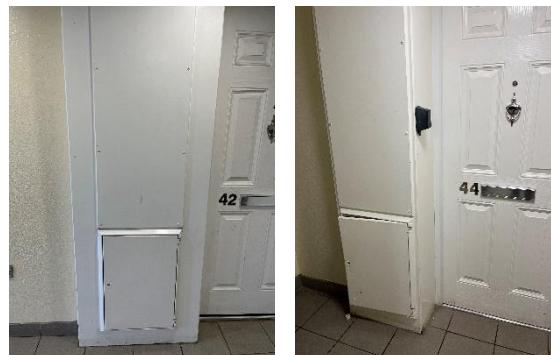
14) Residents electrical meter cabinets are situated in the corridors there is a panel above each cabinet that appears to be of light timber construction. See observations.

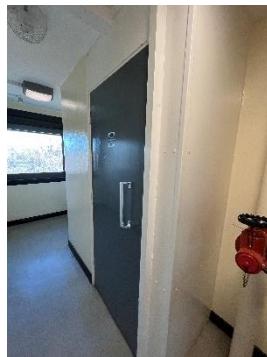
9) The doors to service cupboards on floors 1-10 in the rear lobby access corridor (next to chute hopper) are upgraded notional FD30s fire doors with an intumescent strip and 25mm stop. The cupboards contain AOV control equipment and cabling. It was noted that cupboards on the 10th and 4th floor are utilised as a cleaner's cupboards. The keys are held centrally at SMBC Roway Lane, and within the firefighter's white box.

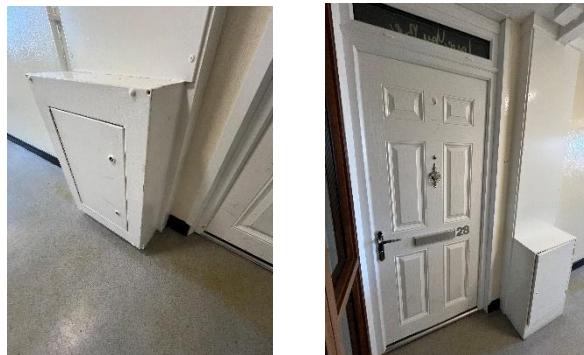
12) Individual electricity meters are housed in modular units fitted with budget locks, located outside each flat within the lobby access corridors. There is an automatic opening vent, FD30s cross corridor door and each installation is regularly inspected (DEICR) which contributes to mitigating the risk. See observations.

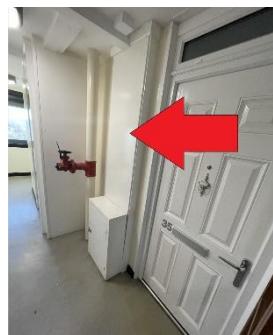
15) Access panels to stop taps are secured behind a panel cupped and screwed above the meter cupboards. See observations.
