Fire Risk Assessment

Sandfield House

**Flats 1 - 14.
Walsall Road.
West Bromwich
B71 3LR.**

Date Completed: 07/01/2025.

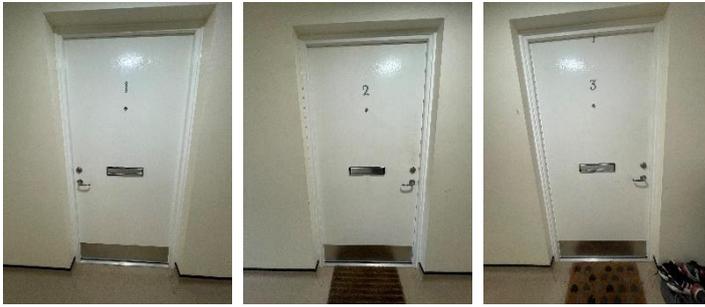
Flat entrance doors were in good condition. The doors appeared to be timber flush doors.

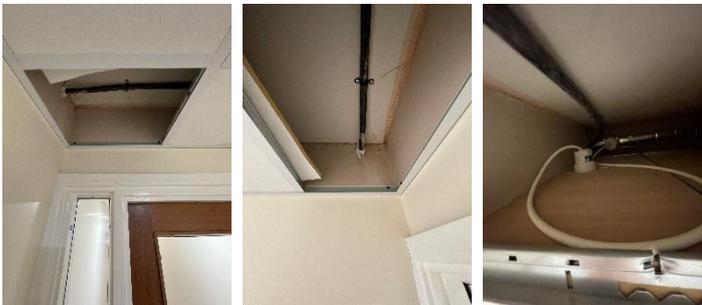
- 1) The building is designed to provide as a minimum 1-hour vertical fire resistance and 1-hour horizontal fire resistance around flats. All flat entrance doors are nominal 30-minute doors, including those in 1-hour rated walls.
- 2) The premise has sufficient compartmentation to limit the travel and effect of smoke and flame in event of a fire.

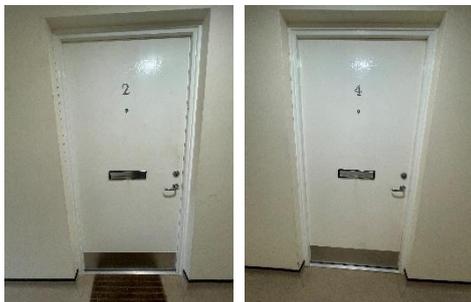
- 5) The means of escape is protected from flats with the use of nominal FD30s doors.
