# **Fire Risk Assessment**

## **1-8 Salop Drive**

**Salop Drive, Oldbury,  
B68 9AG**

**Date Completed: 22.05.25.**

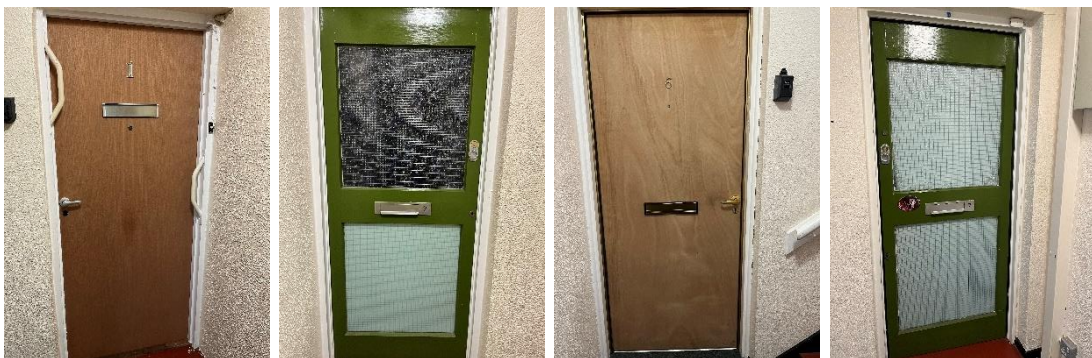
- 8) Surface coatings to the walls in the staircases appear to be Class 0 rated.
- 9) The building has sufficient passive controls that provide effective compartmentation to support a Stay Put Policy. Therefore, residents are advised to remain in their flat unless the fire directly affects them.
- 10) Flat entrance doors are a combination of notional timber and GWG doors and nominal timber FD 30 entrance doors. These should be upgraded to certified FD30s as part of any future refurbishments.

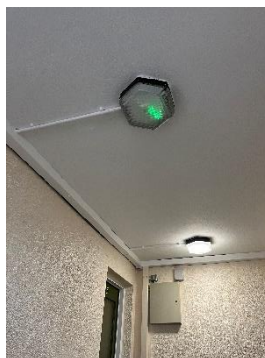
- 12) The premises has emergency lighting installed.

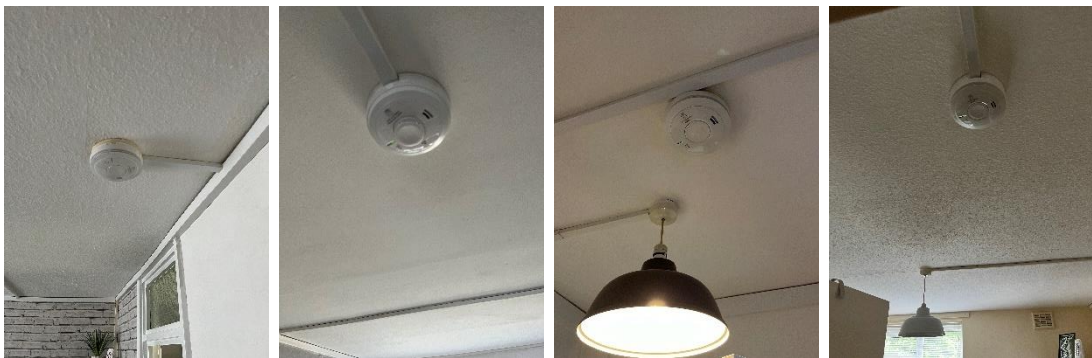
- 1) Early warning is limited to hard wired or battery smoke alarms within each of the resident's flats. The equipment is subjected to a cyclical test.
- 2) Based on the sample of properties accessed during the fire risk assessment the smoke alarms within resident's flats are installed to an LD1 Standard. Flat 4 was accessed and has smoke detection in the hallway, lounge, bedroom and kitchen.

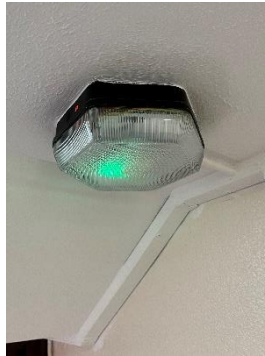
- 1) The premises has a sufficient emergency / escape lighting system in accordance with BS 5266 and has test points strategically located.

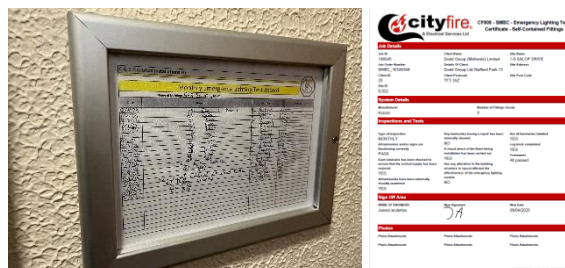
- 2) The self-contained units are provided to the communal landings, stairs.
- 3) All installed equipment is checked and tested on a monthly basis by Sandwell MBC in house electrical team or approved contractor, in accordance with current standards. The emergency lighting was subject to a monthly test by a competent provider, namely City Fire and Electrical Services Ltd on 09.04.25.

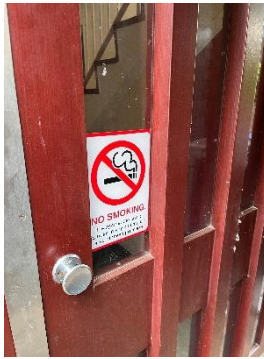
- 1) All fire doors display “Fire Door Keep Shut” where appropriate.
- 2) No smoking (Smoke Free England) signage is displayed at the front entrance to the premises.
