# Fire Risk Assessment

## 1-8 Beever Road

Tipton  
DY4 0FE

**Date Completed:** 14/05/2025

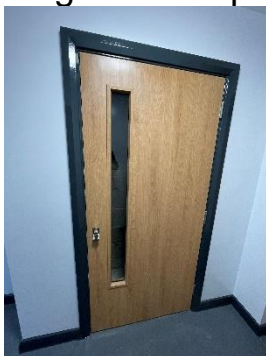
An unused cupboard has been formed to the 1<sup>st</sup> and 2<sup>nd</sup> floor lobbies. The cupboards were originally designed to form a smoke extraction shaft however, the feature was deemed not necessary during the construction stage. The cupboards have been secured with locked FD60s doors.

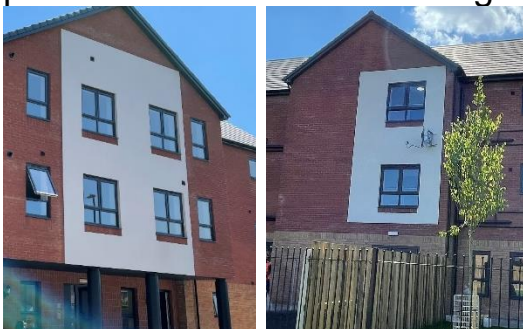
- 2) There's a limed based rendered coating to a section of the 1<sup>st</sup> & 2<sup>nd</sup> floor front & rear elevations. The product is manufactured by Knauf – product reference Presto Regal Range.

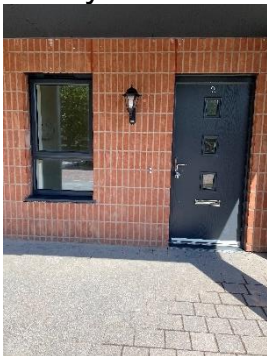
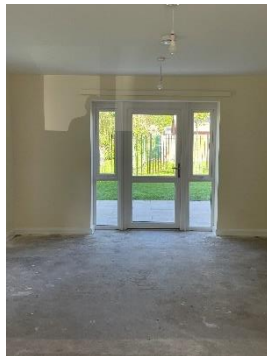
- 5) Entrance doors to flats 1 & 2 are PVC-u non fire rated doors which is deemed acceptable because they open into a place of ultimate safety.

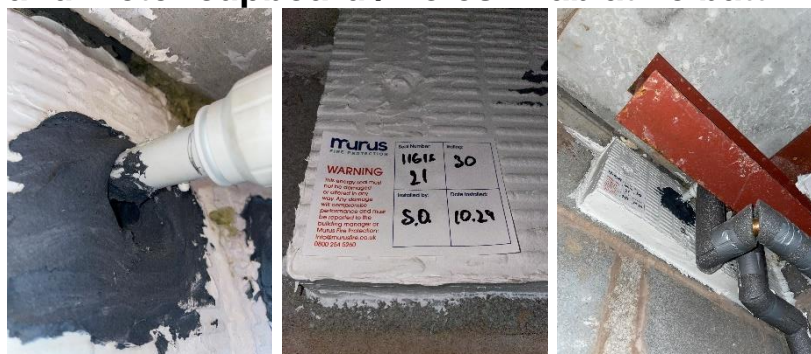
- b) Ground floor meter cupboard, penetration holes not fire stopped, and edges of ablative batt are exposed.**

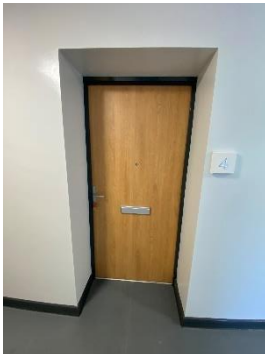
**b) Flat 4 - Not reliably fully self-closing.**

P2	Within 1-3 months Urban Designs	
10/14b	Flat 4 - Adjust entrance door to ensure it reliably fully self closes into frame.	 	P2	Within 1-3 months Urban Designs

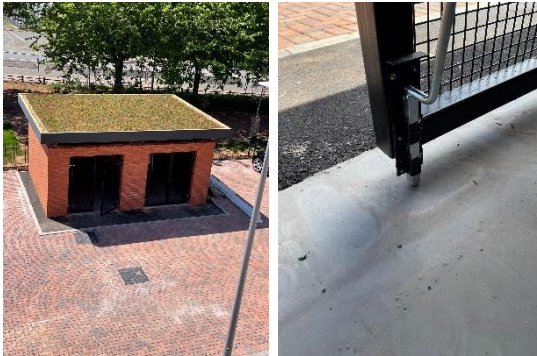
- 1) Refuse containers are contained within an external bin store. **The bin store cannot be secured because there are no holes for the drop down bolts.**

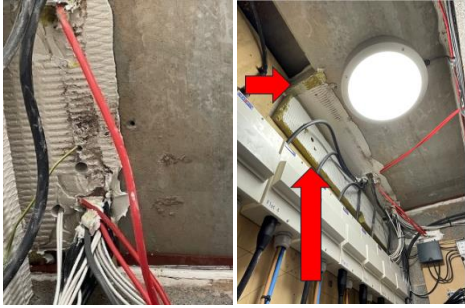
10/3b	Ground floor meter cupboard - Fire stop holes in ablative batt at cable penetrations. Also, exposed edges of batt should be "battered" with ablative coating.

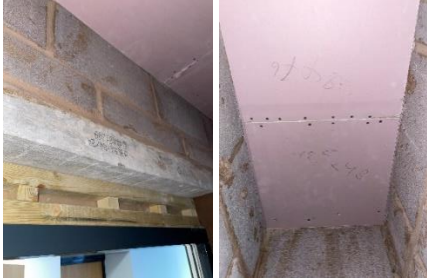
P2	Within 1-3 months Urban Designs	
10/3c	2 <sup>nd</sup> floor cupboard – exposed studwork to be suitably finished to create 60 minutes integrity. Also fire rated plasterboard to be finished / skimmed.

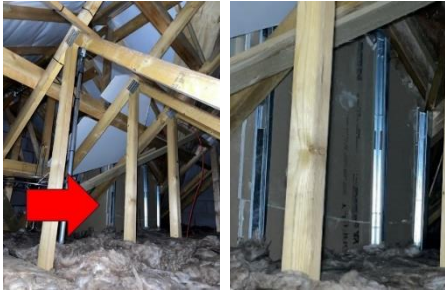
P2	Within 1-3 months Urban Designs	
10/3d	AOV shaft to be suitably boarded on roof void side to ensure 60 minutes integrity.

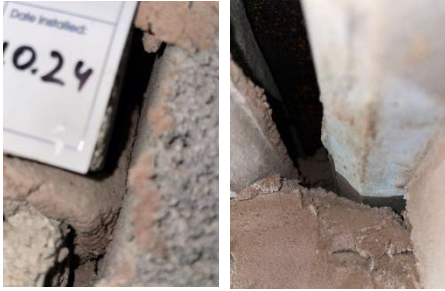
- e) Various gaps noted in service cupboards concerning blockwork and between blockwork and exposed floor slabs above. Firestopping required.**

10/3e	Service cupboards - Fire stop all obvious gaps within blockwork and between floor slabs / blockwork.

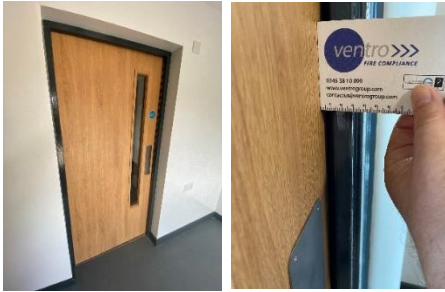
**a) Ground floor stairwell door not reliably self-closing fully.**

P2	Within 1-3 months Urban Designs	
10/12a	Ground floor stairwell door requires adjustment to ensure it reliably fully self closes into frame.

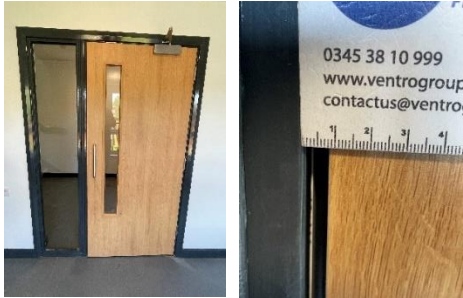
**b) 1<sup>st</sup> floor stairwell door not reliably self-closing fully and excessive gap up to 8mm on leading edge.**

P2	Within 1-3 months Urban Designs	
10/12b	1 <sup>st</sup> floor stairwell door requires adjustment to ensure it reliably fully self closes into frame.  Also, excessive gap (8mm) on leading edge to be corrected.

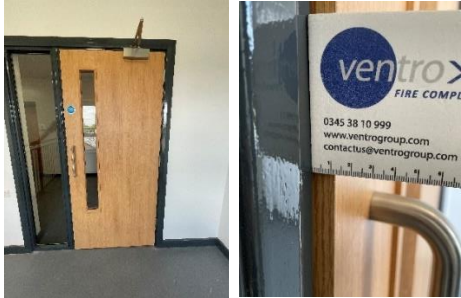
**c) 2<sup>nd</sup> floor stairwell door not reliably self-closing fully.**

10/12c	2 <sup>nd</sup> floor stairwell door requires adjustment to ensure it reliably fully self closes into frame.

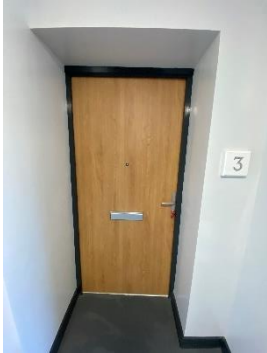
**a) Flat 3 - Not reliably fully self-closing.**

P2	Within 1-3 months Urban Designs	
10/14a	Flat 3 – Adjust entrance door to ensure it reliably fully self closes into frame.

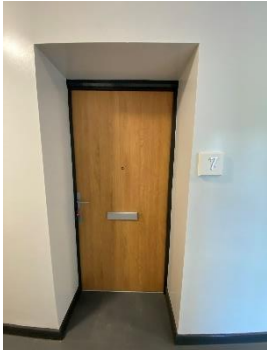
**e) Flat 7 - Not reliably fully self-closing.**

P2	Within 1-3 months Urban Designs	
10/14e	Flat 7 - Adjust entrance door to ensure it reliably fully self closes into frame.

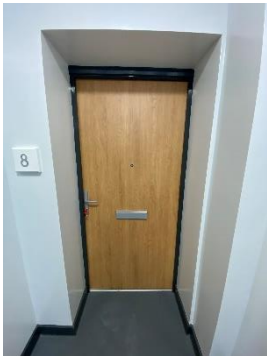
**f) Flat 8 - Not reliably fully self-closing.**

10/14f	Flat 8 - Adjust entrance door to ensure it reliably fully self closes into frame.

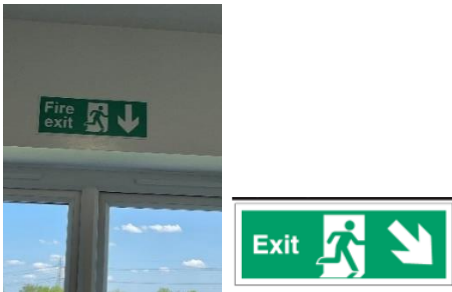
**5) Escape signage on stairwell 1<sup>st</sup> and 2<sup>nd</sup> floor landings display incorrect arrow. The arrow should be pointing diagonally downwards and right to signify “progress down to the right” as per BS 5499 - 4.**

P2	Within 1-3 months Urban Designs	
12/2	Install "Fire Door Keep Shut" signage to 5 x locked service / store cupboard doors.	n/a	P2	Within 1-3 months Urban Designs	
12/3	Install a Fire Action Notice adjacent the front and rear final exit doors as per CLG low rise flats guidance.	n/a	P2	Within 1-3 months Urban Designs	
12/5	Escape signage on stairwell landings (2) to be replaced with signage as per BS5499 – 4 / arrow pointing downwards and right.

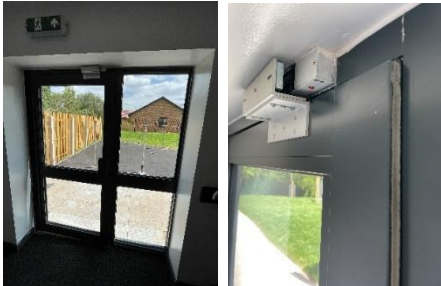
- 1) Once occupied regular checks will be undertaken by Caretakers / Cleaning Team(s) 365 days per year which helps reduce the risk of arson.
- 2) Access to the building is restricted by a door entry system.
- 3) **The rear entrance / exit door is failing to reliably self-close therefore, the magnetised latch is not holding the door.**

P2	Within 1-3 months Urban Designs	
17/3	The rear entrance door requires adjustment to ensure it reliably makes contact with the magnetised latch. Door isn't currently securing.
