Fire Risk Assessment

1-9 Keats House

**Tudor Road, Oldbury,
B68 9RE**

Date Completed: 03/06/2025.

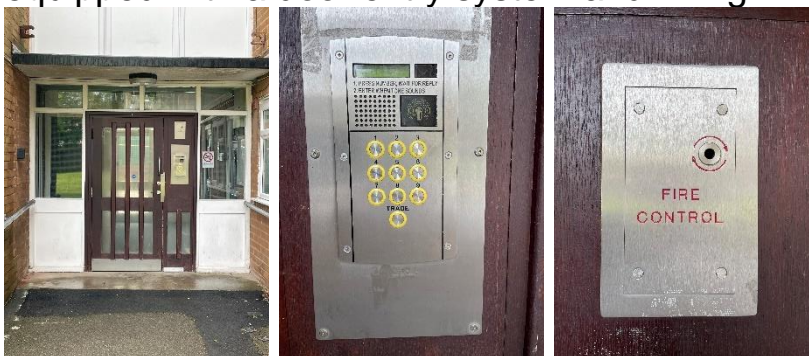
There is a main entrance / exit to the front elevation. The door is equipped with a door entry system and firefighter's override switch.

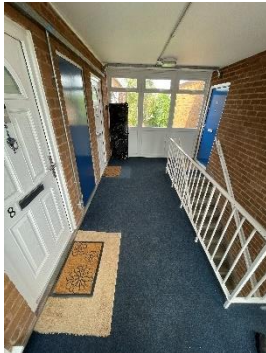
However, three leaseholder flats are currently without a suitable FD30s flat entrance door therefore, replacement doors have been included within the action plan. The leaseholder management team have been tasked with resolving this issue as soon as reasonably practical.

All flat entrance doors open into the stairwell.

7/3c	Flat 7 – Entrance door is not a suitable fire door. FD30s certified door set to be installed. <i>Leaseholder property.</i>	 	P4	Programmed Work Leasehold Manager	
7/3d	Flat 6 – Entrance door is not a suitable fire door. FD30s certified door set to be installed. <i>Leaseholder stated they have already requested SMBC replace the door.</i>	 	P4	Programmed Work Leasehold Manager

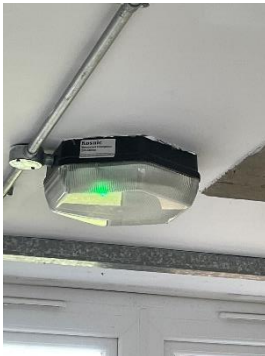
- 1) This premises has a sufficient emergency / escape lighting system in accordance with BS 5266 and has test points strategically located.
- 2) The self-contained units are provided to the communal landings and stairs.

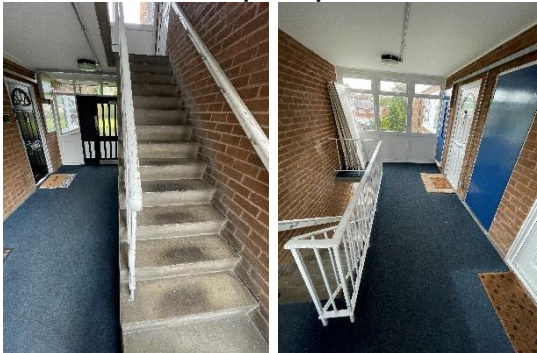
1. The building is designed to provide as a minimum 1-hour vertical fire resistance and 1-hour horizontal fire resistance around flats. All flat entrance doors are 30-minute nominal doors, including those in 1-hour rated walls.
- 2) The premise does not have sufficient compartmentation to limit the travel and effect of smoke and flame in event of a fire in communal areas due to open plan staircase.

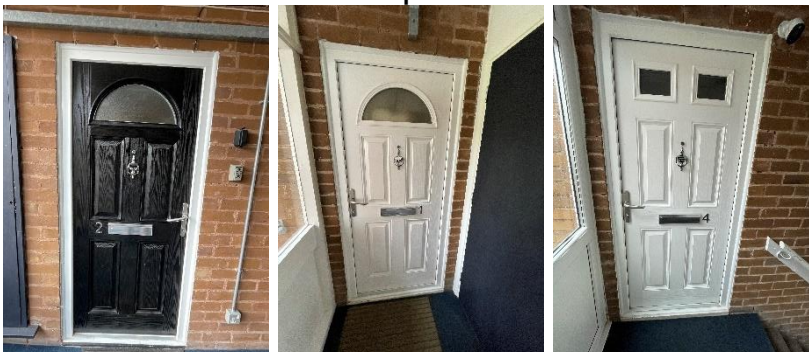
- 3) The means of escape is predominantly protected from flats with the use of FD30s rated composite doors.

Doors to flats 5, 6 & 7 are non fire rated doors sets and have been detailed in section 7 of the report.
