1-9 Keswick House Lovett Avenue, Oldbury, B69 1BP

Date Completed: 08/07/2025 Review Period: 3 years.

Current Risk Rating = Tolerable

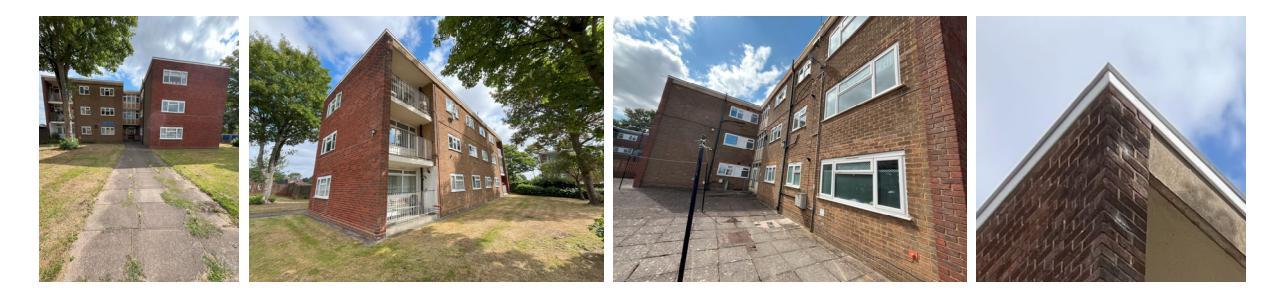
1) The external surface of the building is predominantly brick structure with UPVC facia to the roof line with felt roof.

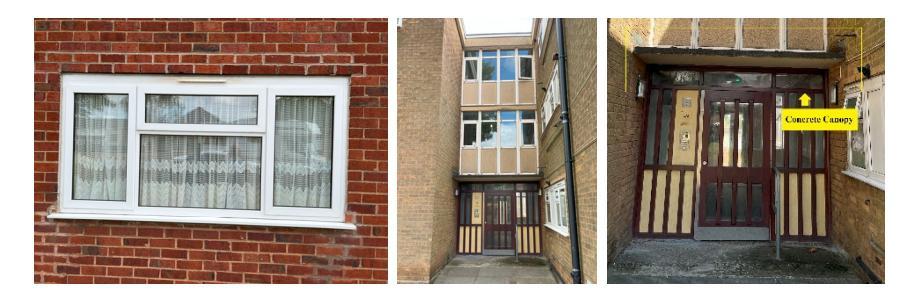
2) UPVC double glazed units have been installed to each flat, UPVC and aluminium units installed in the communal stairwell, with spandrel panels on lower sections of stairway units. There is a canopy situated over the entrance to the block.

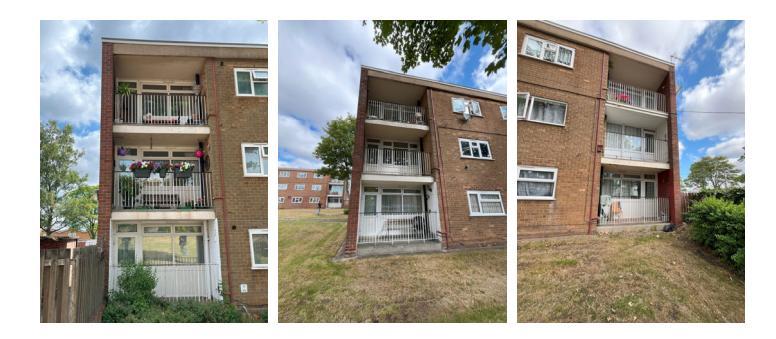
3) Each flat has an individual balcony with steel railings

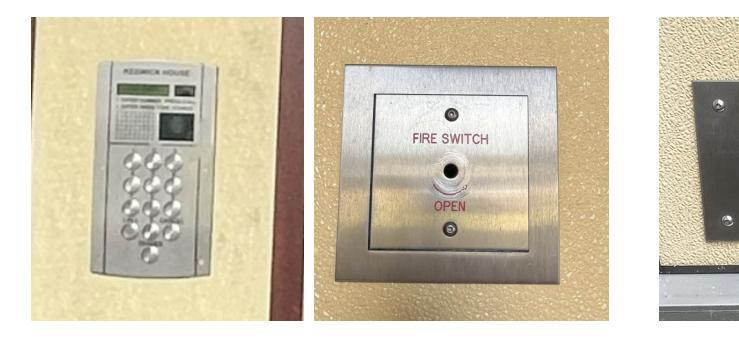
4) Access to the building: front entrance is via a call point/fob system, and firefighting override system. Rear entrance is a fob access only

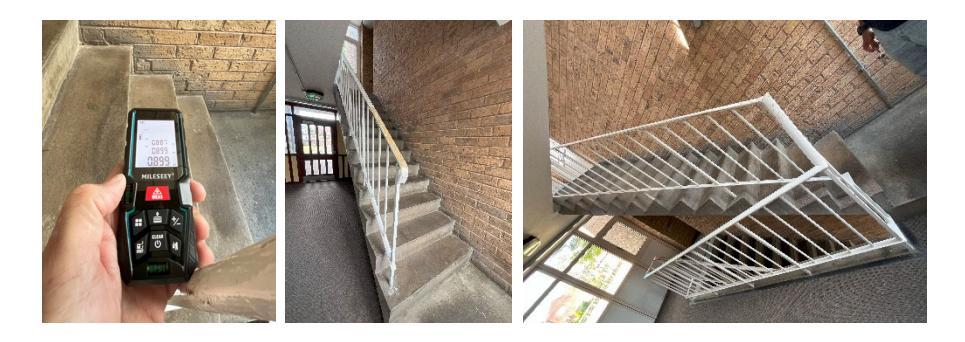
1) Each floor consists of a single staircase that provides a means of escape and has a width of 899mm.

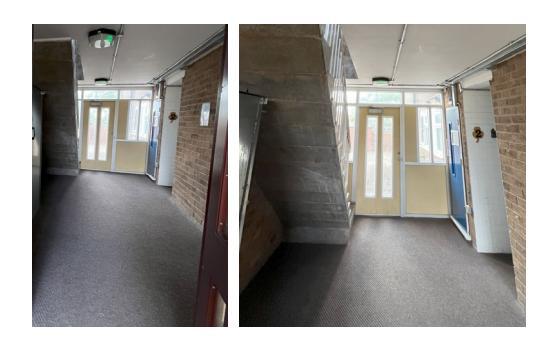
2) All corridors are of adequate width (at least 1050mm) and will be maintained clear to that width as a minimum.

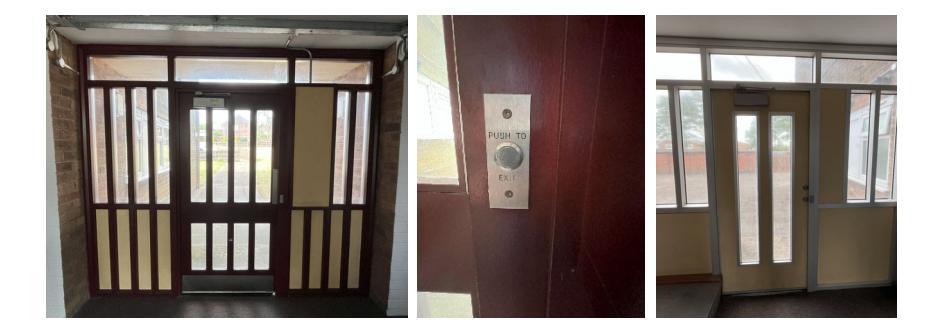
- 3) None of the corridors that form part of the means of escape are dead ends.
- 4) The means of escape are protected to prevent the spread of fire and smoke.
- 5) The only communal doors within the block are the final exit doors, which are fitted with automatic closing devices that are checked on a regular basis by caretaking teams as part of their checks. Defective closing devices are replaced either by the Caretaking Team(s) or the in-house repairs team(s).

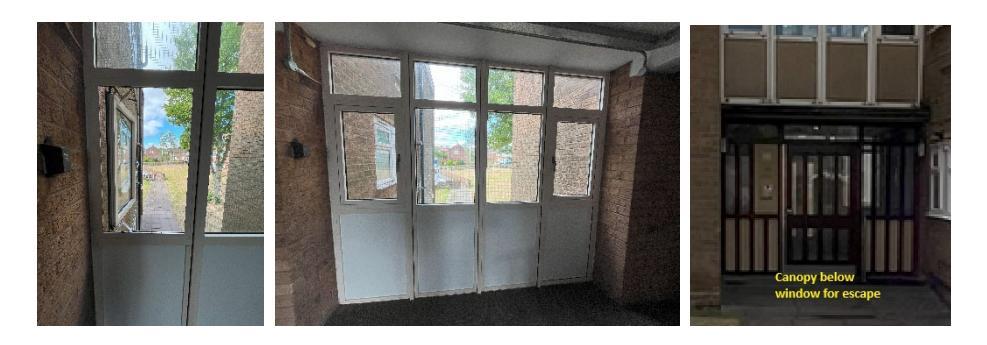
7) Windows on the front first floor fully open and can be used as a means of escape.

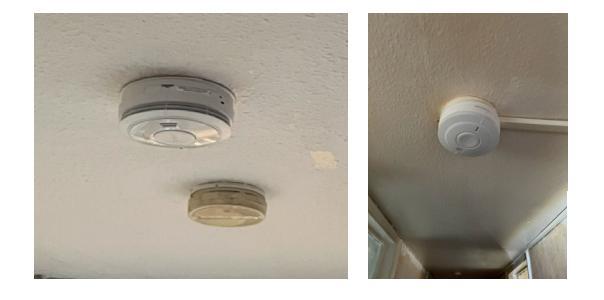
Flat 7 & 6 was inspected at the time of inspection

- 1) Early warning is limited to hard wire or battery smoke alarms within each of the resident's flats the equipment is subjected to a cyclical test.
- 2) Based on the sample of properties accessed during the fire risk assessment the smoke alarms within resident's flats are installed to an LD3 Standard.

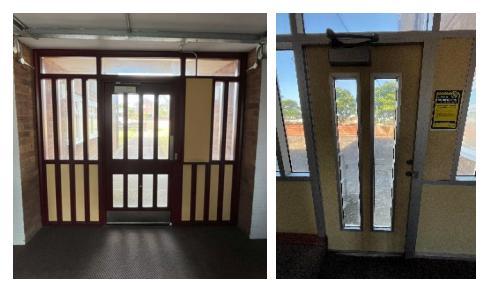
- 1) The building is designed to provide as a minimum 1-hour vertical fire resistance and 30 minutes horizontal fire resistance.
- 2) The premise does not have sufficient compartmentation to limit the travel and effect of smoke and flame in the event of a fire in communal areas due to having an open plan stairwell. Whilst the existing fire stopping is fit for purpose, there is a cyclical programme to ensure fire stopping as not been compromised by third parties and where applicable enhance the fire stopping.
- 3) There are no communal doors fitted with automatic closing devices other than the final exit doors. These are checked on a regular basis by Caretaking Teams as part of their checks. Defective closing devices are replaced either by the Caretaking Team(s) or the in-house repairs team(s).

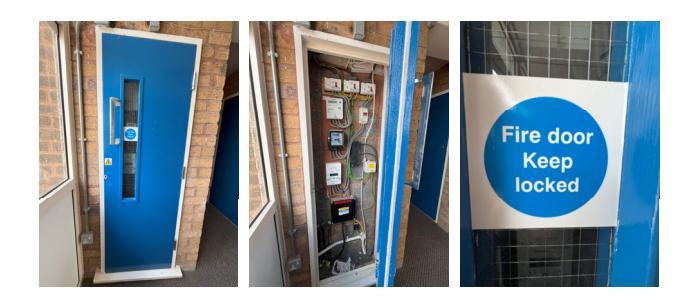
4) All service cupboards to communal landings are FD30s rated and lockable with budget locks and include a fire door Keep locked sticker.

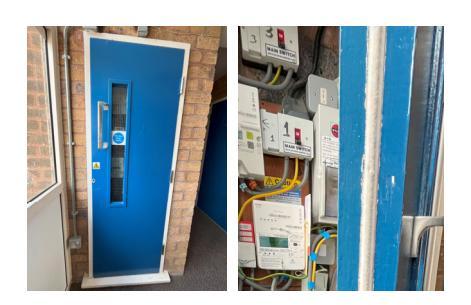
8) All Residents service cupboards on each floor are housed behind a FD30s fire rated doors. All cupboards are free from any combustibles.

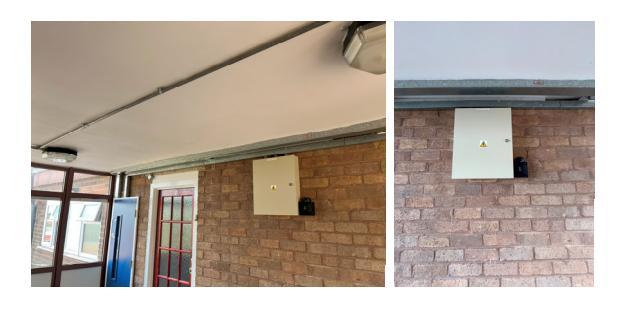
9) 2nd floor has door entry system power supply unit installed on the wall, this is secure and away from resident's reach, all cabling is housed within boxed metal trunking above.

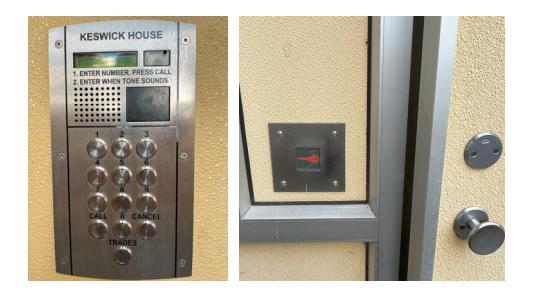
- 1) Regular checks are undertaken by Caretakers / Cleaning Team(s) 365 days per year which helps reduce the risk of arson.
- 2) Restricted access to the premises by means of a door entry system to the front and the rear.

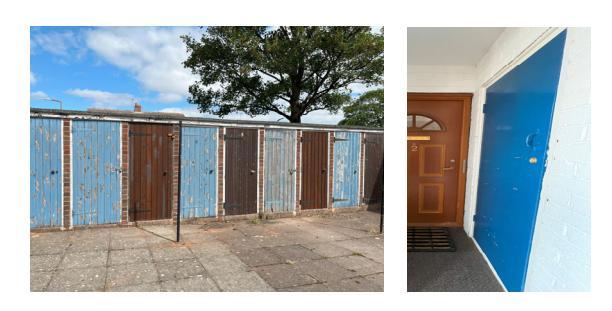
- 1) Residents instructed not to bring L.P.G cylinders into block.
- 2) The tenancy conditions, Section 7 Condition 5.6 stipulates "If you live in a flat or maisonette, you, people living with you and any visitors to your property must not keep or use paraffin oil, petrol, bottled gas appliances or any other explosive, FLAMMABLE or dangerous material in the property. This restriction also applies to any storage facility situated in or attached to the block, which has been provided for your use."
- 3) No Flammable liquids stored on site by Caretakers / cleaners.
- 4) There are no flammable liquids or gas cylinders stored on site.
- 5) Residents have individual storage cupboard internally and externally which they keep secured by means of own keys.
