**Lovett Avenue, Oldbury,  
B69 1BT**

Sandwell  
Metropolitan Borough Council

Burnett House  
Lovett Avenue  
Oldbury  
B69 1BT

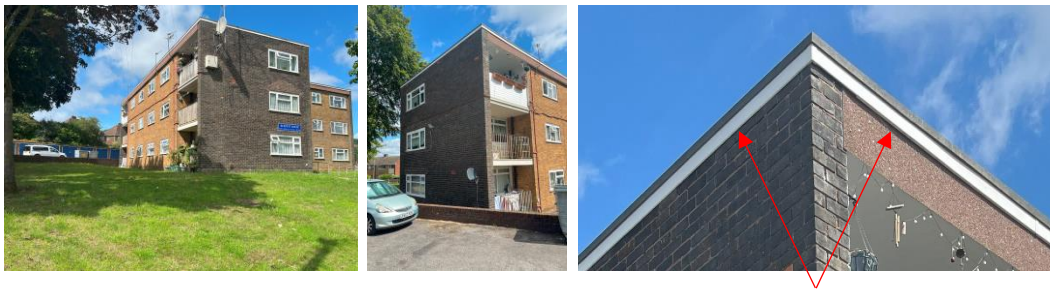
UPVC and felt roofline

- 1) The external construction of the building is predominantly brick with UPVC and felt fascia to the roof line

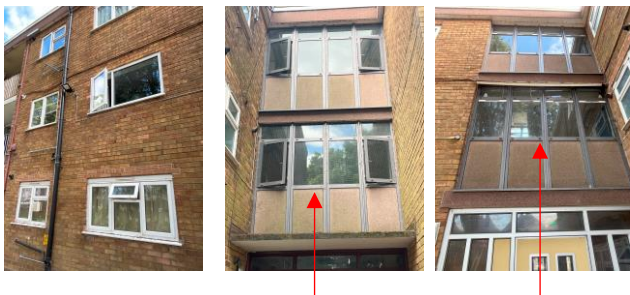
UPVC Units Front and rear Aluminium Framing

- 2) UPVC double glazed units have been installed to each flat. Aluminium framed units to the communal stairwell.

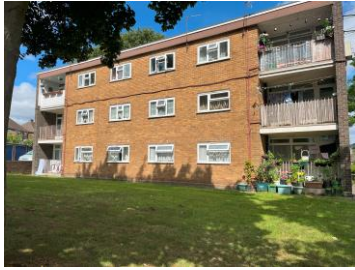
- 3) Each flat is equipped with its own private balcony with steel railings.

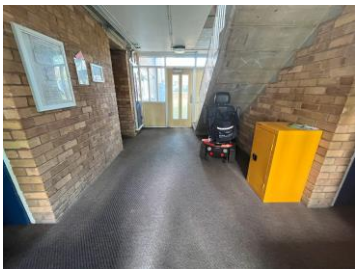
- 1) Ground floor houses flat 1,2,3, they are located off the main communal hallway. All corridors are of adequate width (at least 1050mm) and will be maintained clear to that width as a minimum.

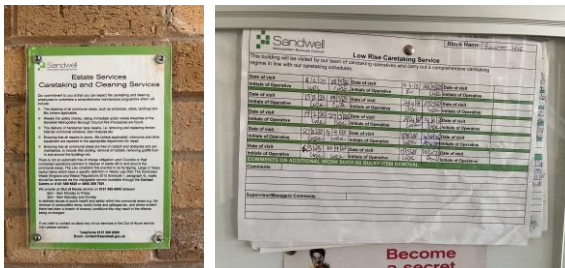
- 5) Communal areas are kept free of flammable items. The communal areas are checked on a regular basis by Caretaking / Cleaning teams 365 days per year and all items of rubbish are immediately removed. There is also an out of hour's service that allows combustible items of furniture / rubbish to be removed.

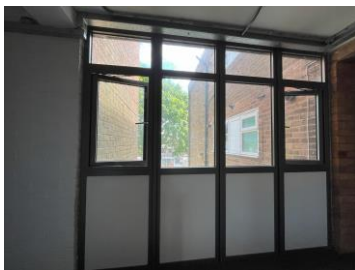
- 8) On the 1<sup>st</sup> and 2<sup>nd</sup> floor communal landings, there are a set of aluminium windows that can be opened without the use of a key, these are to allow sufficient airflow. There is no AOV (Automatic Opening Vents) system installed in this premises.

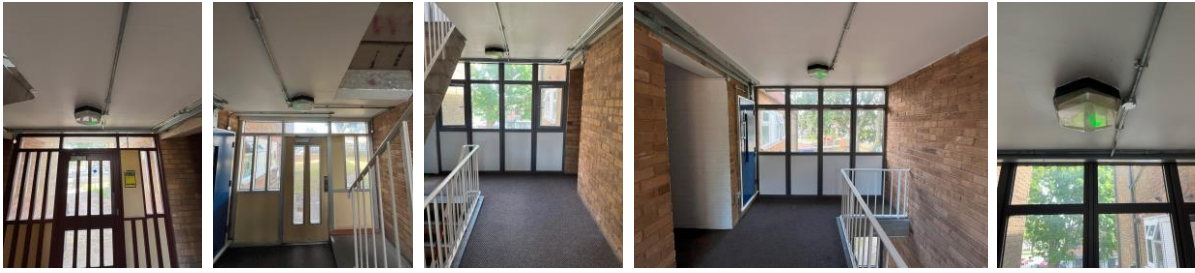
- 9) Emergency lighting is installed throughout the building, there is a set of lights to each floor, at either end which provide suitable emergency lighting in the event of an emergency.

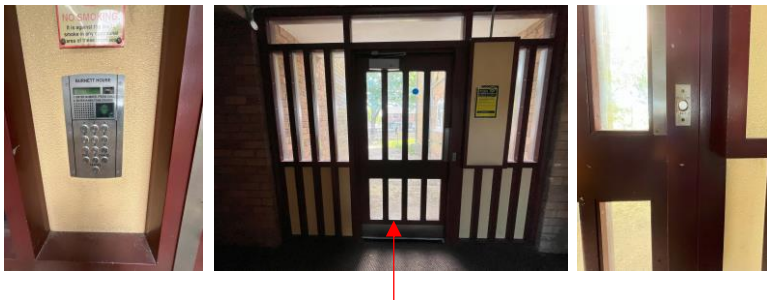
Front door entry/exit

- 10) The final exit doors have door entry systems installed. These systems are designed to fail safe i.e. door unlocked in the event of a power failure. This prevents residents being locked in or out of the building. These doors are checked on regular bases by the Caretaking Teams as part of their checks. Defective closing devices are replaced either by the Caretaking Team(s) or the in-house repairs team(s).

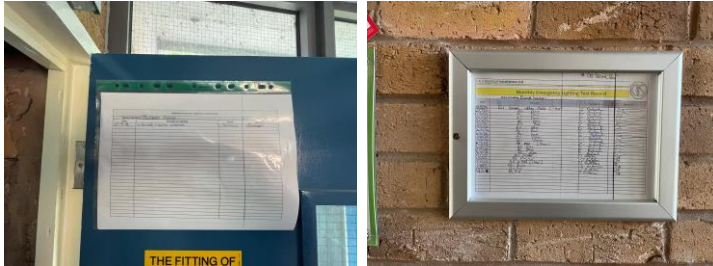
- 3) Emergency lights are also checked and tested monthly by Sandwell MBC in house electrical team

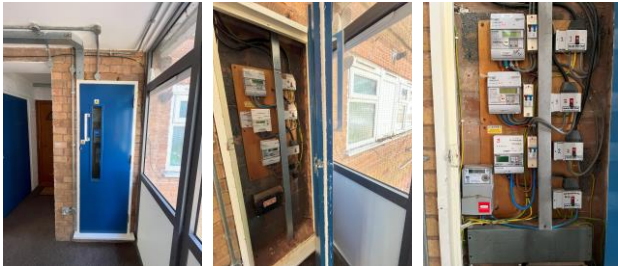
7) All Residents service cupboards on each floor are housed behind a FD30s fire rated doors. All cupboards are free from any combustibles

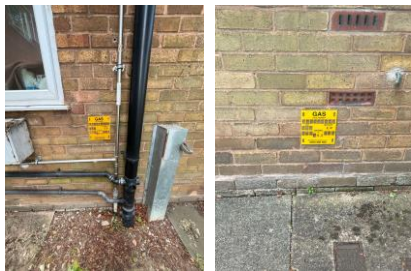
8) Gas appliances and pipework (where installed) are subject to annual testing and certification. This contract is managed by the in-house Gas team. Gas supply to this premises is external.

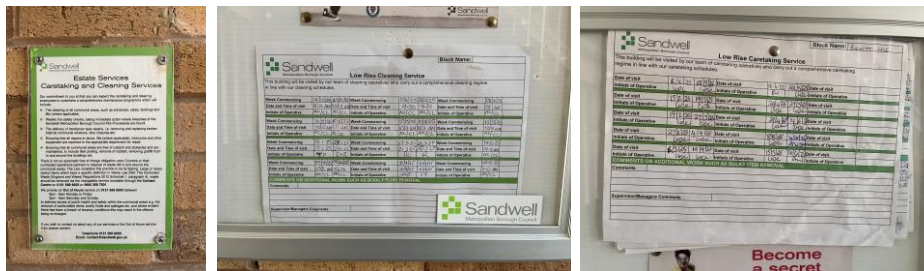
- 1) There is a regular Cleaning Service to the premises.

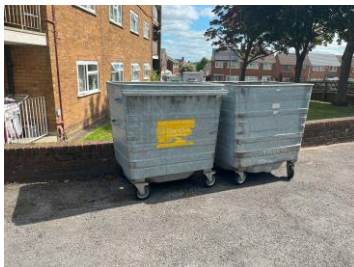
- 2) Refuse bins are stored to the rear of the building. Bins Are regularly emptied by site services.

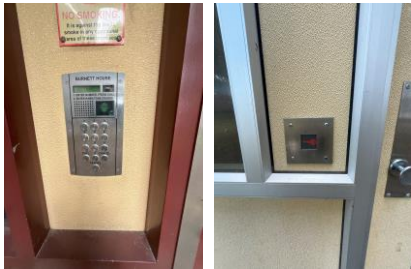
- 1) Regular checks are undertaken by Caretakers / Cleaning Team(s) 365 days per year which helps reduce the risk of arson.
- 2) Restricted access to the premises by means of a door entry system to the front and the rear.

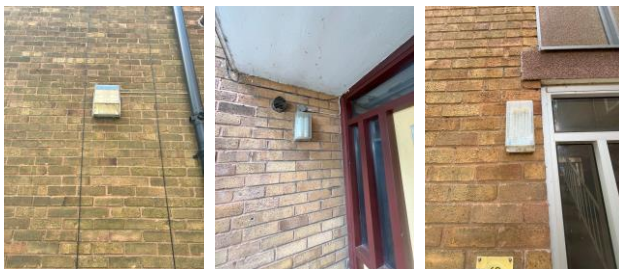
Lighting to the front and rear entrances

- 3) There is no current evidence of arson.
- 4) The perimeter of the premises is well illuminated.

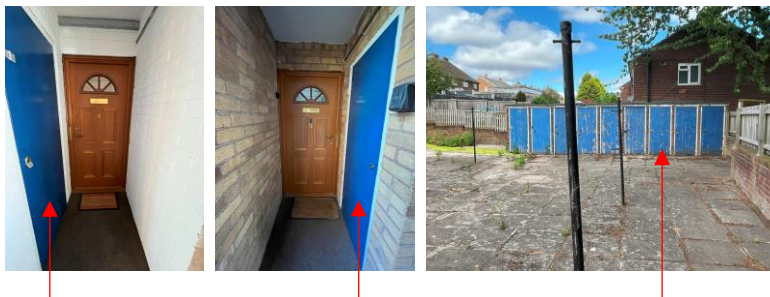
Internal storage cupboards and external resident storage units

- 1) Residents instructed not to bring L.P.G cylinders into block.
- 2) The tenancy conditions, Section 7 – Condition 5.6 stipulates “If you live in a flat or maisonette, you, people living with you and any visitors to your property must not keep or use paraffin oil, petrol, bottled gas appliances or any other explosive, FLAMMABLE or dangerous material in the property. This restriction also applies to any storage facility situated in or attached to the block, which has been provided for your use.”
- 3) No Flammable liquids stored on site by Caretakers / cleaners.
- 4) There are no flammable liquids or gas cylinders stored on site.
- 5) Residents have individual storage cupboard internally and externally which they keep secured by means of own keys.
