Fire Risk Assessment

Grasmere House

**Lovett Avenue, Oldbury,
B69 1DQ**

Date Completed: 3rd July 2025

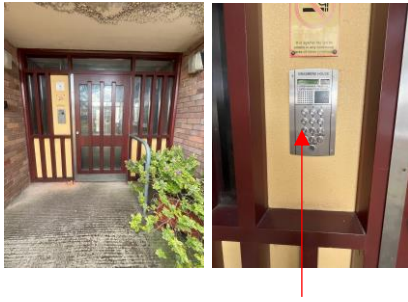
Front entrance and fob

Entrance to the building is accessed through the main entrance, which is set back from the main road with a walkway that leads up to the front of the property. The entrance is of a timber frame and glass with timber and glass side panels to either side of the door.

Both front and rear door entrances are accessed through a fob reader, the front entrance is equipped with a firefighters override switch which is located above the door access panel.

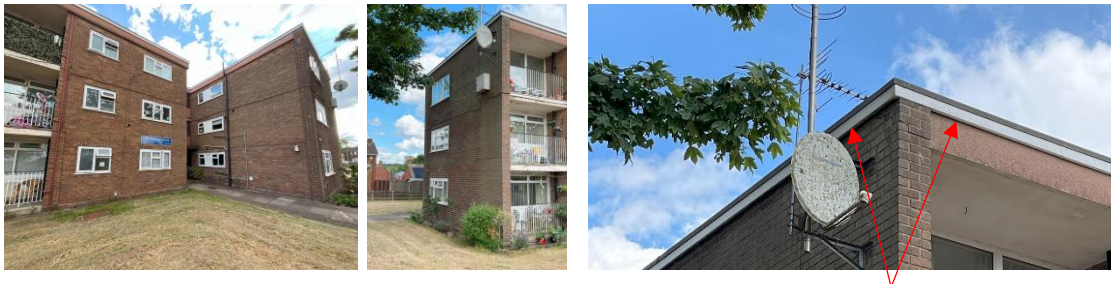
UPVC and felt roofline

- 1) The external construction of the building is predominantly brick with UPVC and felt fascia to the roof line

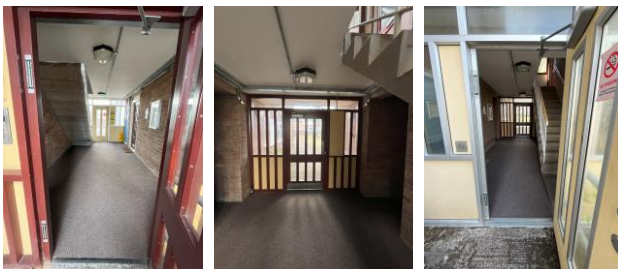
Ground Communal hallway

- 2) Ground floor houses flat 1,2,3, they are located off the main communal hallway. All corridors are of adequate width (at least 1050mm) and will be maintained clear to that width as a minimum.

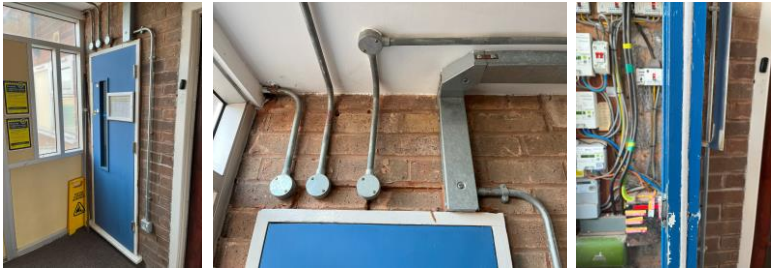
- 3) Near the rear final exit there is a resident's meter cupboard, this is protected by a FD30s rated fire door. The door is secured by a budget lock; residents have been provided a key for access to this cupboard. There is metal box trunking that is installed above the door and across the ceiling providing electrical supply to each flat.
-

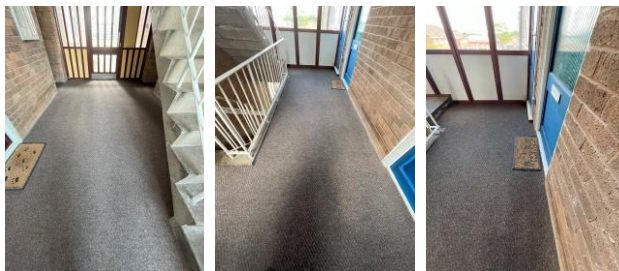
- 4) All communal hallway floors are carpeted, the flat entrances have door mats, the fire rating is not known on the door mats.

All floors have S.M.B.C. fitted carpet. Due to the fact SMBC specified and managed the installation of the carpets, they are in accordance with BS EN 13501-1

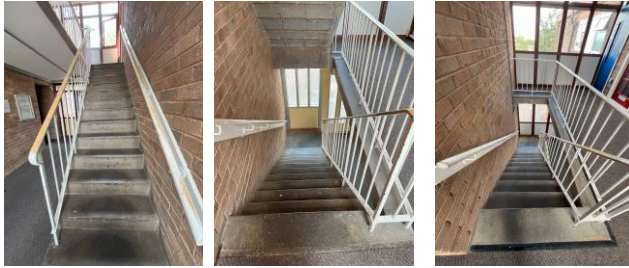
- 6) The premises consists of a single staircase that provides means of escape, this is located as you enter the building, this has been measured and 750mm in width.

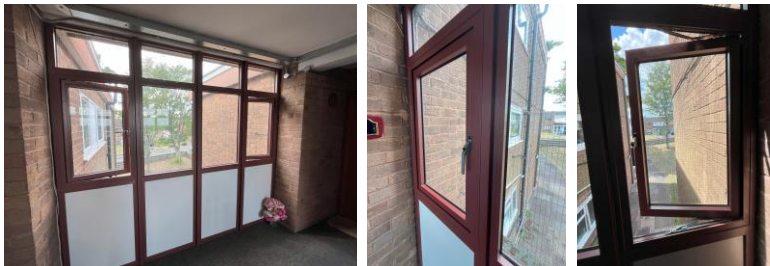
- 8) On the 1st and 2nd floor communal landings, there are a set of aluminium windows that can be opened without the use of a key, these are to allow sufficient airflow. There is no automatic smoke ventilation system installed in this premises.

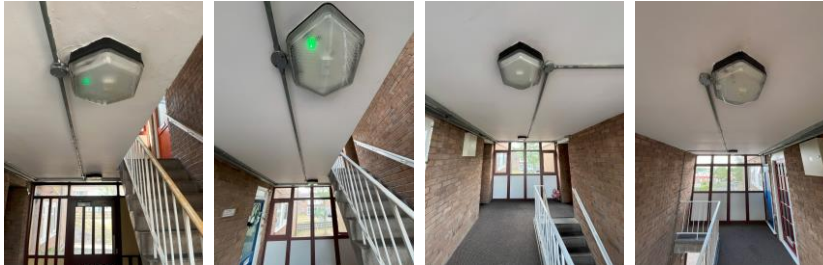
- 9) Emergency lighting is installed throughout the building, there is a set of lights to each floor, at either end which provide suitable emergency lighting in the event of an emergency.

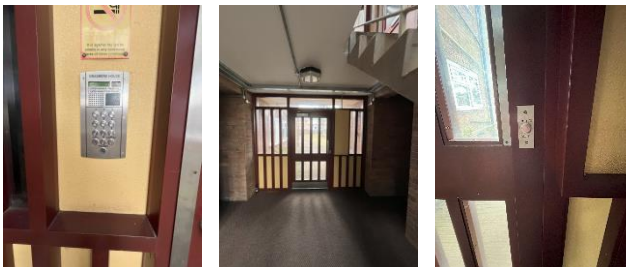
Front door entry/exit

- 10) The final exit doors have door entry systems installed. These systems are designed to fail safe i.e. door unlocked in the event of a power failure. This prevents residents being locked in or out of the building. These doors are checked on regular bases by the Caretaking Teams as part of their checks. Defective closing devices are replaced either by the Caretaking Team(s) or the in-house repairs team(s).

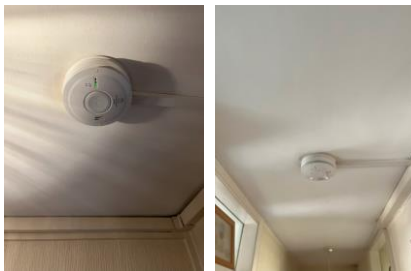
Flat 1 detection to a LD2 standard.

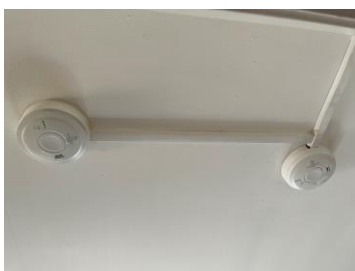
Flat 3 detection to a LD2 standard.

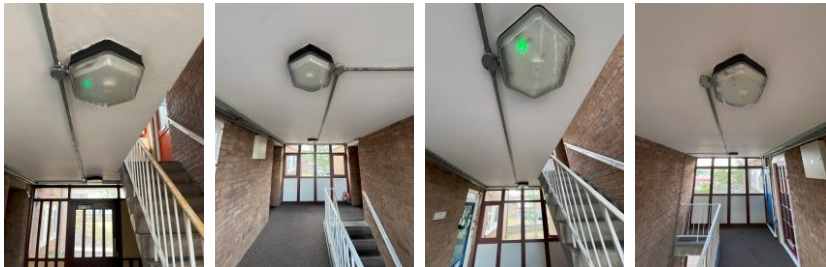
- 4) There are self-contained units installed on each floor consisting of 2 units per floor

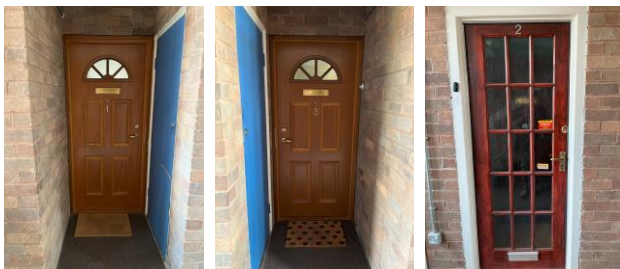
Ground, Flats 1,2,3

- 1) The building is designed to provide as a minimum 1-hour vertical fire resistance and 1-hour horizontal fire resistance.
- 2) The premise does not have sufficient compartmentation to limit the travel and effect of smoke and flame in the event of a fire in communal areas due to having an open plan stairwell. Whilst the existing fire stopping is fit for purpose, there is a cyclical programme to ensure fire stopping as not been compromised by third parties and where applicable enhance the fire stopping.
- 3) All service cupboards on each floor containing residents' meters are lockable.
- 4) A variety of methods and materials have been used to achieve fire-stopping including Rockwool and intumescent pillows.
- 5) All individual flat doors are FD30s rated composite doors.

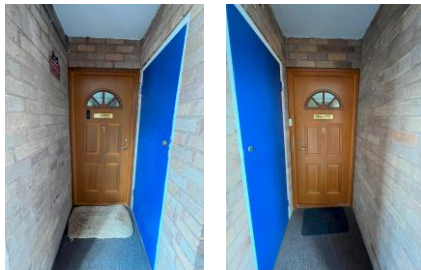
- 6) All residents' storage cupboards next to their own front entrances are secured by residents own key. The door is a notional fire door.

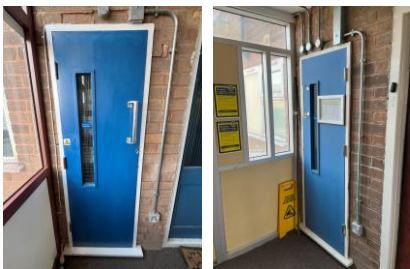
- 7) Ground, 1st and 2nd floor residents' electrical cupboards are secured behind FD30s rated fire doors.

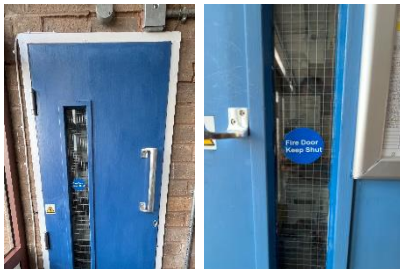
- 1) Fire door keep shut signs are displayed where appropriate. All resident meter cupboards display "Fire Door Keep locked" sign.

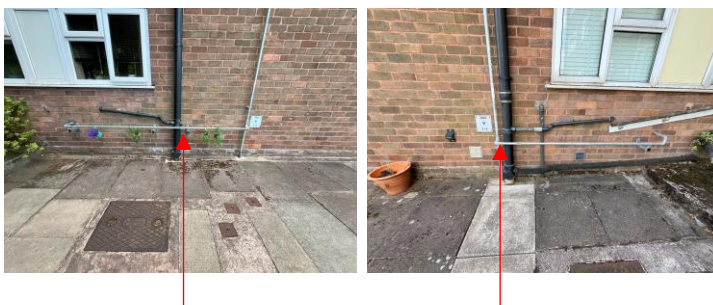
External gas pipework to the property

- 9) Gas appliances and pipework (where installed) are subject to annual testing and certification. This contract is managed by the in-house Gas team. Gas supply to this premises is external.

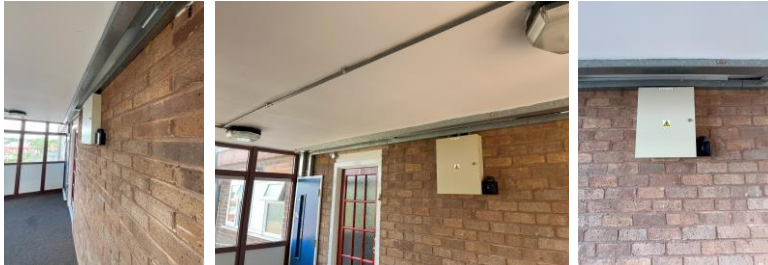
- 10) 2nd floor has door entry system power supply unit installed on the wall, this is secure and away from resident's reach, all cabling is housed within boxed metal trunking above.

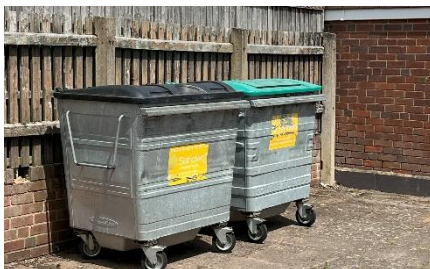
- 2) Refuse bins are stored to the rear of the building. Bins Are regularly emptied by site services.

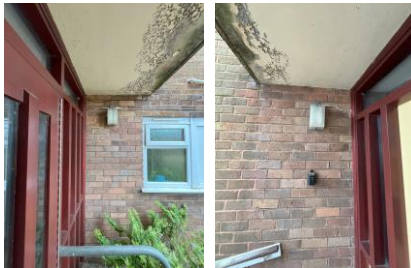
External wall lighting to the front

- 3) There is no current evidence of arson.
- 4) The perimeter of the premises is well illuminated.

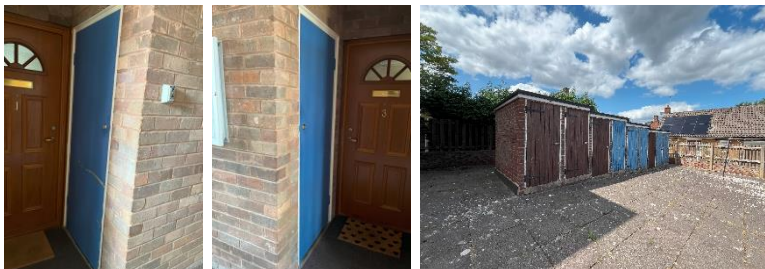
Internal storage cupboards and external resident storage units.

- 1) Residents instructed not to bring L.P.G cylinders into block.
- 2) The tenancy conditions, Section 7 – Condition 5.6 stipulates “If you live in a flat or maisonette, you, people living with you and any visitors to your property must not keep or use paraffin oil, petrol, bottled gas appliances or any other explosive, FLAMMABLE or dangerous material in the property. This restriction also applies to any storage facility situated in or attached to the block, which has been provided for your use.”
- 3) No Flammable liquids stored on site by Caretakers / cleaners.
- 4) There are no flammable liquids or gas cylinders stored on site.
- 5) Residents have individual storage cupboard internally and externally which they keep secured by means of own keys.
