Fire Risk Assessment

Martley Road 48-58

**Martley Road, Oldbury,
B69 1DZ**

Date Completed: 4th August 2025

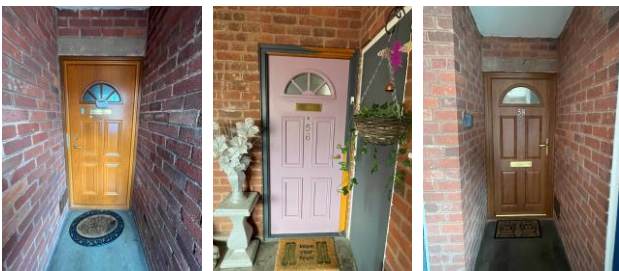
- 1) All flats are equipped with minimum LD3 detection.
- 2) On the first floor, flat 56 has a UPVC framed unit installed, on investigation, the window can be opened as confirmed by the tenant, this window is accessed through the bathroom of this property.
- 3) First floor flats 54,56,58, have door mats outside the front entrance, the fire rating is not known on the door mats.

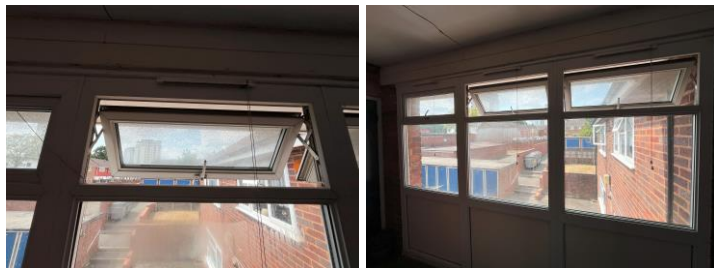
- 8) On the 1st floor communal landings, there are a set of UPVC windows the windows can be opened without the use of a key, these allow sufficient airflow into the landing. There is no automatic smoke ventilation system installed in this premises.

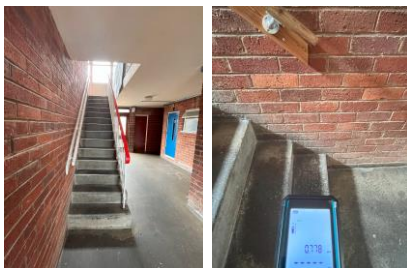
- 9) The premises consists of a single staircase that provides means of escape, this is located as you enter the building, The stairs have a secondary handrail installed on the wall narrowing its initial width, it has been measured and 778mm in width from rail to rail which is acceptable.

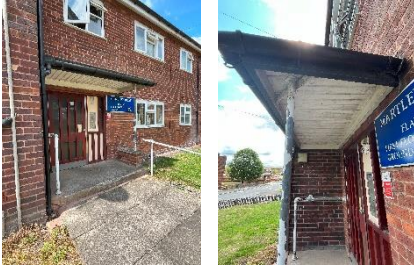
- 10) Flat 56 has a window that exits out on to the front entrance canopy. This is acceptable as the floor level no more than 4.5m in height.

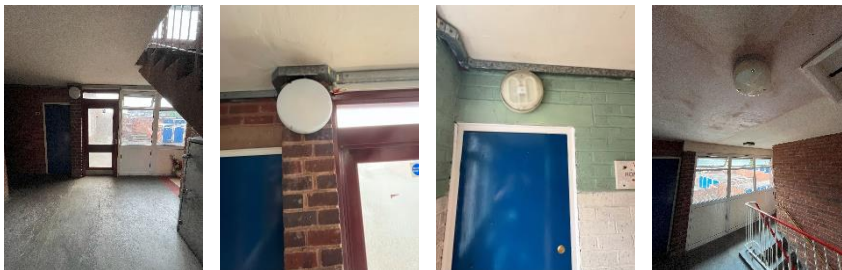
These are standard light fittings within the communal area of the building.

- 12) Ground floor communal entrance near to the front entrance door, there is a wall light unit that is damaged, the plastic cover is secured with gaffer tape, this will need a new secure fitting.**

7/12	Ground floor communal hallway, damaged light. Needs replacing	 		P2	1-3 Months Electrical Team	
------	---	--	--	----	-------------------------------	--

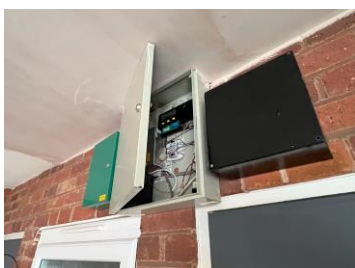
- 11) Gas appliances and pipework (where installed) are subject to annual testing and certification. This contract is managed by the in-house Gas team. Gas supply to this premises is internal.
- 13) 1st floor has door entry system power supply unit installed on the wall; this was not secured shut at the time of FRA. Email has been sent to the door access control team to have these units made secure.
