Fire Risk Assessment

1-12 Davies house

Lodge street, Oldbury
B69 4JE

Date Completed: 14th August 2025

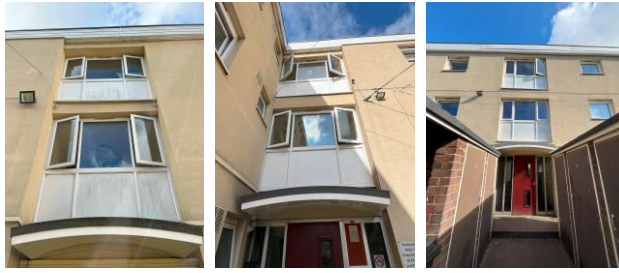
UPVC Units to front and rear communal staircase.

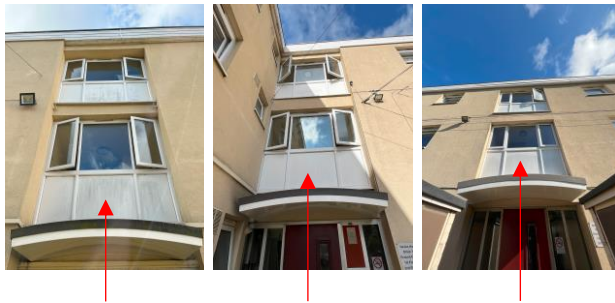
Front and Rear Spandrel panelling under the window units.

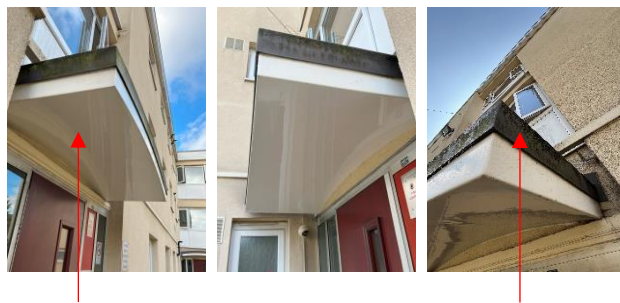
Plastic underside of canopies with composite type overlay.

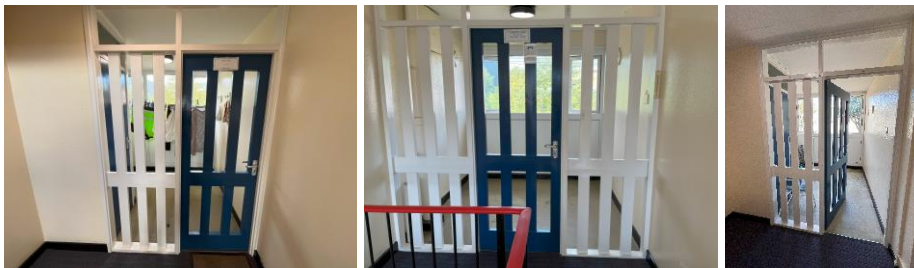
- 4) Each landing within blocks have former drying room areas adjacent to the stairs. This area is secured, and tenants have access via a key.

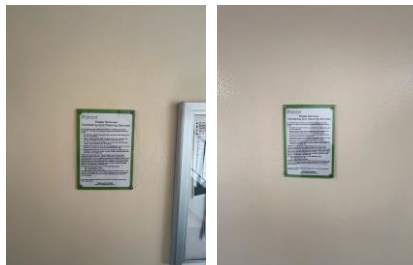
- 5) Communal areas are kept free of flammable items. The communal areas are checked on a regular basis by Caretaking / Cleaning teams 365 days per year and all items of rubbish are immediately removed. There is also an out of hour's service that allows combustible items of furniture / rubbish to be removed. On this FRA, there were considerable number of items within the communal areas of the 2 blocks.

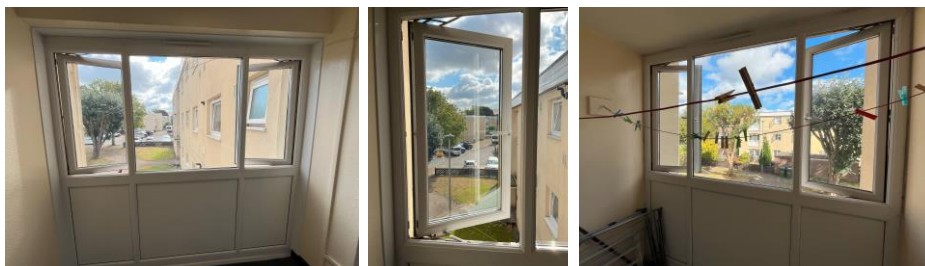
- 7) On both blocks, 1st and 2ⁿ floor communal landings, have a set of UPVC windows, these windows can be opened without the use of a key in the case of escape from the 1st floor, these also allow sufficient airflow. There is no automatic smoke ventilation system installed in this premises.

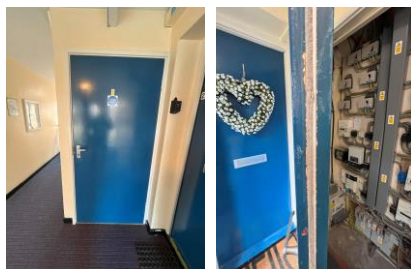
- 3) Service cupboards on ground floor containing residents' meters are lockable with a budget key.

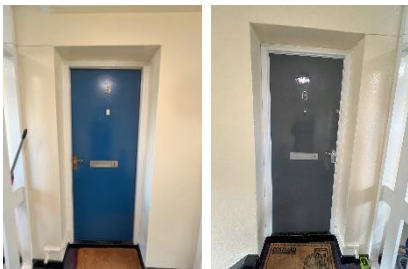
2nd floor flats 5,6

6) Flat 5 has no door closure fitted, there is also no smoke seals on the door or the door frame.

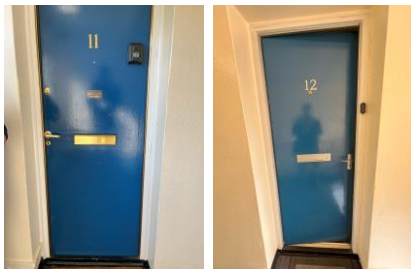
2nd floor flats 11,12

- 4) A variety of methods and materials have been used to achieve fire-stopping including Rockwool and intumescent pillows where needed.
- 5) All individual flats are installed with notional FD30 rated timber doors, however there were no smoke seals evident on the doors sampled.

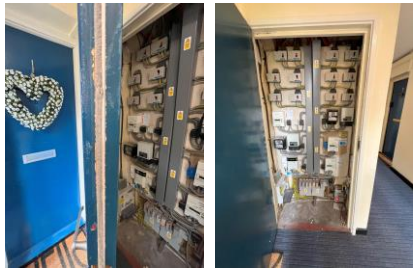
- 7) All Residents service cupboards on each floor are housed behind a FD30s fire rated doors. All cupboards are free from any combustibles.

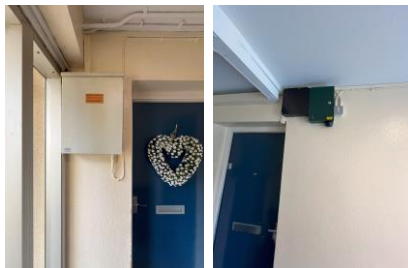
- 12) Door access power supply is housed in a secure metal unit on the wall.

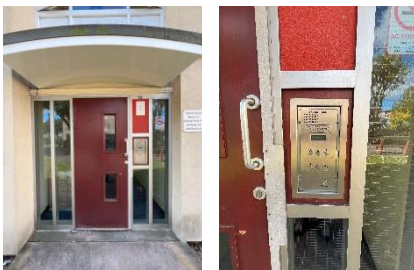
Front and rear entrance

- 1) Regular checks are undertaken by Caretakers / Cleaning Team(s) 365 days per year which helps reduce the risk of arson.
- 2) Restricted access to the premises is via a key lock, each resident has their own key to gain access. There is an intercom system that can allow visitors and contractors in.

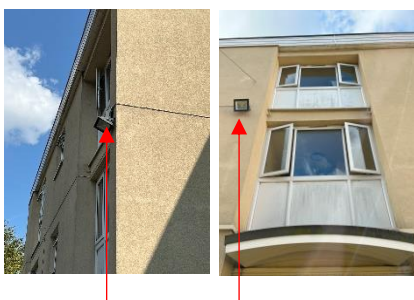
Front External lighting

- 3) There is no current evidence of arson.
- 4) The perimeter of the premises is well illuminated.

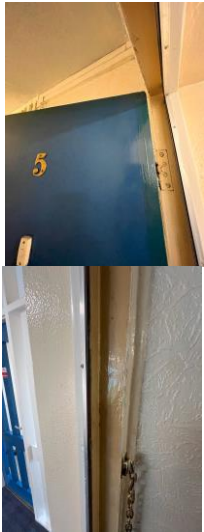
10/6	Flat 5 has no door closure fitted, no smoke seals on the door or the door frame. Needs fitting.

P2	1-3 Months Housing Team

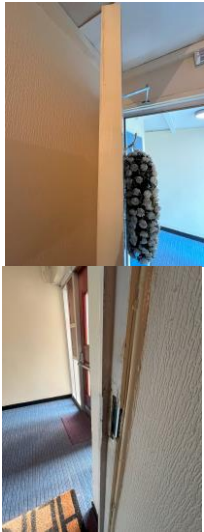
P2	1-3 Months Fire Rapids Response	
10/7	Flat 7 has no smoke seals on the door or the door frame. No evidence of intumescent seals. Needs Fitting

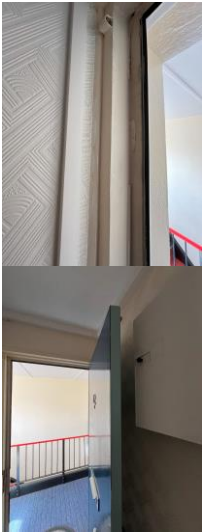
10/8	Flat 12 has no door closure, it's a notional door, no smoke seals, no intumescent strips. Needs fitting.

P2	1-3 Months Fire Rapid Response

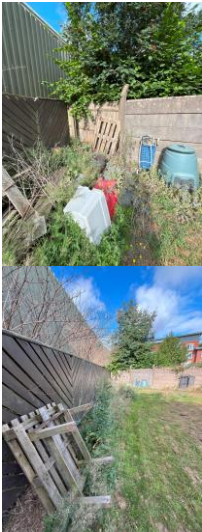
- 4) Was noted that there are discarded timber pallets and plastic containers left to the rear of the building.**

P2	1-3 Months Fire Rapid Response	
15/4	Discarded timber pallets and plastic containers left to the rear of the building. Need to be removed.

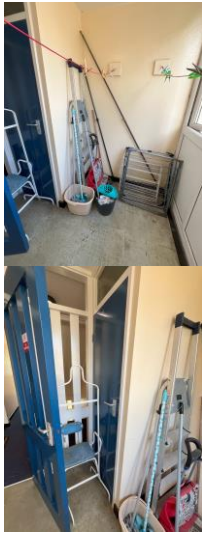
07/12	Former drying area on block 1-6, on the 1 st floor outside flat 3 has various items stored in it,Need to be removed.

P2	1 -3 Months Caretaking Team

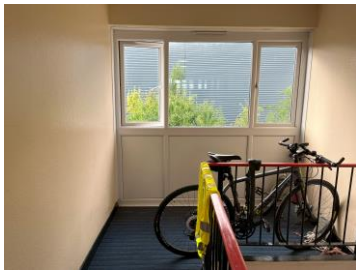
P2	1-3 Months Housing Team	
07/14	2 nd floor on block 1-6, there is a bike and other items stored at the end of the landing. Need removing
