# Fire Risk Assessment

**1-12 Parkes House  
Lodge Street,  
Oldbury,  
B69 4JE.**

**Date Completed: 14/08/2025**

**Current Risk Rating = Tolerable**

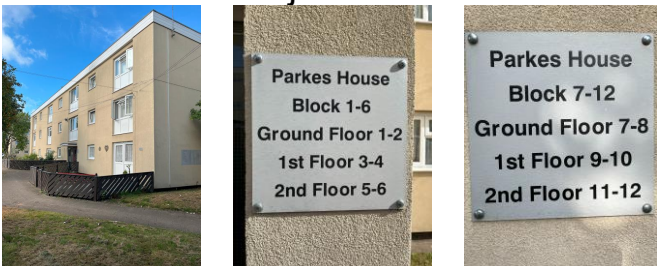
The Low-rise block was constructed in the 1963. The block is a Wimpey no-fines construction with a flat roof. The block consists of 3 storeys (inclusive of the ground floor). The block has been divided into two sections with flats 1-6 having a separate entrance/exit and staircase to flats 7-12. A plaque stating which flats are accessed by each staircase is located on the front elevation adjacent to the main entrances.

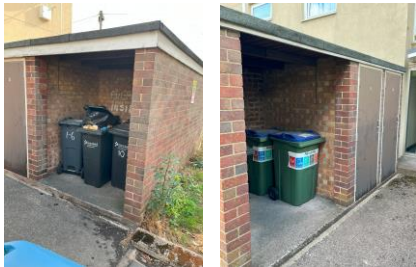
- 1) There is a regular Cleaning Service to the premises.
- 2) Refuse bins are stored to the front and rear of the building in a purpose-built store away from the main building. Bins Are regularly emptied by site services.

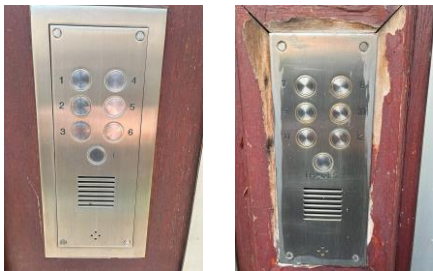
- 1) Regular checks are undertaken by Caretakers / Cleaning Team(s) 365 days per year which helps reduce the risk of arson.
- 2) Restricted access to the premises by means of a door entry system to the front and the rear.

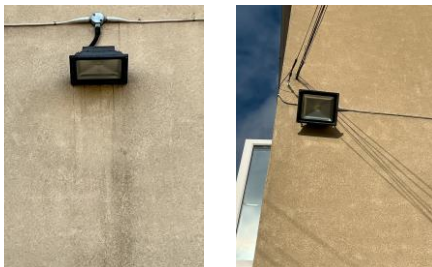
- 3) There is no current evidence of arson.
- 4) The perimeter of the premises is well illuminated.
