Fire Risk Assessment

1-6, 7-12

Jackson House,
Oldbury,
B69 4JG

Date Completed: 05/09/2025

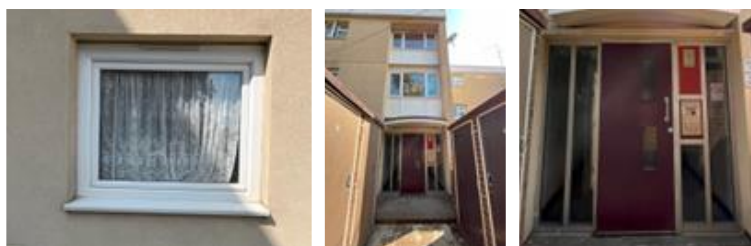
- 3) UPVC double glazed blocks have been installed to each flat and communal stairway. There is a canopy situated over the front and rear entrance to the block. Entrance & rear door are timber with steel framework and glass panelling.

- 2) **The building currently has several areas of damaged render that require repair to maintain fire safety standards. Recommend a joint visit with the repairs team and Fire Risk Assessor to identify areas. Also, to carry out a review of the fire risk assessment every 12 months.**

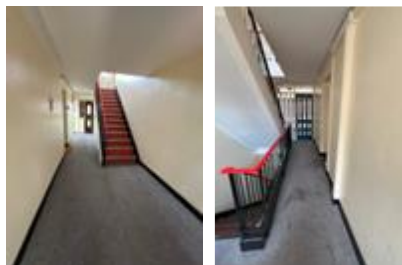
- 3) All communal hallway floors are carpeted. All floors have S.M.B.C fitted carpet. Due to the fact S.M.B.C specified and managed the installation of the carpets it has been presumed that they are BS 5287,1988 specification for assessment and labelling of textile floor coverings and BS 4790 Fire Test Method to textile Floor Coverings.

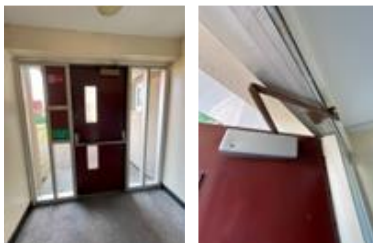
- 4) The means of escape are protected to prevent the spread of fire and smoke. All service cupboards to communal landings are updated timber notional doors with added smoke seal and intumescent strip, they are lockable with budget locks and include fire door Keep locked signage. A Stay Put Unless strategy is in place to protect residents.
-

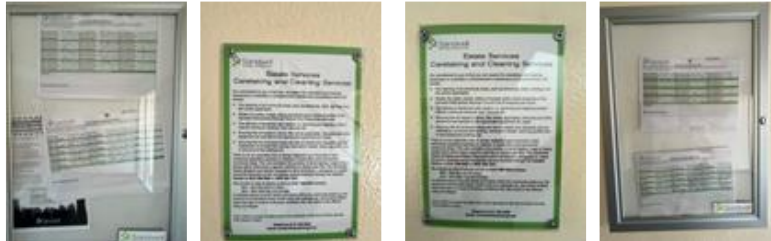
Block 1-6

- 11) Communal areas are kept free of flammable items. The communal areas are checked on a regular basis by Caretaking / Cleaning teams 365 days per year and all items of rubbish are immediately removed. There is also an out of hour's service that allows combustible items of furniture / rubbish to be removed.

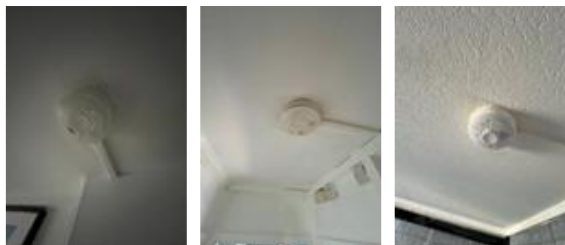
- 1) Early warning is limited to hard wire or battery smoke alarms within each of the resident's flats the equipment is subjected to a cyclical test.
- 2) Based on the sample of properties accessed during the fire risk assessment the smoke alarms within resident's flats are installed to a minimum of LD3 Standard.
 - Flat 1 was checked at the time of the fire risk assessment: Smoke detection within the hallway (LD3)
 - Flat 2 was checked at the time of the fire risk assessment: Smoke detection within the hallway and a heat and carbon monoxide detector in the kitchen (LD2)
 - Flat 8 was checked at the time of the fire risk assessment: Smoke detection with the hallway, living room and a heat and carbon monoxide detector in the kitchen (LD2)

- 3) Recommend flats are upgraded to LD1 in future improvement programs.

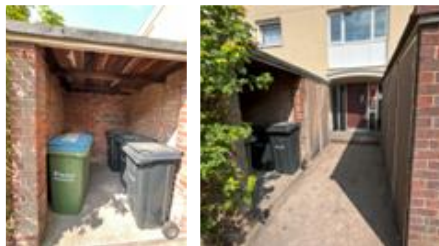
- 1) There is a regular Cleaning Service to the premises.
- 2) Waste bins are stored within a purpose-built brick structure detached from the main building. These are emptied by SMBC on a regular basis.

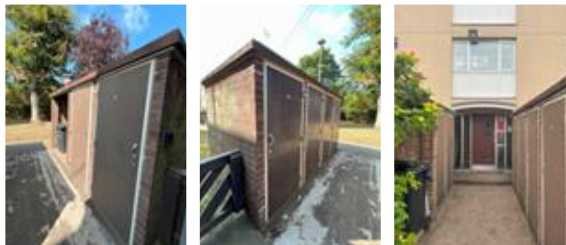
- 1) Residents instructed not to bring L.P.G cylinders into block.
- 2) The tenancy conditions, Section 7 – Condition 5.6 stipulates “If you live in a flat or maisonette, you, people living with you and any visitors to your property must not keep or use paraffin oil, petrol, bottled gas appliances or any other explosive, FLAMMABLE or dangerous material in the property. This restriction also applies to any storage facility situated in or attached to the block, which has been provided for your use.”
- 3) No Flammable liquids stored on site by Caretakers / cleaners.
- 4) There are no flammable liquids or gas cylinders stored on site.
- 5) Residents have individual storage cupboards externally which they keep secured by means of their own keys.
