Fire Risk Assessment

2 - 26

**Underhill Street,
Oldbury,
B69 4SJ**

Date Completed: 15/09/2025

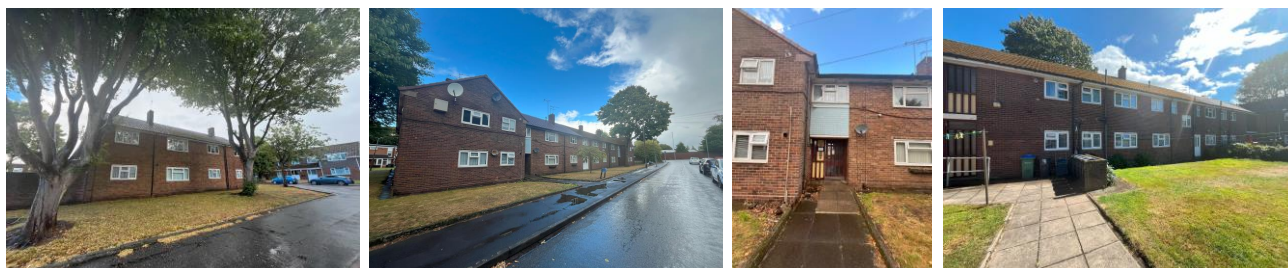
- 1) The external surface of the building is predominantly brick structure with timber soffits and fascia. The roof is pitched and fitted with Marley concrete interlocking roof tiles are fitted on the roof.

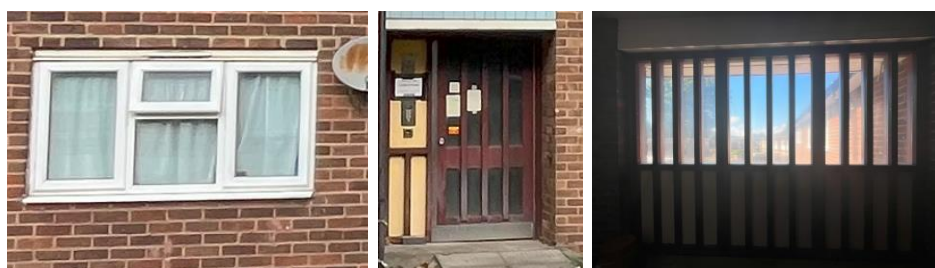
- 2) UPVC double glazed units have been installed to each flat. The front & rear doors are timber, within a timber frame. Side panels are also timber framed with glass panelling within the top section and spandrel panels in the lower. Recommend ventilation fitted in any future refurbishment program.

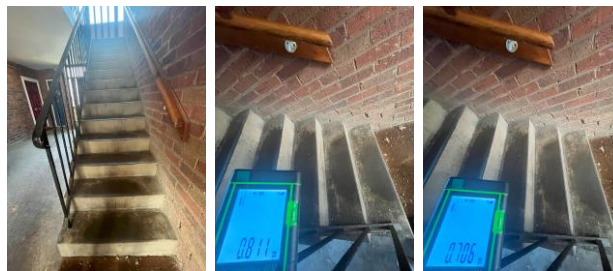
- 1) 2-12 Underhill Street: The first floor is accessed via a single staircase that provides a means of escape and has a width of 811mm reducing to 706mm between the handrails. The stairwell width has been reduced slightly due to added handrail, this reduction in width is unlikely to affect acceptable evacuation times.

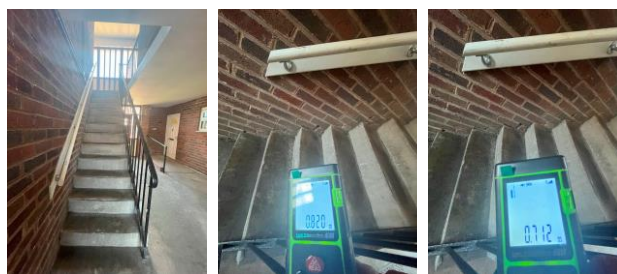
- 2) 16-26 Underhill Street: The first floor is accessed via a single staircase that provides a means of escape and has a width of 820mm reducing to 712mm between the handrails. The stairwell width has been reduced slightly due to added handrail, this reduction in width is unlikely to affect acceptable evacuation times.

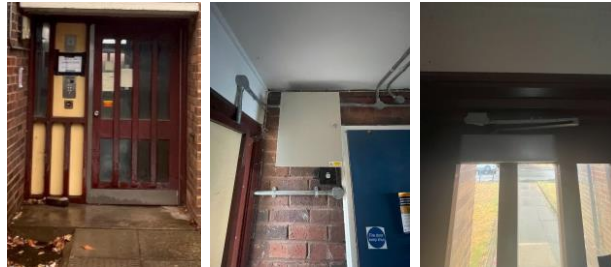
- 4) The means of escape are protected to prevent the spread of fire and smoke. All service cupboards to communal landings are updated timber notional doors with added smoke seal and intumescent strip, they are lockable with budget locks and include fire door Keep locked signage. A Stay Put Unless strategy is in place to protect residents.
- 5) The final exit doors are fitted with automatic closing devices that are checked on a regular basis by caretaking teams as part of their checks. Defective closing devices are replaced either by the Caretaking Team(s) or the in-house repairs team(s). The final exit doors have door entry systems installed. These systems are designed to fail safe i.e. door unlocked in the event of a power failure. This prevents residents being locked in or out of the building.

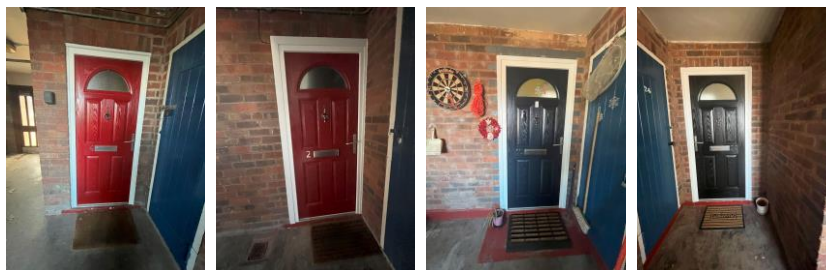
- 6) Individual flat doors are FD30s rated composite doors sets. Access is gained to a sample of properties as part of the fire risk assessment to ensure the doors have not been tampered with. Flat numbers 6 and 16 were accessed at the time of the assessment and both doors need adjusting see section 10/11.
- 7) Several flats have door mats present at the entrances; the fire rating is not known on these door mats and are deemed to be low risk.

P2	Within 1-3 months Housing Manager	
7/9a	Flat 6: Adjust door. Door does not close without assistance

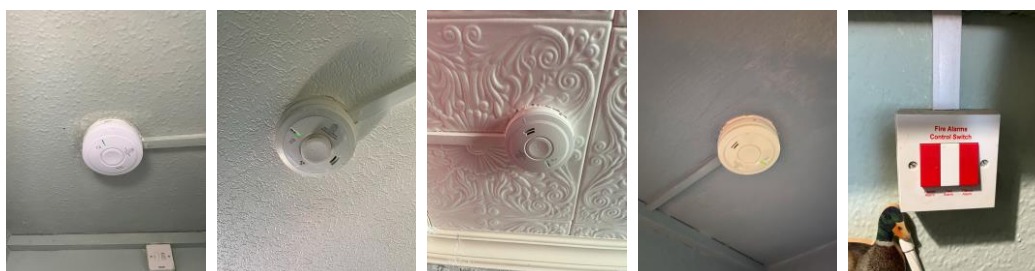
- 1) Early warning is limited to hard wire or battery smoke alarms within each of the resident's flats the equipment is subjected to a cyclical test.
- 2) Based on the sample of properties accessed during the fire risk assessment the smoke alarms within resident's flats are installed to a minimum LD3, flats also have installed a fire alarm control switch to test and silence the alarm.
 - Flat 6: LD2
 - Flat 16: LD1 all rooms covered

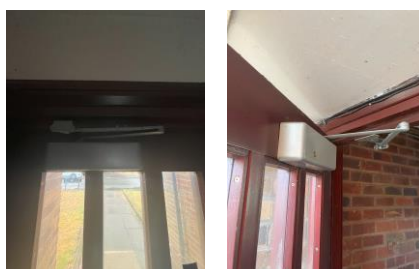
- 5) A variety of methods / materials have been used to achieve fire-stopping such as intumescent mastic around cable penetrations.
- 6) The front and rear doors are fitted with automatic closing devices. These are checked on a regular basis by Caretaking Teams as part of their checks. Defective closing devices are replaced either by the Caretaking Team(s) or the in-house repairs team(s).

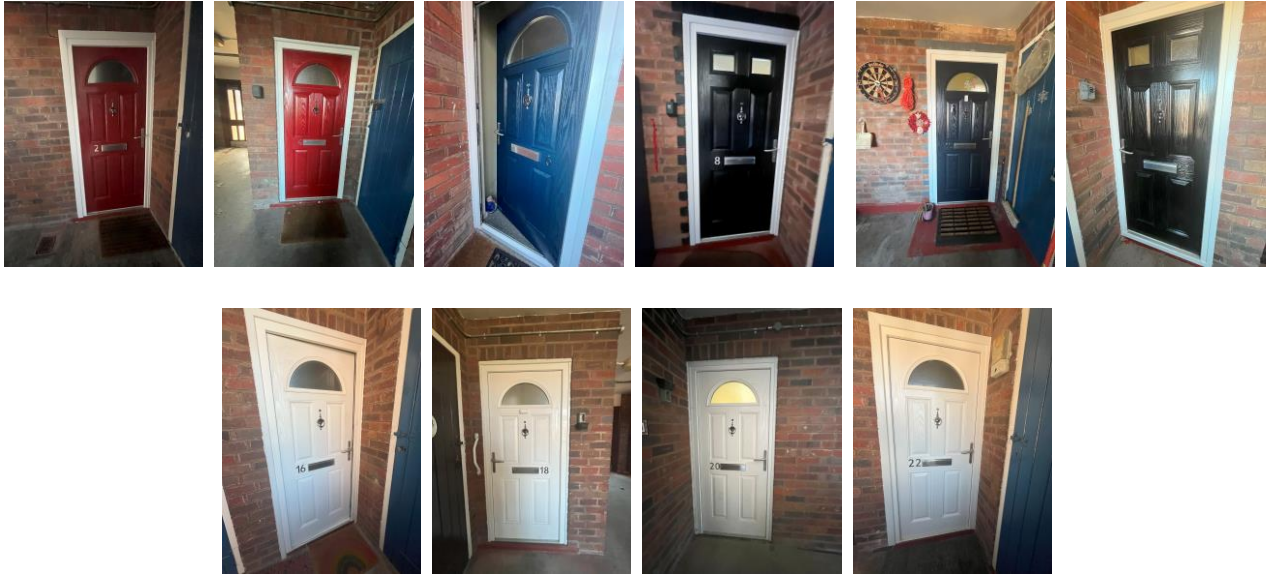
9) Individual flat doors are FD30s rated composite fire door construction.

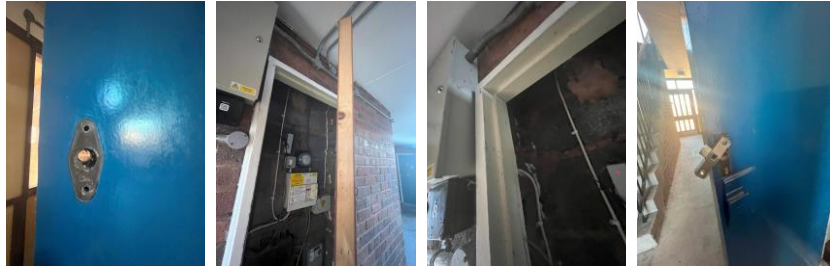
- a) **Service cupboard in block 2-12 requires fire stopping or replacement door due to hole where an old lock has been removed. Service cupboard door requires intumescent strips and smoke seals fitting.**
- b) **Service cupboard in block 16-26 requires replacement lock due to damage and the door not closing.**

- 7) All Residents service cupboards on each floor are housed behind a FD30 fire rated doors. All cupboards are free from any combustibles. Service cupboards require upgrade see Section 10/7

P2	Within 1-3 months Fire Rapid Response	
10/7b	Block 16-26: Replace lock due to damage. Fit intumescent strips and smoke seal.

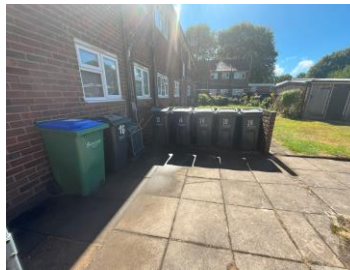
- 1) There is a regular Cleaning Service to the premises.
- 2) Refuse bins are stored in the rear garden area in an open-air purpose-built brick-built structure. Recommend this is relocated in future refurbishment program away from the building, added this to observations. Bins are emptied with the regular SMBC refuse collections.

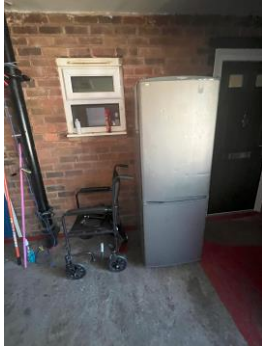
- 8) Within block 2-12 a number of flammable items and trip hazards were being kept within the communal areas.
- a) **Outside flat 6 and under the stairway, flammable items i.e. waste bin, cushions etc are being kept along with plant pots including plants. These items need to be removed from the common area.**
 - b) **On the 1st floor, outside flats 8, 10, and 12 a number of items are being stored i.e. aerosol, fridge freezer, wheelchair etc. These items need to be removed from the common area.**

7/8b	Block 2-12 first floor remove items on the landing ie fridge freezer, wheel chair etc
