# **Fire Risk Assessment**

## **Arden Grove**

**Arden Grove, Oldbury**  
**B69 4SU**

**Date Completed:** 1<sup>st</sup> September 2025

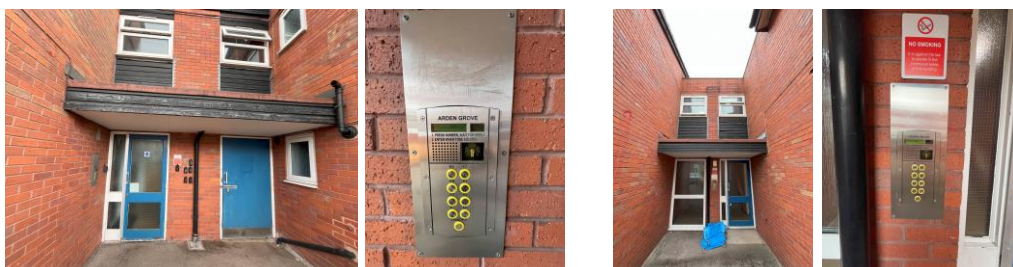
Both the front and rear entrances are accessed via fob readers, with the front entrance additionally featuring a firefighter override switch. Both doors are timber-framed, with Georgian wired glass fitted to the front and rear doors, while the side pane of the rear door is made of frosted double-glazed glass.

Front entrance with door access.

Rear Entrance with door access

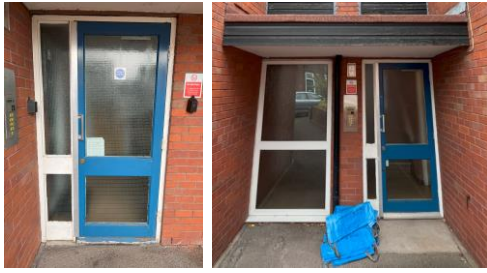
Front and rear entrance with GWG and standard glazing

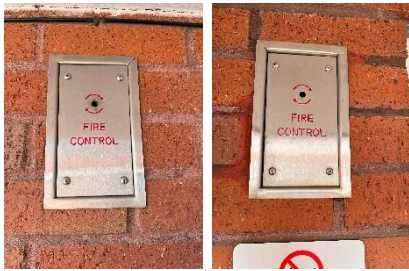
Front and rear firefighters Override Switch.

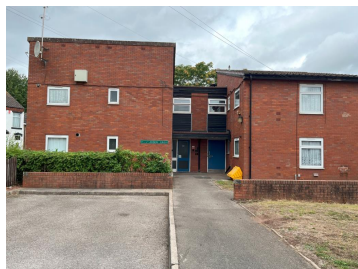
Front Elevation

- 1) The external surface of the building is a traditional brick build with UPVC units fitted to each flat. The roof is pitched with concrete roof tiles.

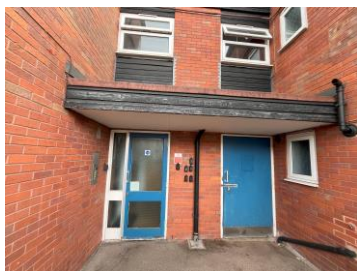
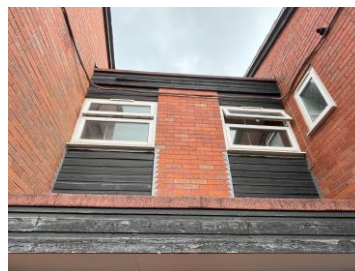
- 2) UPVC double glazed units have been installed to each and to communal staircase and landing. Both front and rear entrances have canopies over the front which are cladded with timber panels on the front, the roof is covered in felt, there is also timber cladding above and below the 2 UPVC window units on the front and rear of the building.

UPVC units to front and rear communal staircase and timber cladding.

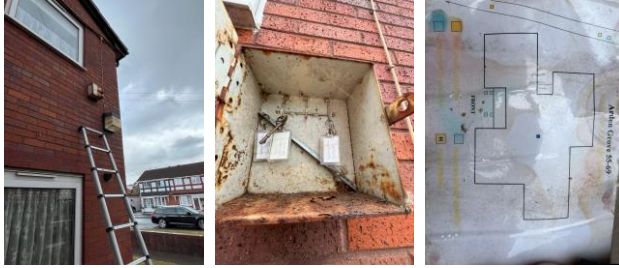
- 3) There is a firefighters information box installed on the outer wall near the front entrance. The box contains a plan of the building, keys for the lift motor room and MEB/ electrical room.

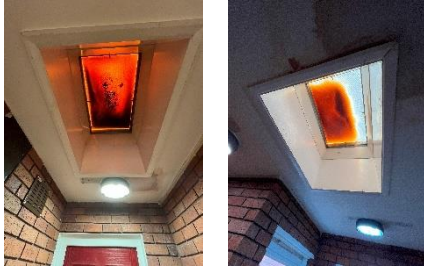
- 5) Even though the roof is pitched to one end, there is no access internally to the roof. The roof is installed with skylights in the communal corridor and landing.

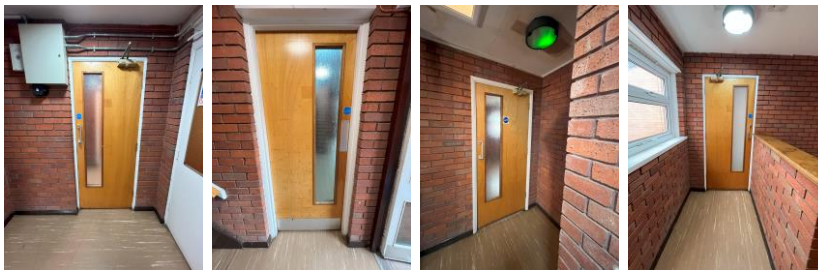
- 1) Each flat is equipped with, as a minimum LD3 fire detection to facilitate means of escape and provide sufficient response time.
- 2) The means of escape is a staircase separated by FD30s doors providing good compartmentation for the construction over 2 floors. (Including the ground floor. These doors separate the flat front door entrances from the communal staircases. All internal walls are of exposed brickwork with no coverings applied.

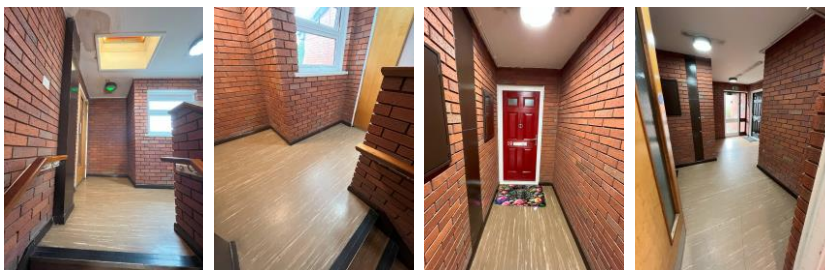
- 3) All corridors are of adequate width and are kept clear to promote and maintain safe exit in an event of fire.

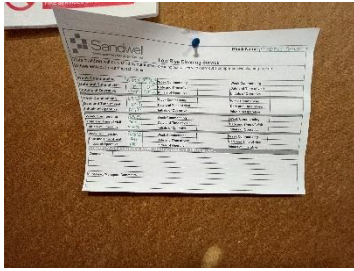
- 4) Communal areas are kept free of flammable items. The communal areas are checked on a regular basis by Caretaking / Cleaning teams 365 days per year and all items of rubbish are immediately removed. There is also an out of hour's service that allows combustible items of furniture / rubbish to be removed.
-

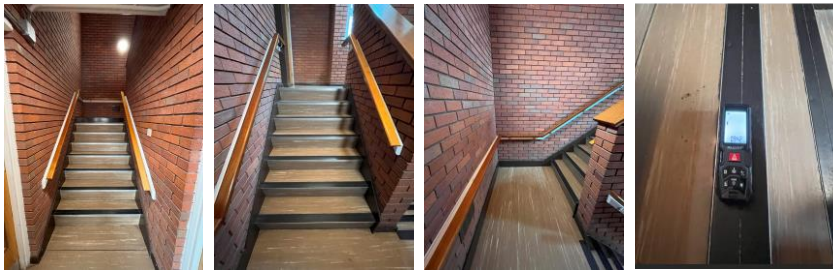
Ground to 1<sup>st</sup> floor

- 6) The premises consists of a single staircase that provides sufficient means of escape, this is located as you enter the building, this has been measured 942mm in width from handrail to handrail, as the handrails are more than 100mm (4 inch) away from the wall, the measurement are taken from rail to rail.

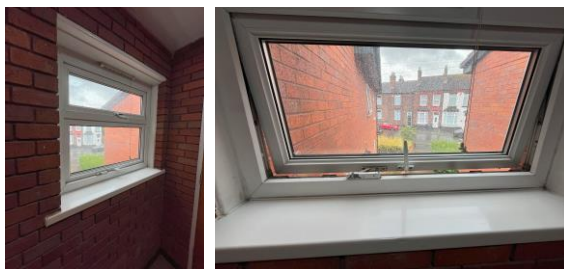
- 7) On communal landings, the block has a set of UPVC windows, these windows can be opened without the use of a key, these also allow sufficient airflow. There is no automatic smoke ventilation system installed in this premises.

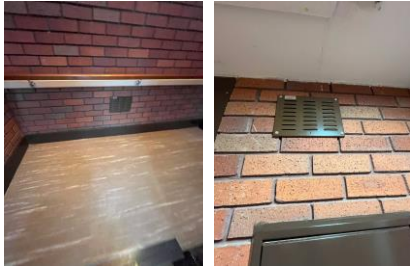
- 8) There is Envirgraf ventilation covers installed at various points within the building. These are located on the landing of the staircase and in the communal landing on the 1<sup>st</sup> floor.

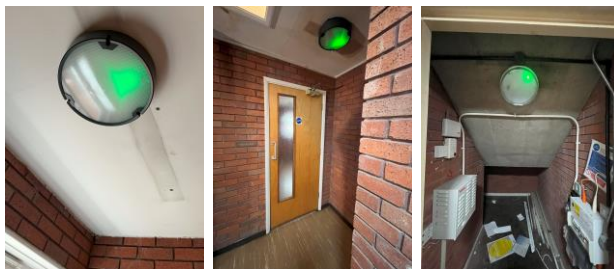
- 9) Emergency lighting is installed throughout the building. There are units installed on the ground floor near the entrance and on the 1<sup>st</sup> floor on the landing, there is also one unit installed in the MEB room on the ground floor.

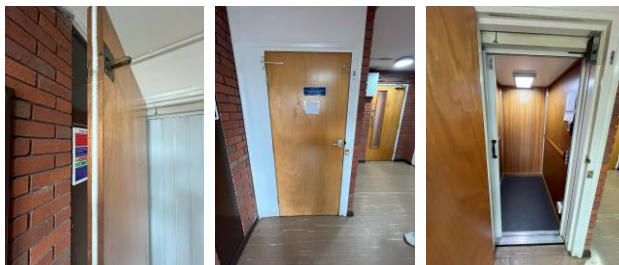
Fire fighters override switch

- 10) On the ground floor, adjacent to the front exit door is access to a residential lift, this is secured by means of a FD30s timber fire door, behind this door is a sliding door that allows access to the lift. There is a firefighters override access switch; the key is kept in the firefighter's box located on the wall outside the front entrance.

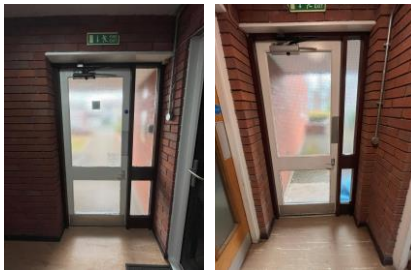
- 12) The final exit doors have door handle exit systems installed. These doors are checked on regular bases by the Caretaking Teams as part of their checks. Defective closing devices are replaced either by the Caretaking Team(s) or the in-house repairs team(s).

Front door & Rear door exits, handle to exit

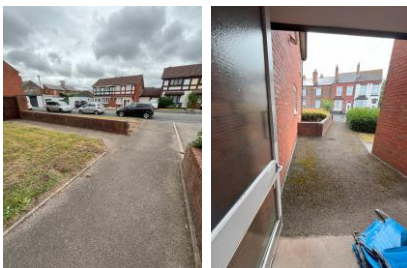
- 13) There is a clear and safe exit out of the building via the two-ground floor exits.

Front final & Rear final exit.

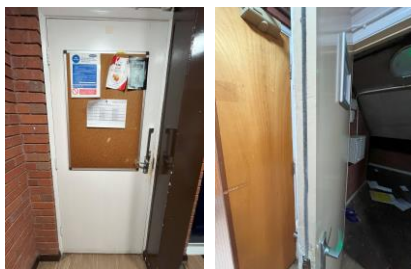
- 4) Electrical cupboard on the ground floor is fitted with FD30s timber fire door and is secured with the use of a 54 key.

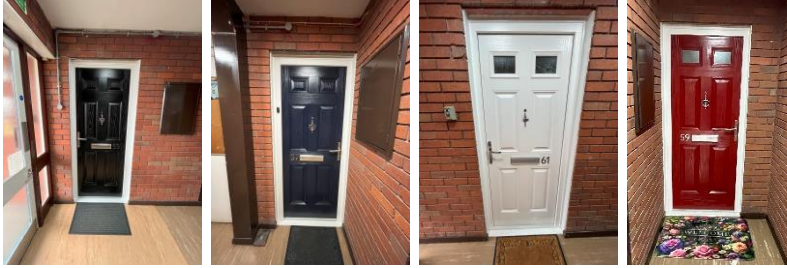
Ground floor flats 55,57,59,61

5) All individual flats are installed with composite FD30s rated doors.

- 8) Flat 61 has a cracked pane of glass in the upper right-hand corner of the door.**

P2	1-3 Months Fire Rapids Response	
10/8	Flat 61 has a cracked pane of glass in the upper right-hand corner of the door. Glass needs replacing.

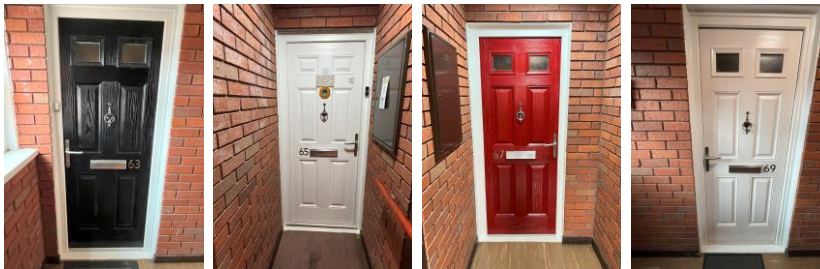
1<sup>st</sup> floor flats 63,65,67,69

**6) Flat 63 was accessed for condition of door closure and smoke seals, from the recommended 15 degree door opening test, the door did not auto close into the frame, this will need to be adjusted. The smoke seals were intact.**

- 7) Flat 69 was accessed to check function of door closure and condition of smoke seals. Door closed as it should from the recommended 15-degree door closure test. Smoke seal is partly missing from door frame; door frame is also damaged partially.**

10/7	Flat 69 requires smoke seal fitted to part of frame, also frame needs assessing due to slight damage.

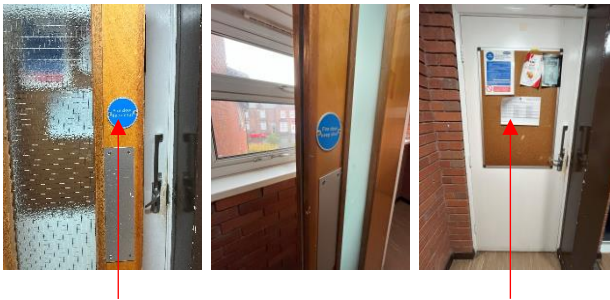
- 1) Fire door keep shut signs are displayed where appropriate. All communal doors to landings have the keep door shut signage, MEB cupboard has a keep locked sign.

Communal doors to landings and MEB cupboard.

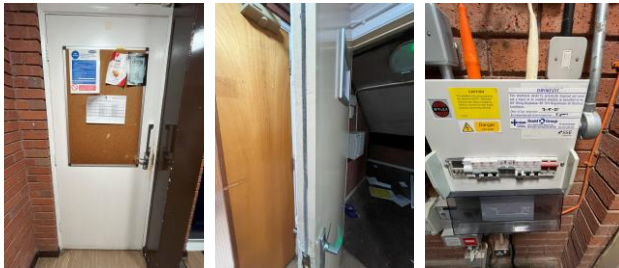
- 7) The electrical distribution board is in the electrical cupboard; this is secured behind a timber FD30s fire rated door.

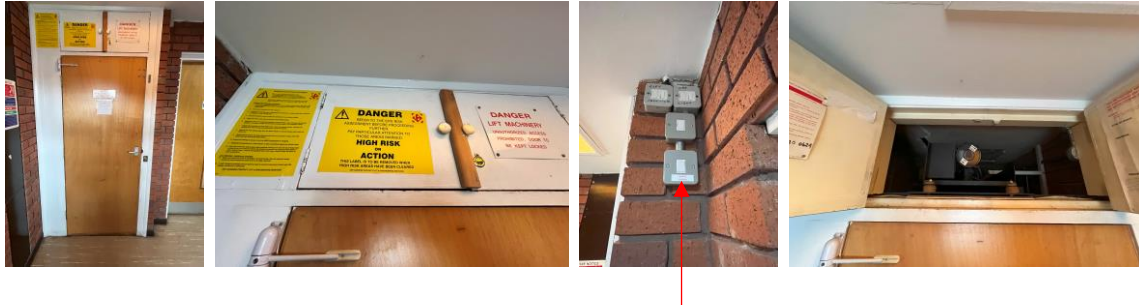
- 11) On the 1<sup>st</sup> floor communal landing, there is a lift motor compartment above the access door to the lift. The Isolation and shaft light switches for the lift are installed on a wall within the communal area.

Lift, motor compartment and shaft access, shaft light and isolation switches.

P2	1-3 Months Glazing/ Repairs	
10/9	Compartmentation above lift motor, electrical and mechanics is breached, needs further investigation into roof void for fire stopping.

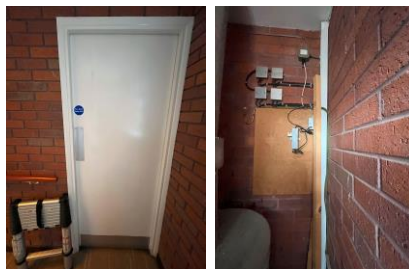
- 12) Within the refuse Shute cupboard on the 1<sup>st</sup> floor, there is some electrical switches installed at the back of the Shute, the cupboard is secured behind a timber FD30s fire door.

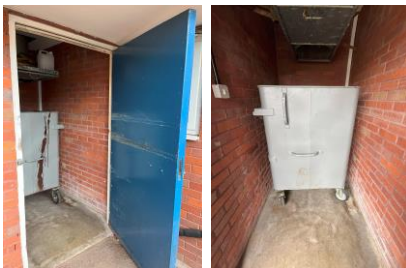
- 2) Refuse bins are stored in the waste refuse cupboard. Bins Are regularly emptied by site services.

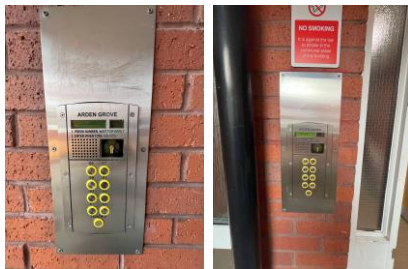
- 1) Regular checks are undertaken by Caretakers / Cleaning Team(s) 365 days per year which helps reduce the risk of arson.
- 2) Restricted access to the premises is via a key lock, each resident has their own key to gain access. There is an intercom system that can allow visitors and contractors in.

Front and rear entrance

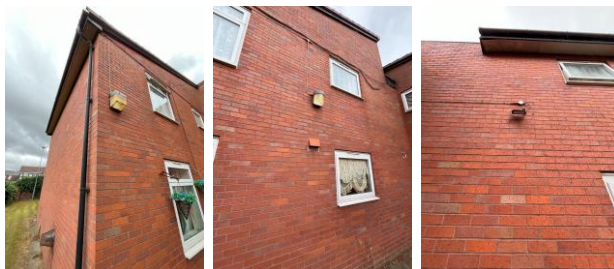
- 3) There is no current evidence of arson.
- 4) The perimeter of the premises is well illuminated.

External lighting located at various points around the building
