Fire Risk Assessment

**12 – 20 Langley High Street,
Oldbury.
B69 4SL.**

Date Completed: 10th September 2025

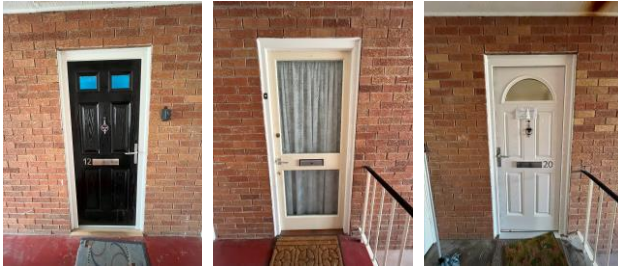
- 1) All flats are equipped with minimum LD3 detection to aid means of escape.
- 2) No emergency lighting is installed within the building.
- 3) Access to the flats is controlled via the use a key entry for the front and rear doors to the building. There is floor mats placed outside each resident flat, the fire rating for these mats is not known.

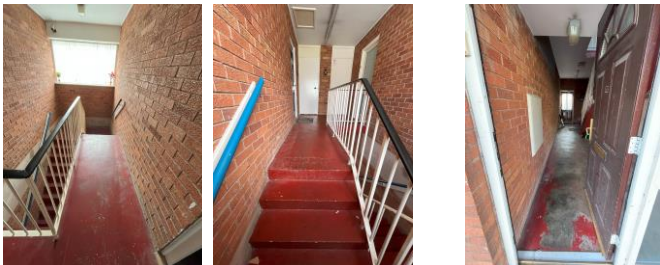
Flats 12 & 14

- 4) All corridors of flats 12,14 & 20 are of adequate width and are usually kept clear to promote maintain safe exit in an event of fire. On this occasion there was items stored on the first floor landing of flat 20, on the ground floor corridor of flat 12,14 there are items placed at the foot of the stairs and on the ground floor of flat 20, there are considerable amounts of combustibles stored which are close to the exit of the stairs and rear fire exit.

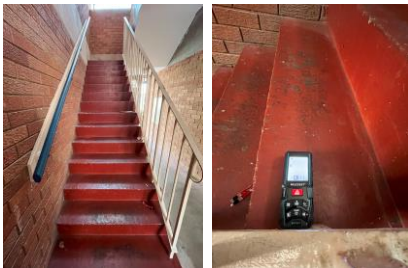
Flats 12 – 14

- 12) There is a single staircase for flats 12,14,20, that provides means of escape, this is located as you enter the building, this has been measured at 811mm for flat 12 -14 and 921mm in width flat 20, from handrail to balustrades. The stairways are kept clear to maintain safe means of escape.

Ground 1st floor staircase

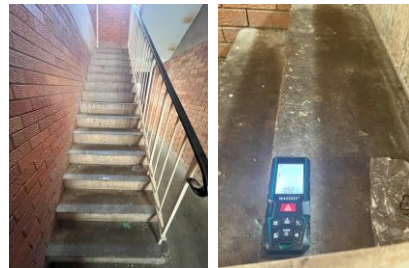
Flat 20

Ground 1st floor staircase

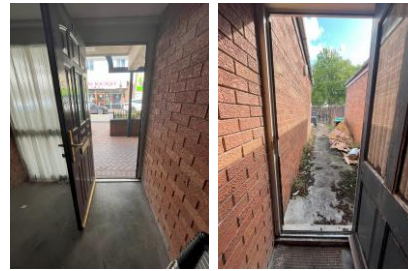
Flat 20

- 17) There is a clear and safe exit out of the building via the two-ground floor exits. On this occasion the rear exit pathway serving flat 20 was not clear of obstructions.

Front final & Rear final exit

- 18) Rear exit pathway serving flat 20 is not clear of obstruction and ground is covered in moss.**

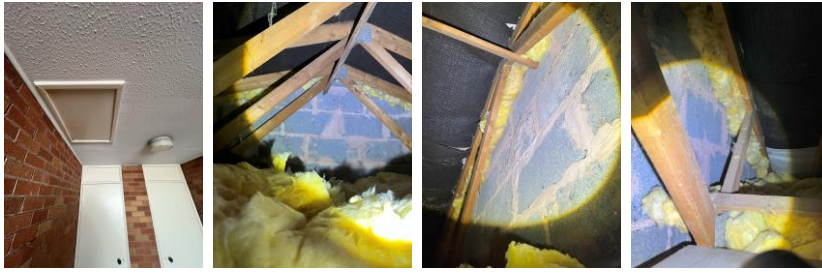
Roof void serving flats 12 -14.

- 7) Both roof voids were inspected through the roof hatches located on the first floor for both blocks. All fire stopping in place with block work in place up to the roofline.

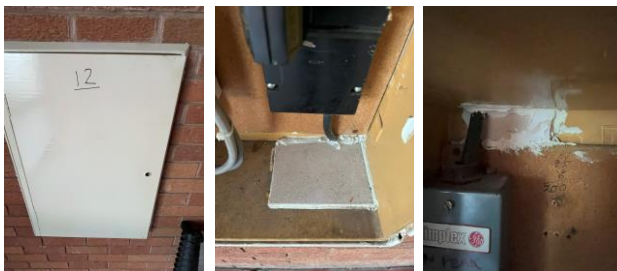
- 8) Previous fire stopping installed within flat 12 residents electrical cupboard.

- 12 Recommended that all residents and landlord electrical cupboards are to be upgraded to fire rated units on any future renovation to the blocks.

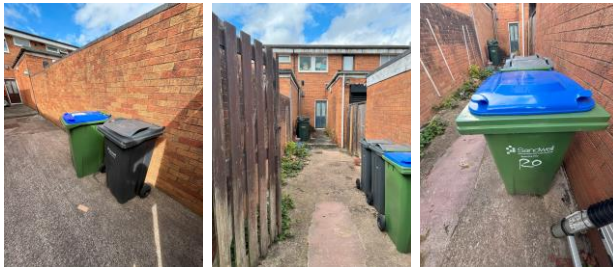
- 1) There is no evidence of any regular cleaning service attending to the premises.
- 2) Refuse bins are stored to the rear of the building. Bins are regularly emptied by site services.

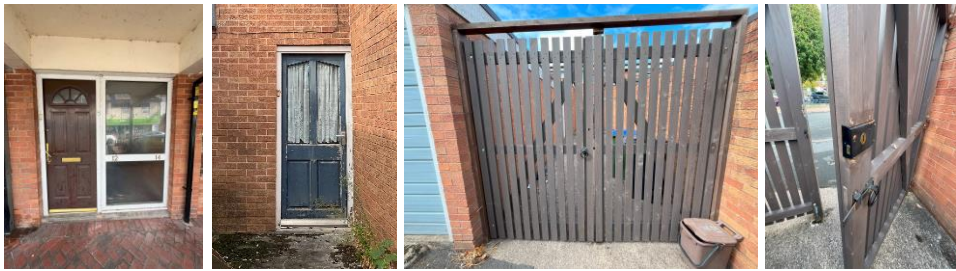
12 -14

- 1) Regular checks are undertaken by Caretakers / Cleaning Team(s) 365 days per year which helps reduce the risk of arson.
- 2) Restricted access to the premises by means of timber doors that are secured with key lock. The rear entrances have timber gates installed for security. There is a mortice lock installed on gate for flat 12 -14, at the time of the FRA being conducted the gates were easily accessible, it is not known as if these gate for flat 12-14 is locked on the night.

Front and rear entrance

Rear entrance gate
