# Fire Risk Assessment

**30 – 52**

**Groveland Road,  
Tipton,  
DY4 7TN**

**Date Completed: 01/10/2025**

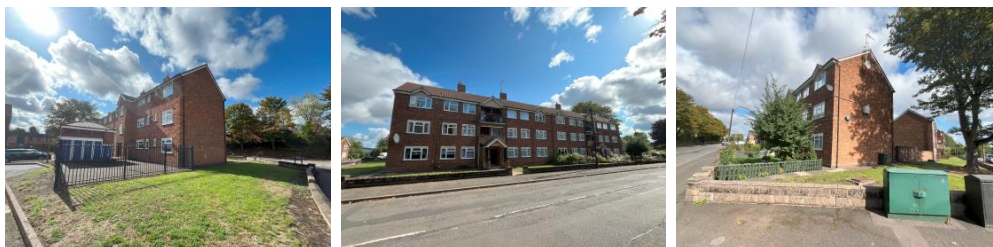
These low-rise, three-storey blocks were constructed in 1963 using traditional brick cavity and concrete construction. The roofs are pitched and finished with Marley concrete interlocking tiles.

The building comprises two semi-detached blocks: Block 30-40 and Block 42-52, each three storeys high. Each block is served by a dedicated central staircase that leads to the timber final exit doors, which are fitted with levered handles to facilitate easy evacuation. This arrangement provides adequate escape routes for occupants.

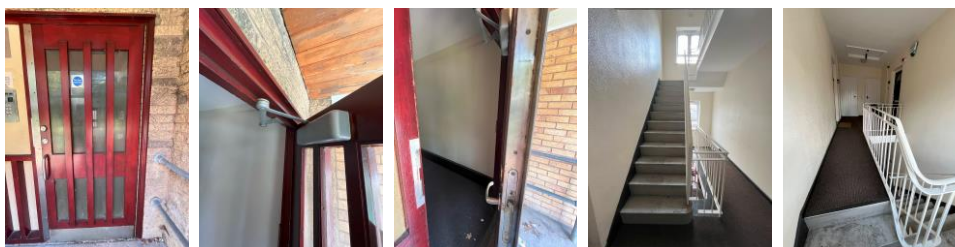
At the front of the premises, the entrance areas feature an open porch with a pitched roof also covered with Marley roof tiles. The front fascia and soffits are made of uPVC, and the underside of the porch is lined with timber boarding with two inset safety/security lights installed.

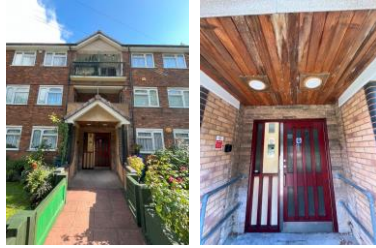
The main entrance to each block is situated on the front elevation off Groveland Road, with a secondary exit located at the rear via Monk Close. The front entrances are fitted with an intercom door entry system, residents' key locks, and a firefighter override switch. The rear entrances are accessed via a key-operated lock.

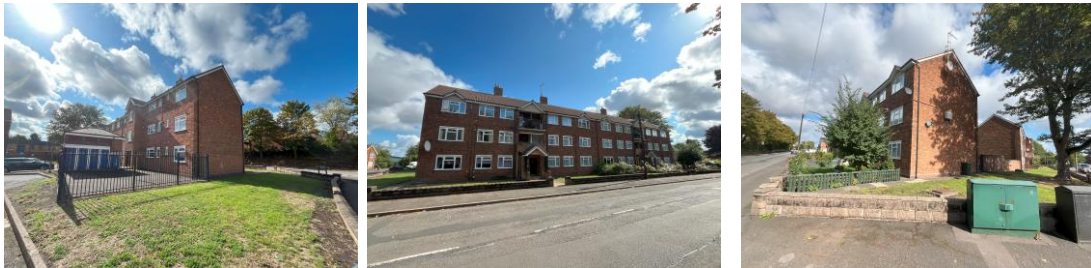
- 1) The external surface of the building is predominantly brick structure with uPVC soffits and fascia. The roof is pitched and fitted with Marley concrete interlocking roof tiles are fitted on the roof.

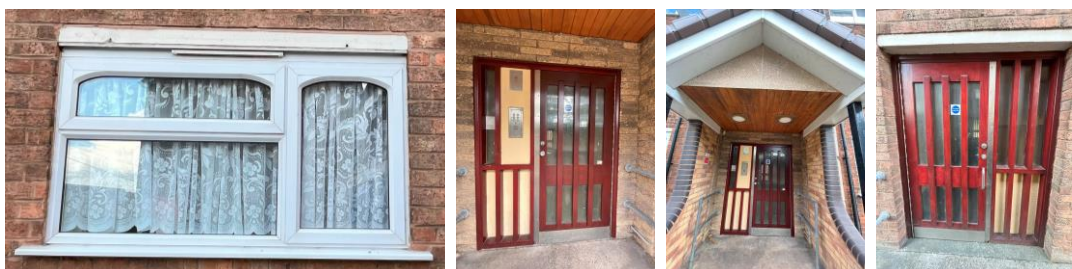
- 2) uPVC double glazed units have been installed to each flat and communal stairway. There is a canopied entrance to the block. The canopy roof is a pitched roof with Marley interlocking roof tiles. There is uPVC fascia and soffits installed around the porch front, and timber on the underside with 2 safety/security lights. Entrance & rear door are mainly timber and glass units, with small section of spandrel panelling.

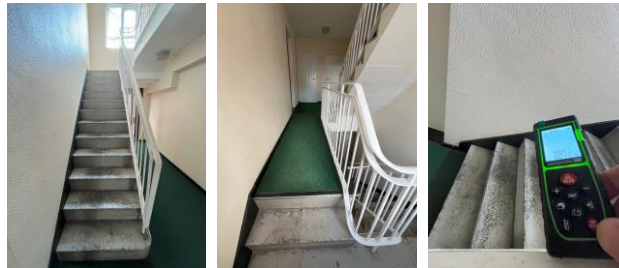
- 8) Within both blocks each floor is accessed via a single staircase that provides a means of escape and has a width of a minimum of 800mm between the handrails.

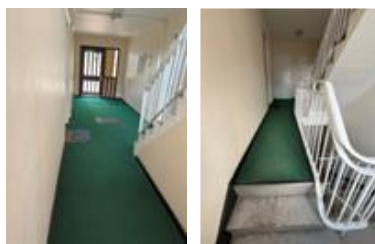
- 10) All communal hallway floors are carpeted. All floors have S.M.B.C fitted carpet. Due to the fact S.M.B.C specified and managed the installation of the carpets it has been presumed that they are BS 5287,1988 specification for assessment and labelling of textile floor coverings and BS 4790 Fire Test Method to textile Floor Coverings.

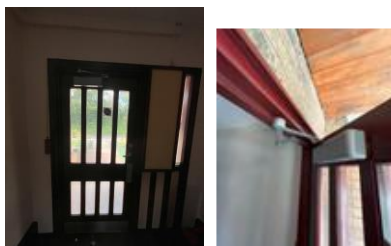
- 14) The final exit doors are fitted with automatic closing devices. To exit the doors, you do so by using a regular push handle. These are checked on a regular basis by caretaking teams as part of their checks. Defective closing devices are replaced either by the Caretaking Team(s) or the in-house repairs team(s). These systems are designed to fail safe i.e. door unlocked in the event of a power failure. This prevents residents being locked in or out of the building.

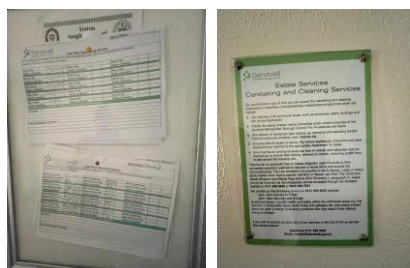
- 15) Communal areas are kept free of flammable items. The communal areas are checked on a regular basis by Caretaking / Cleaning teams 365 days per year and all items of rubbish are immediately removed. There is also an out of hour's service that allows combustible items of furniture / rubbish to be removed.

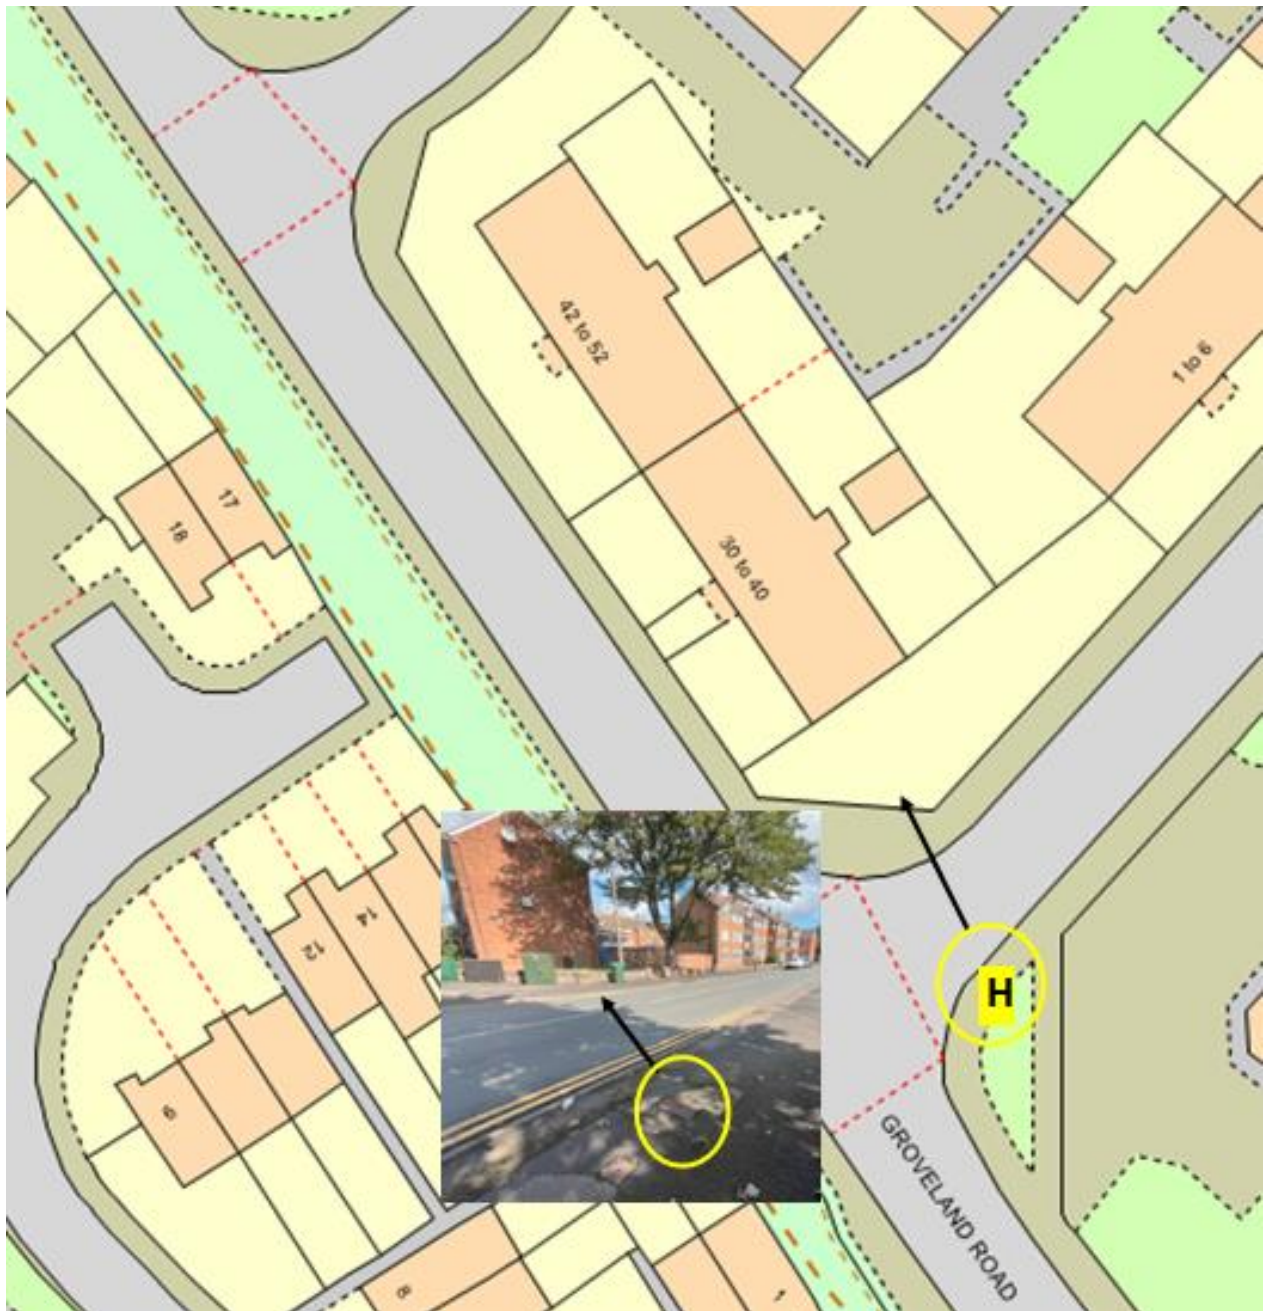
- 1) There is no firefighting equipment on this premises.
- 2) Nearest fire hydrant is indicated within the attached plan

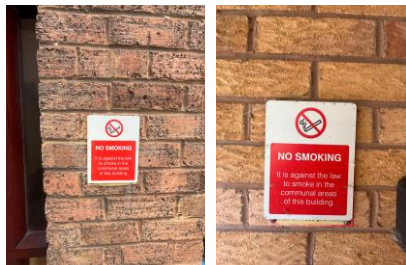
- c) Smoking is prohibited within any communal parts of the building in line with Smoke Free England legislation.

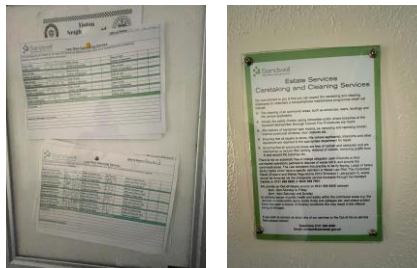
- 3) Regular checks are carried out by Caretakers to minimise risk of waste accumulation.

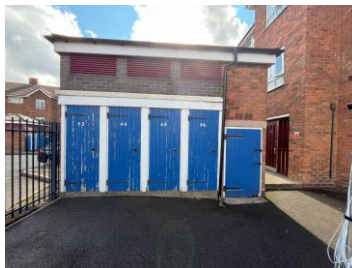
- 1) Residents instructed not to bring L.P.G cylinders into block.
- 2) The tenancy conditions, Section 7 – Condition 5.6 stipulates “If you live in a flat or maisonette, you, people living with you and any visitors to your property must not keep or use paraffin oil, petrol, bottled gas appliances or any other explosive, FLAMMABLE or dangerous material in the property. This restriction also applies to any storage facility situated in or attached to the block, which has been provided for your use.”
- 3) Residents should not store flammable liquids or gas cylinders on site.
- 4) No Flammable liquids stored on site by Caretakers / Cleaners.
- 5) Residents have individual storage cupboard internally and externally which they keep secured by means of own keys.
