# Fire Risk Assessment

**13-18**

**Willow Close,  
Cradley Heath,  
B64 6EG**

**Date Completed: 10/10/2025**

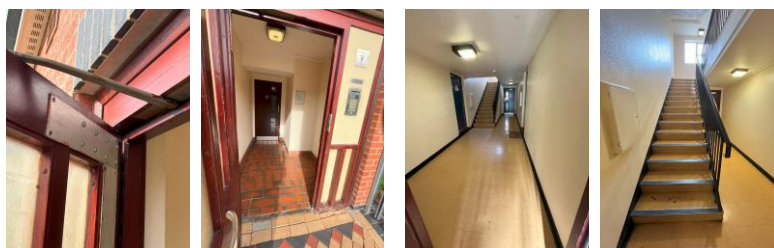
The building has a dedicated central staircase leading to the final exit doors. Prior to reaching these final exits, there are FD30s fire doors positioned to create small lobby area between the fire door and the fire exit at both the front and rear of the property. The final exit doors are fitted with self-closers and have levered handles for easy evacuation, ensuring adequate escape routes.

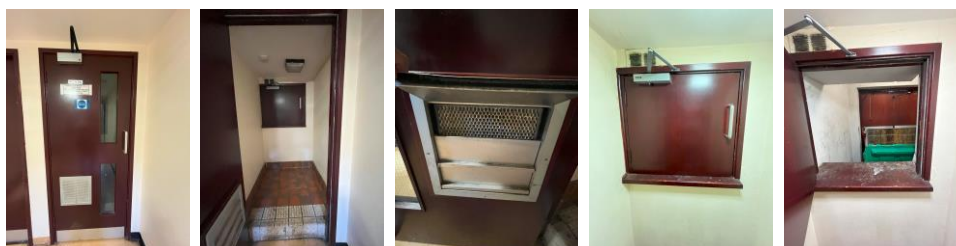
Residents' refuse is disposed of through an FD30s fire door on the ground floor, which is also fitted with an intumescent vent. Behind this fire door is a small, self-closing FD30s fire door that provides access to the bin chute.

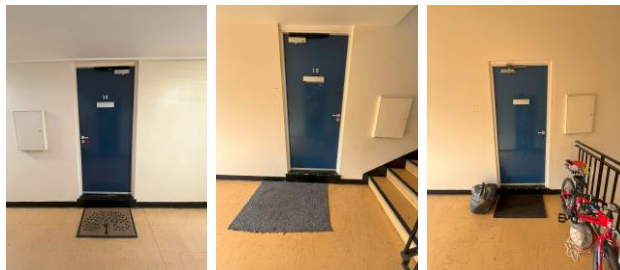
- 6) At a number of flat entrances door mats are present; the fire rating is not known on these door mats and are deemed to be low risk.

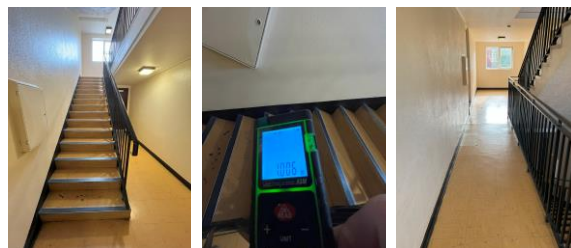
- 7) Within the block each floor is accessed via a single staircase that provides a means of escape and has a width of a minimum of 1000mm between the handrails.

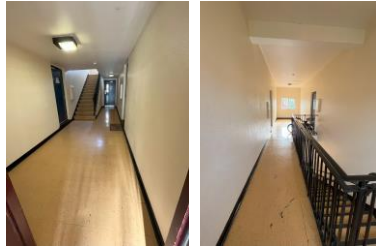
8) Corridors and landings are at least 1050mm in width and are kept clear.

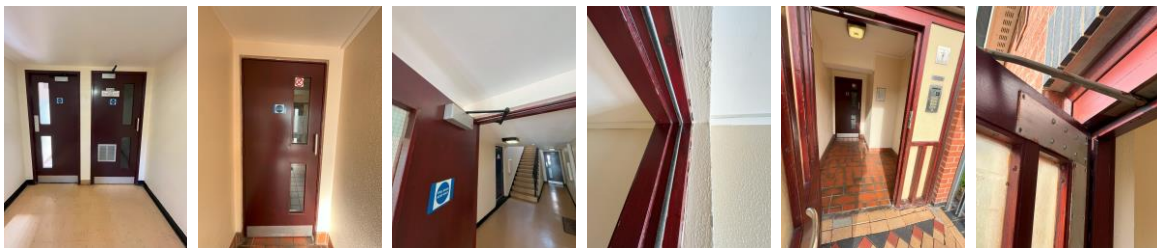
10) The means of escape are protected to prevent the spread of fire and smoke. There is an FD30s fire door prior the final exit door of the block at the front and rear of the block. These doors are fitted with automatic closing devices. To exit the doors, you do so by using a regular push handle. These are checked on a regular basis by caretaking teams as part of their checks. Defective closing devices are replaced either by the Caretaking Team(s) or the in-house repairs team(s). These systems are designed to fail safe i.e. door unlocked in the event of a power failure. This prevents residents being locked in or out of the building.

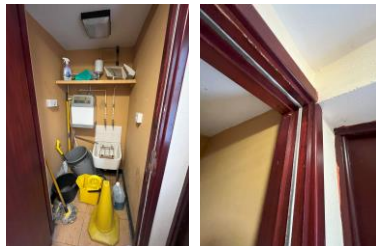
- 8) Flats are fitted with a minimum of timber notional FD30 doors. A number of flat doors were assessed at the time of the visit. See section 7/5
- 9) On the ground floor next to the rear final exit door is situated a storeroom that is used by the cleaner. This room is fitted with an FD30s door that is locked with a 054 lock.

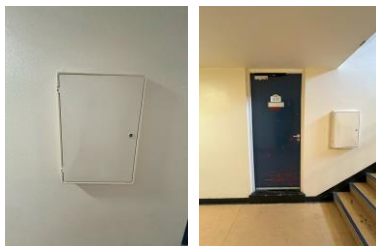
- 11) Outside each flat is situated a fire rated electric meter overbox. These are locked with a budget key.

**a) Electric meter overbox outside flat 15 requires replacing or fire stopping due to damage to the case**

| 10/11a | Electric meter overbox outside flat 15 requires replacing or fire stopping due to damage to the case | | P3 | Within 3-6 months<br>Electrical | |

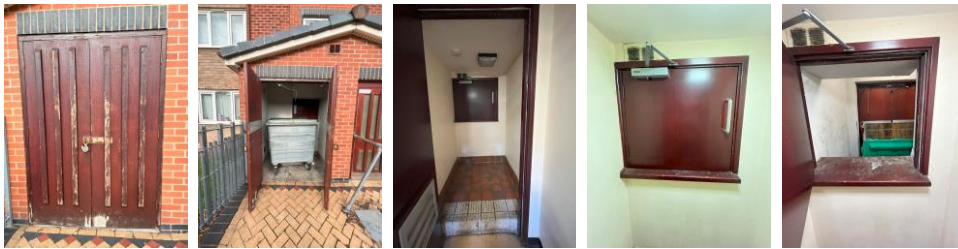
- 1) There is a regular Cleaning Service to the premises.
- 2) The refuse bin is located at the front of the block within a room next to the blocks front entrance. Rubbish is disposed of via a bin chute from within the block, the bin is kept in its own room.
