# Fire Risk Assessment

**2 -24**

**Monk Close,**

**Date Completed: 06/10/2025**

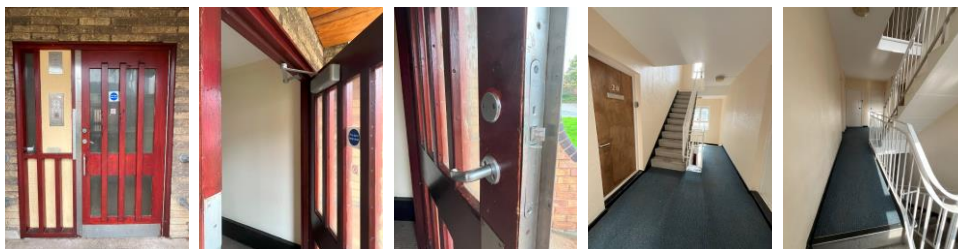
The building comprises two semi-detached blocks: Block 2-12 and Block 14-24, each three storeys high. Each block is served by a dedicated central staircase that leads to the timber final exit doors, which are fitted with levered handles to facilitate easy evacuation. This arrangement provides adequate escape routes for occupants.

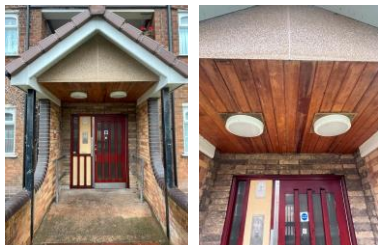
At the front of the premises, the entrance areas feature an open porch with a pitched roof also covered with Marley roof tiles. The front fascia and soffits are made of uPVC, and the underside of the porch is lined with timber boarding with two inset safety/security lights installed.

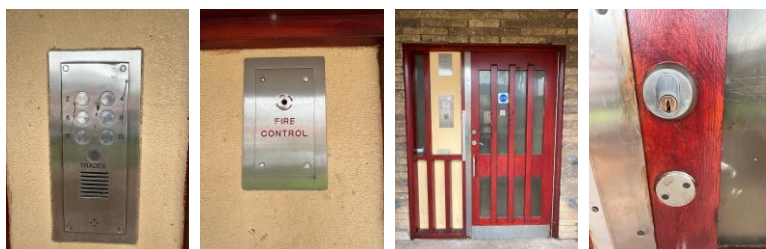
The main entrance to each block is situated on the front elevation off Monk Close, with a secondary exit located at the rear via Cleton Street. The front entrances are fitted with an intercom door entry system, residents' key locks, and a firefighter override switch. The rear entrances are accessed via a key-operated lock.

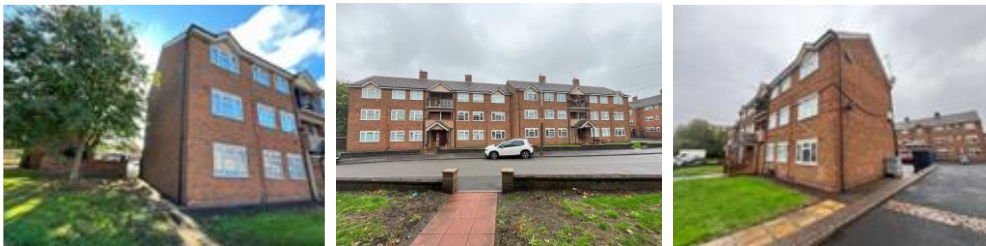
- 1) The external surface of the building is predominantly brick structure with uPVC soffits and fascia. The roof is pitched and fitted with Marley concrete interlocking roof tiles are fitted on the roof.

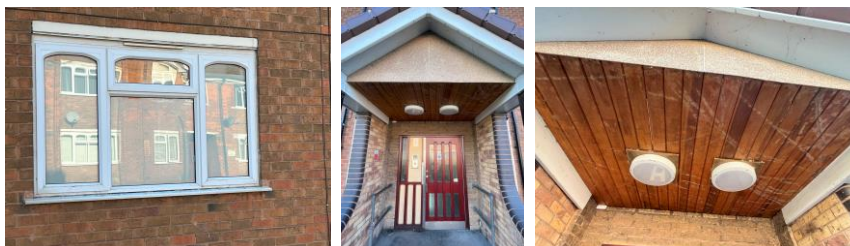
- 2) uPVC double glazed units have been installed to each flat and communal stairway. There is a canopied entrance to the block. The canopy roof is a pitched roof with Marley interlocking roof tiles. There is uPVC fascia and soffits installed around the porch front, and timber on the underside with 2 safety/security lights. Entrance & rear door are mainly timber and glass units, with small section of spandrel panelling.

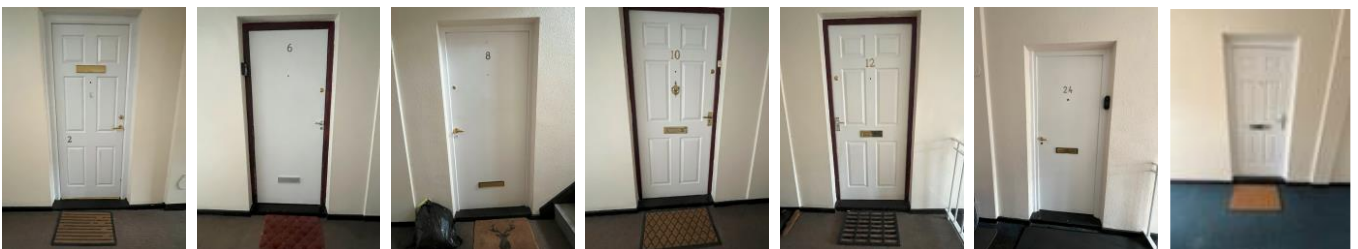
- 5) At a number of flat entrances door mats are present; the fire rating is not known on these door mats and are deemed to be low risk.**

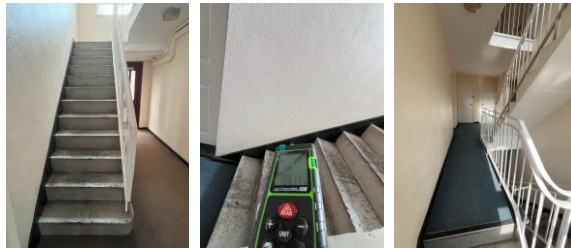
- 7) Within both blocks each floor is accessed via a single staircase that provides a means of escape and has a width of a minimum of 800mm between the handrails.

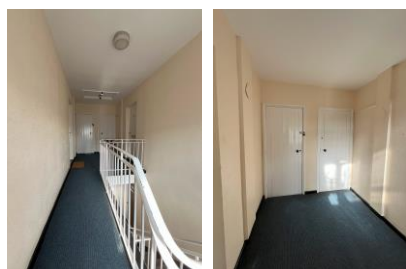
- 9) All communal hallway floors are carpeted. All floors have S.M.B.C fitted carpet. Due to the fact S.M.B.C specified and managed the installation of the carpets it has been presumed that they are BS 5287, 1988 specification for assessment and labelling of textile floor coverings and BS 4790 Fire Test Method to textile Floor Coverings.

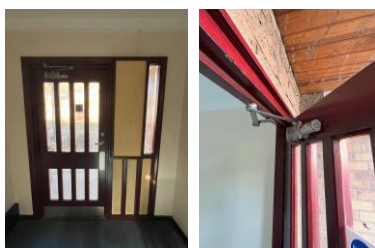
- 13) The final exit doors are fitted with automatic closing devices. To exit the doors, you do so by using a regular push handle. These are checked on a regular basis by caretaking teams as part of their checks. Defective closing devices are replaced either by the Caretaking Team(s) or the in-house repairs team(s). These systems are designed to fail safe i.e. door unlocked in the event of a power failure. This prevents residents being locked in or out of the building.

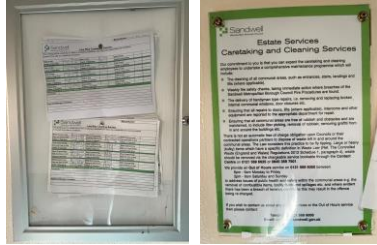
- 14) Communal areas are kept free of flammable items. The communal areas are checked on a regular basis by Caretaking / Cleaning teams 365 days per year and all items of rubbish are immediately removed. There is also an out of hour's service that allows combustible items of furniture / rubbish to be removed.

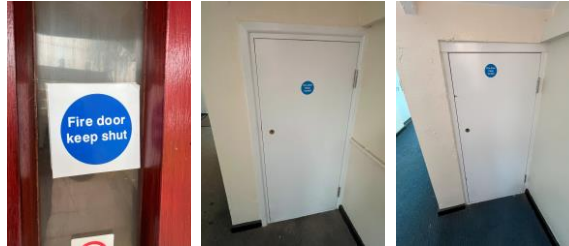
- 1) Fire door keep shut signs are displayed on the entrance and exit doors. The service cupboards should display "Fire Door Keep locked"

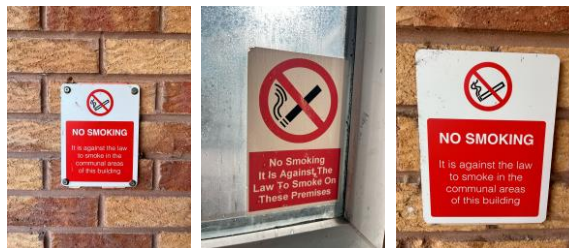
- 2) Smoking is prohibited within any communal parts of the building in line with Smoke Free England legislation.

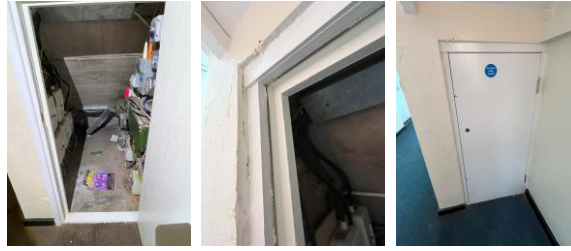
- 7) The blocks service cupboards are located on the ground floor and consist of an FD30s fire rated door. All cupboards should be free from any combustibles.

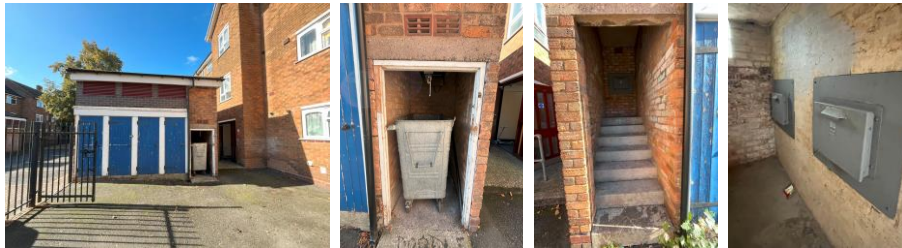
- 1) There is a regular Cleaning Service to the premises.
- 2) The refuse bin is located to the rear of the main building, within a purpose-built brick structure. Rubbish is disposed of via a bin chute, the bin is kept in its own room.

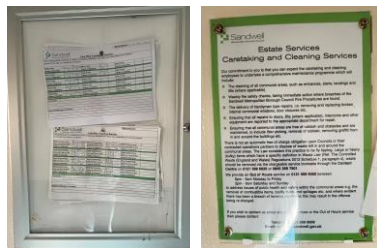
- 3) Regular checks are carried out by Caretakers to minimise risk of waste accumulation.

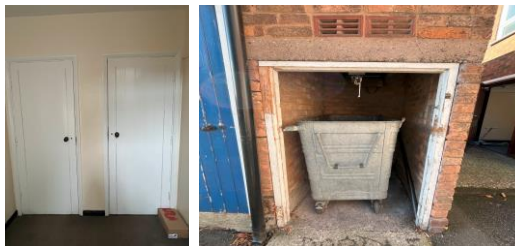
- 1) Residents instructed not to bring L.P.G cylinders into block.
- 2) The tenancy conditions, Section 7 – Condition 5.6 stipulates “If you live in a flat or maisonette, you, people living with you and any visitors to your property must not keep or use paraffin oil, petrol, bottled gas appliances or any other explosive, FLAMMABLE or dangerous material in the property. This restriction also applies to any storage facility situated in or attached to the block, which has been provided for your use.”
- 3) Residents should not store flammable liquids or gas cylinders on site.
- 4) No Flammable liquids stored on site by Caretakers / Cleaners.
- 5) Residents have individual storage cupboard internally and externally which they keep secured by means of own keys.
