# **Fire Risk Assessment**

## **Church Court**

**Church Street,  
Cradley Heath, B64 6DS**

**Date Completed: 1st October 2025**

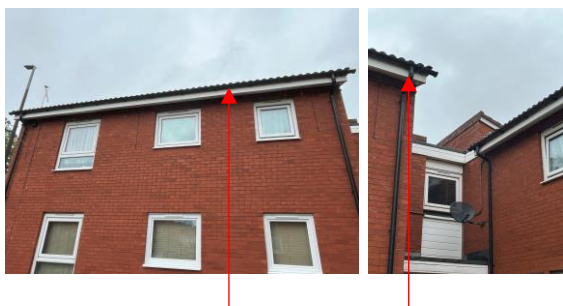
UPVC Fascias boards with concrete roof tiles.

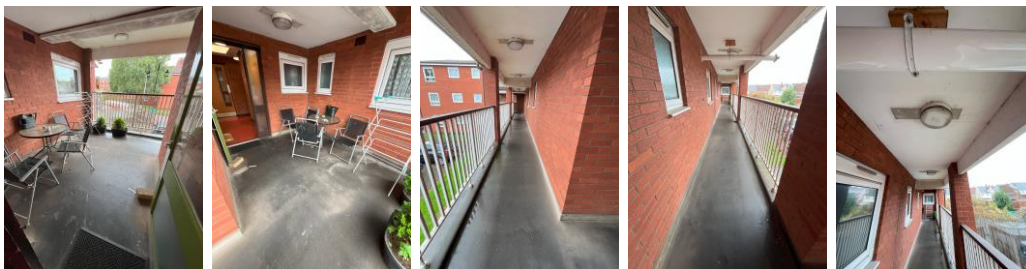
- 5) The open deck access connecting both blocks on the first floor is unobstructed, with no flat entrance doors opening outward onto the pathway. The area is adequately lit. While residents have placed a table and chairs on the landing section of the deck, this does not impede safe evacuation, as it is not within the designated exit route.

Deck access and landing

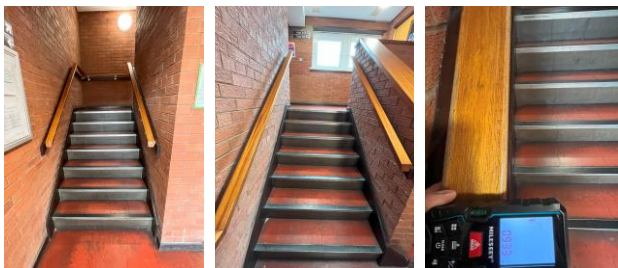
- 7) The premises consists of a single staircase that provides sufficient means of escape, this is located as you enter both blocks. The width of the staircases has been measured from handrail to handrail at a measurement of 933mm and 926mm. These stairs are kept clear to maintain safe means of escape.

Ground to 1<sup>st</sup> & 2<sup>nd</sup> floor staircase.

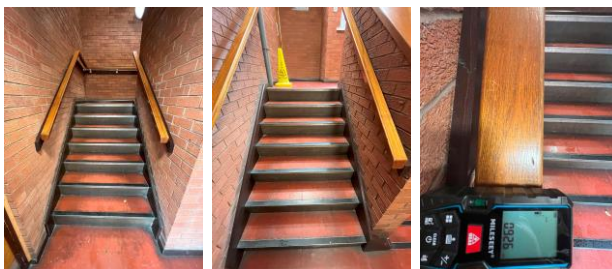
Ground to 1<sup>st</sup> floor staircase.

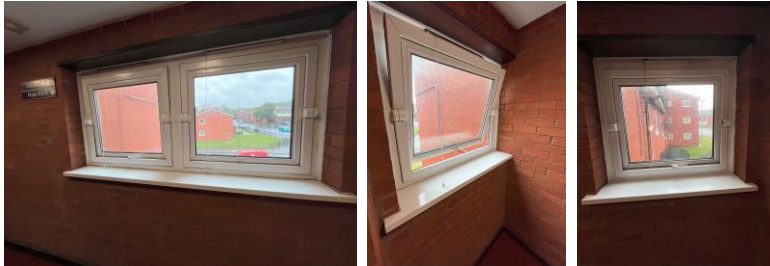
- 8) On both blocks, 1<sup>st</sup> and 2<sup>n</sup> floor communal landings and flat corridors, UPVC windows units, these windows can be opened without the use of a key, these also allow sufficient airflow into the corridor and stairwell. There is no automatic smoke ventilation system installed in this premises.

Double units are installed on the staircase landing, single units within flat corridors.

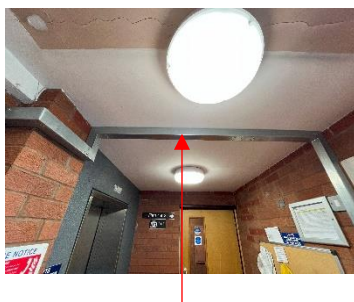
- 11) Flats 1-4,9-12,18-21 has a lift located on the ground floor communal area. This is serviced by LES (Lift Engineering Services).
- 12) Metal trunking for electrical cabling is installed within the ground floor lobby area for flats 1-4,9-12,18-21

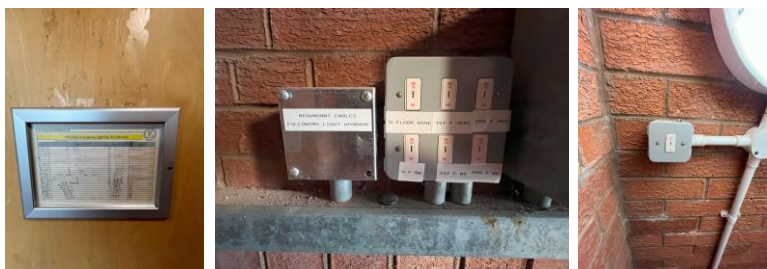
- 3) Emergency lights are also checked and tested monthly by Sandwell MBC in house electrical team

Monthly Sandwell test record and testing switches

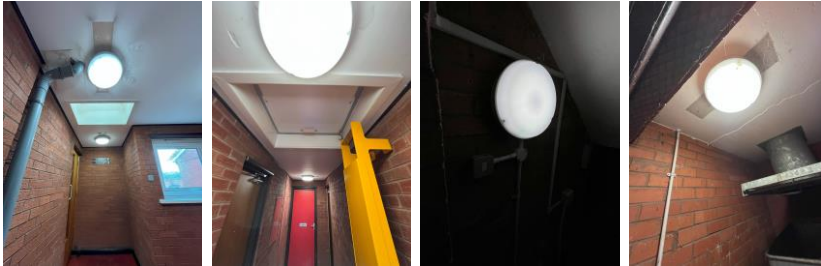
- 4) Emergency lighting is installed throughout the building, units are installed in communal areas e.g. stairways, corridors, lobbies, they are also installed within the electrical cupboard, refuse cupboards and stores.

Communal area, service and refuse cupboard emergency lighting

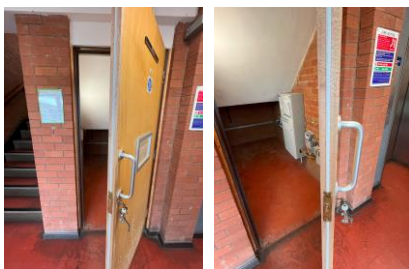
- 3) Electrical Service cupboard on ground floor is located behind an FD30s timber fire door, this secured by 054 mortice lock key; this is only held by authorised staff.

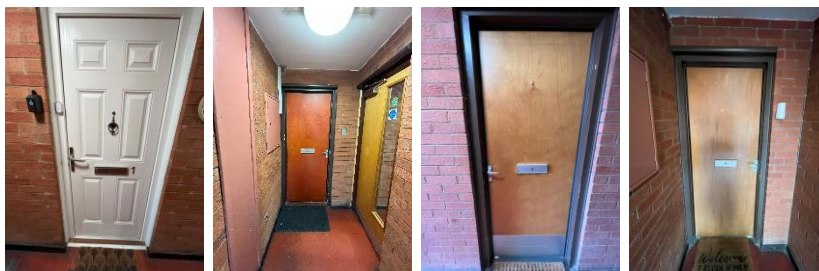
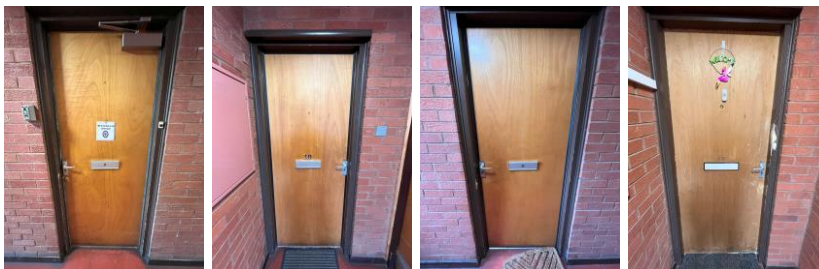
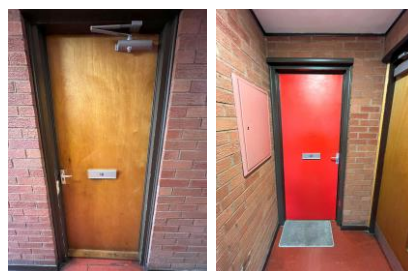
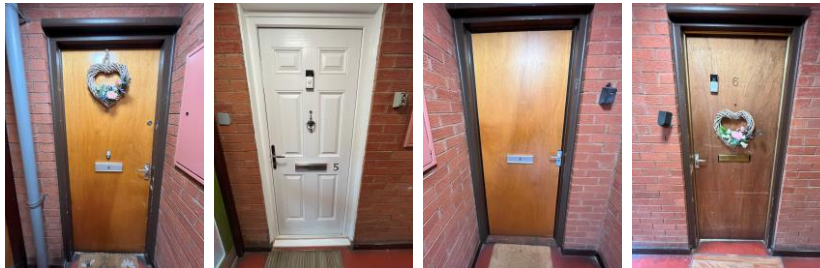
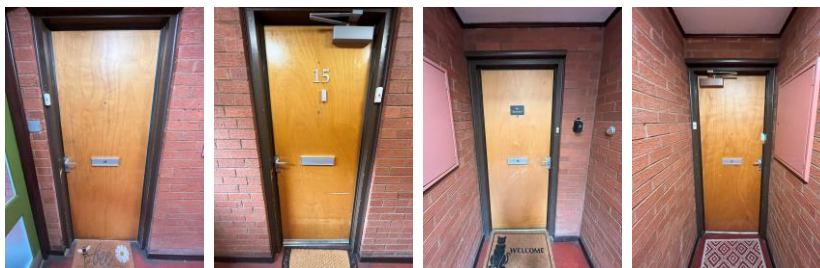
- 4) A variety of methods and materials have been used to achieve fire-stopping including Rockwool and intumescent pillows where needed.
- 5) All individual flats are installed with notional FD30/FD30s rated timber doors. It has been recommended that on the next refurbishment to the building that the FD30 timber doors be upgraded to FD30s fire rated doors.

It is recommended that for future renovations of the block that the notional FD30 timber fire doors be replaced with FD30s certified fire rated doors.

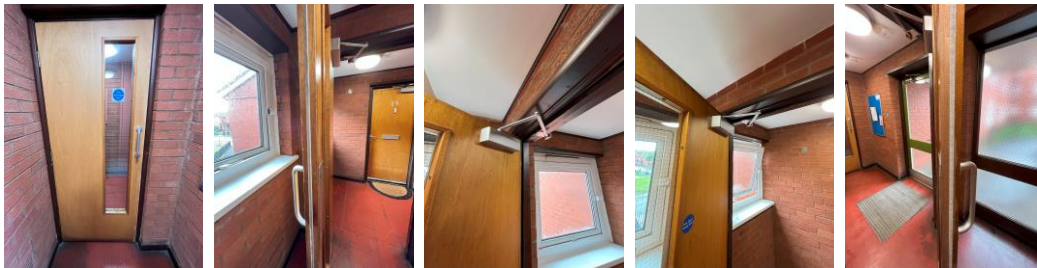
7) The building has sufficient compartmentation between the communal areas, staircases, landing corridors by the means of FD30s fire doors with door closures, all communal doors were checked to see if self-closing device worked as should, no issues were found.

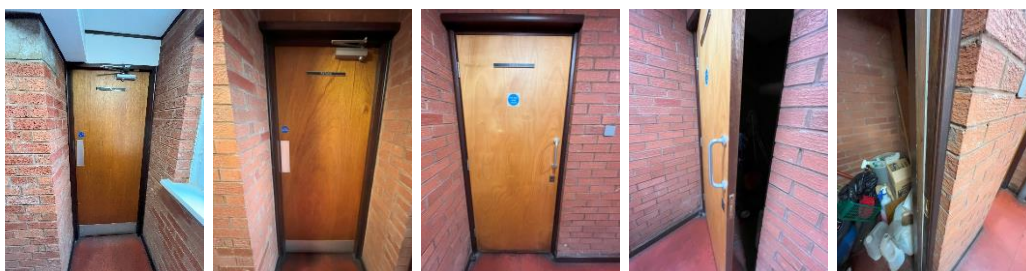
8) All refuse waste cupboards on each communal landing are secured by a means of an timber FD30s fire doors. Cleaners storage cupboard on the ground floor is installed with timber FD30s fire door. This door is locked by a 54 morice key and only held by authorised staff.

Refuse and cleaners storage cupboard

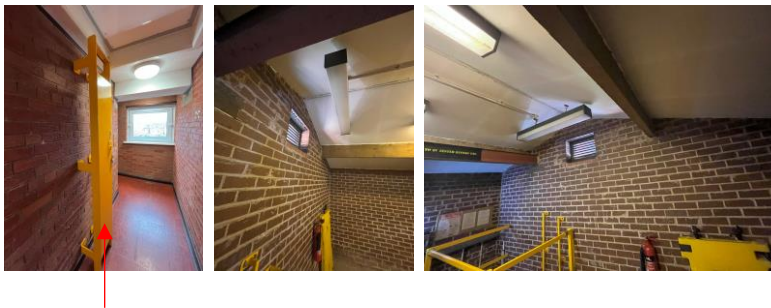
- 10) Lift motor room on the 2<sup>nd</sup> floor of flats 1-4,9-12,18-21 was inspected for compartmentation. No issues in compartmentation was found.

Access to lift room and lift motor room

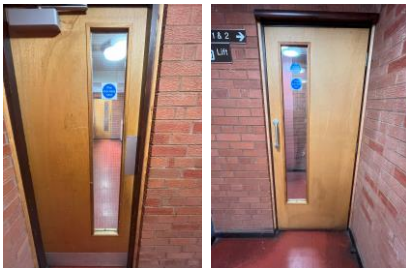
Communal fire doors have signage of keeping door closed

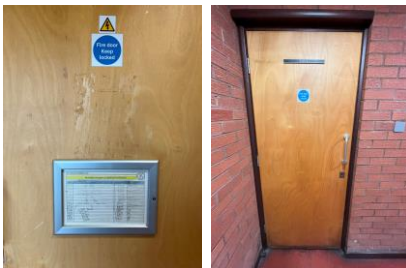
Electrical cupboard and storeroom have signage of keeping door locked.

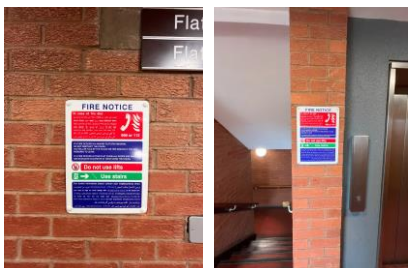
- 2) Fire Action Notices are displayed throughout the building notifying residents of basic fire safety.

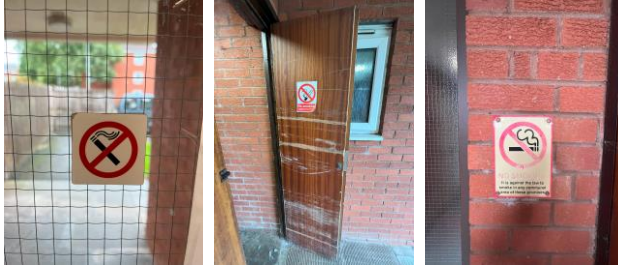
- 4) Smoking is prohibited within any communal parts of the building in line with Smoke Free England legislation. Signage is also displayed in the external refuse cupboard located next to the entrance doors.

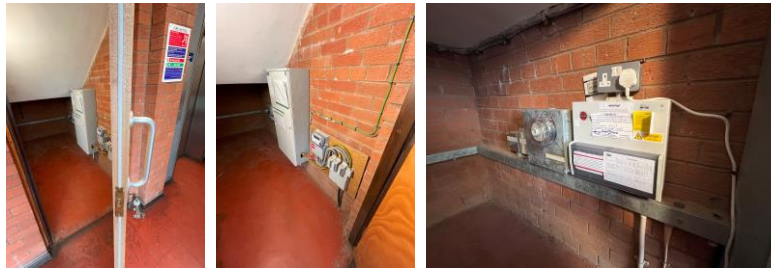
- 7) Electrical service cupboard on the ground floor is secured behind a FD30s fire rated door. Cupboard is free from any combustibles.

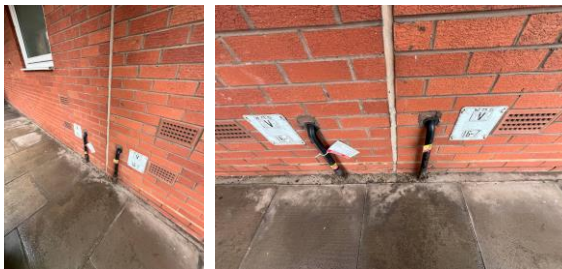
- 8) Gas appliances and pipework (where installed) are subject to annual testing and certification. This contract is managed by the in-house Gas team. Gas supply to these premises is external.

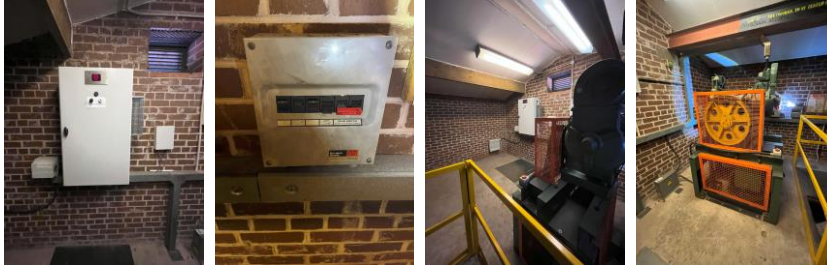
- 10) Lift motor room on the 2<sup>nd</sup> floor for flats 1-4,9-12,18-21 has electrical supply for the lift contained within secured metal units, there are no combustibles stored within the lift motor room.

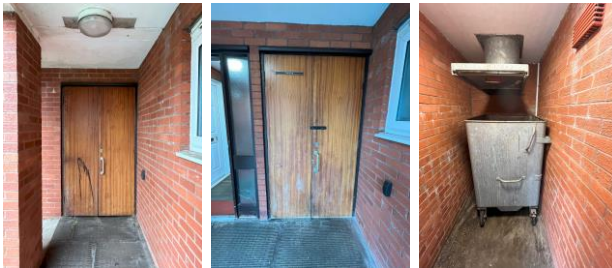
- 2) Refuse bins are stored in 2 refuse cupboards that are located next to the front entrances of the building. Bins Are regularly emptied by site services.

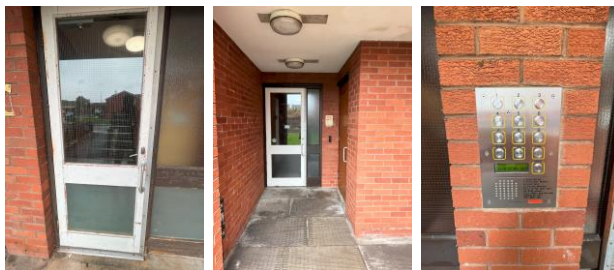
- 1) Regular checks are undertaken by Caretakers / Cleaning Team(s) 365 days per year which helps reduce the risk of arson.
- 2) Restricted access to the premises is via a key lock, each resident has their own key to gain access. There is an intercom system that can allow visitors and contractors in.

Entrance doors and intercom access system.

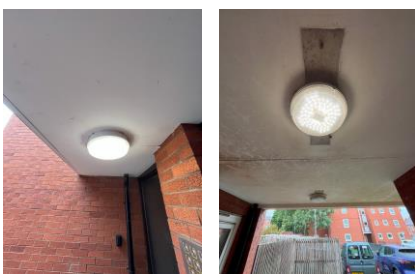
- 3) There is no current evidence of arson.
- 4) The perimeter of the premises is well illuminated.

Front External lighting
