# Fire Risk Assessment

**1 – 6 Willow Close  
Cradley Heath,  
B64 6LJ**

**Date Completed: 6<sup>th</sup> October 2025**

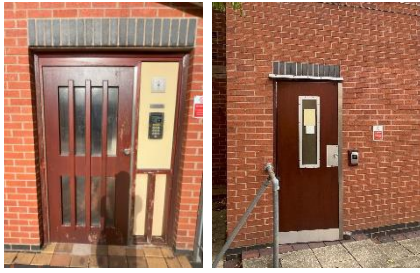
Front and rear entrances to block

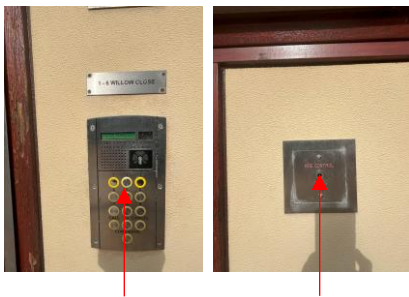
Main entrance to the building is through a porch, with both the front and rear doors accessed via fob reader, trades and visitors use an intercom system. For emergency access there is a firefighter manual override switch located above the door intercom panel. On the day of assessment, the firefighters switch did not allow access into the building. Noted in Section 7, means of escape.

Intercom access and firefighter's switch

- 11) Firefighters override switch will not access the building. An email has been sent to CCTV team on the 08/10/2025 and again on the 13/10/2025. This has now been logged with a contractor.

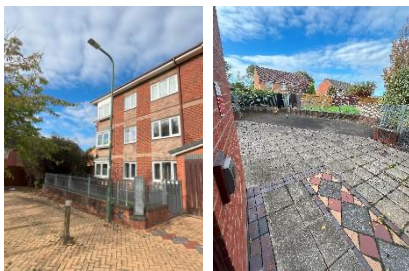
Metal railing fencing perimeter and courtyard at the rear.

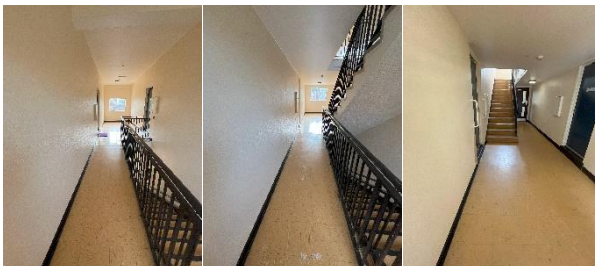
- 3) All corridors, landing and staircase are of adequate width and are kept clear to promote & maintain safe exit in an event of fire.

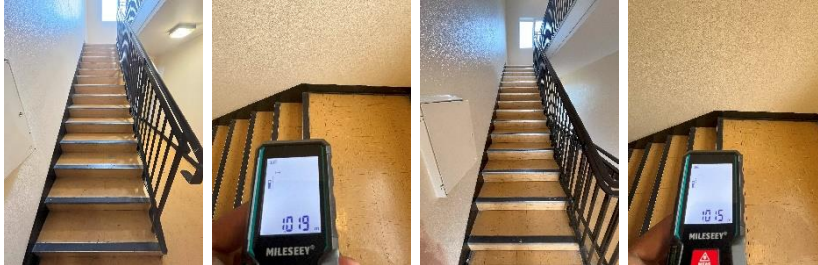
- 5) 1- 6 Willow Close consists of a single staircase that provides sufficient means of escape, this is located as you enter each block. The width of the staircases has been measured from handrail to handrail at a measurement of 1019mm and 1015mm. These stairs are kept clear to maintain safe means of escape.

Ground to 1<sup>st</sup> & 2<sup>nd</sup> floor staircase.

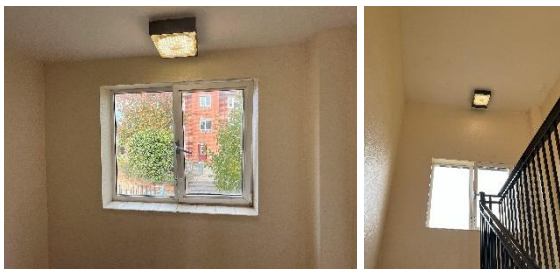
- 6) UPVC windows units have been installed on the staircase landing and within the corridors to the flats, these windows can be opened without the use of a key to allow sufficient airflow into the corridor and stairwell. There is no automatic smoke ventilation system installed in this premises.

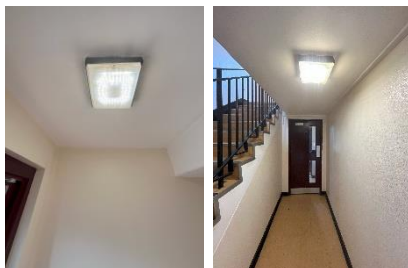
- 7) Emergency lighting is installed throughout the building, these are installed near final exit doors, communal staircase, landing and the corridors for flat entrances.

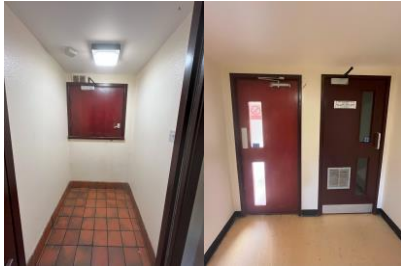
- 8) On the ground floor communal hallway there is access to a bin refuse room which is located behind a FD3s fire door.

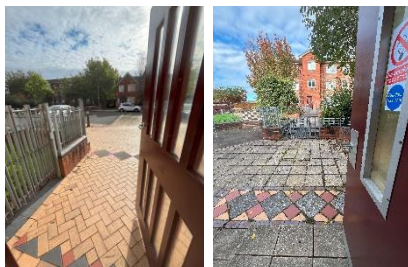
- 10) There is a clear and safe exit out of the building via the two-ground floor exits. The final exit doors are opened by a levered handled.

Front final & Rear final exits.

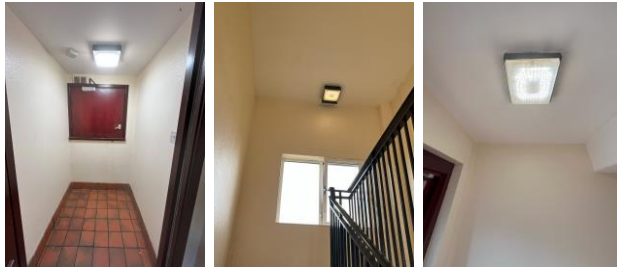
Communal area, service and refuse cupboard emergency lighting

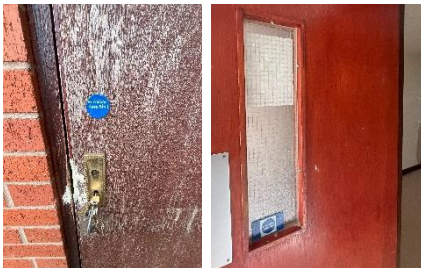
- 1) Fire door keep shut signs are displayed where appropriate, on external electrical cupboard and communal fire doors display Fire Door Keep Shut/Locked” sign.

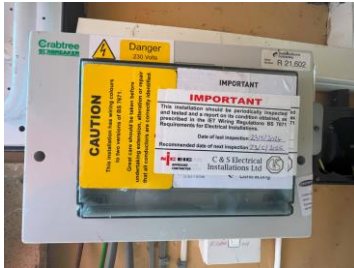
- 7) Electrical service cupboard on the ground floor which is located externally on the rear of the building is secured behind a FD30s fire rated door. Cupboard is free from any combustibles.

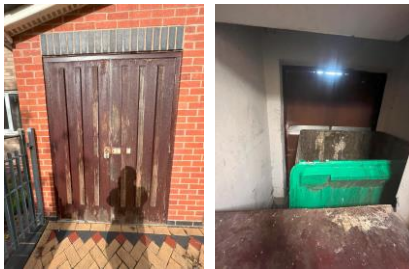
- 1) There is a regular Cleaning Service to the premises.
- 2) Refuse bin is stored in a secured bin room that is located next to the front entrance of the building. This can be accessed from both internal and externally and is kept secure. Bins Are regularly emptied by site services.

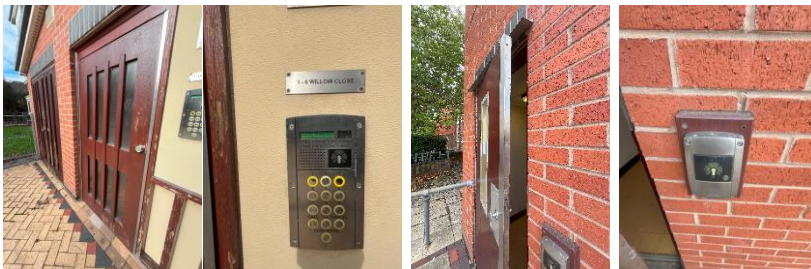
Front and rear entrance doors with access system.
