# Fire Risk Assessment

## Trinity Court

Church Street,  
Cradley Heath, B64 6DS

**Date Completed:** 3<sup>rd</sup> October 2025

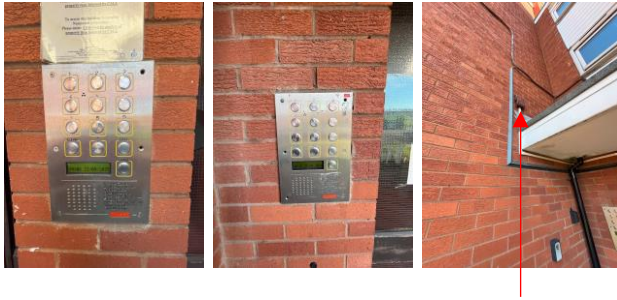
Intercom access and firefighter's lift override switch.

- 15) A fire switch for the lift on the 3-story block that is located at the front entrance, just above the canopy, on investigation it was found that it had been left in the ON position of override and did not override the lift on inspection. An email has been sent to the electrical team on the 20/10/2025.

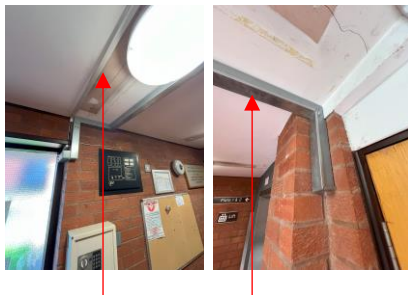
- 13) Metal trunking for electrical cabling is installed within the ground floor lobby area of flats 1-4,9-12,18-21.

Metal trunking

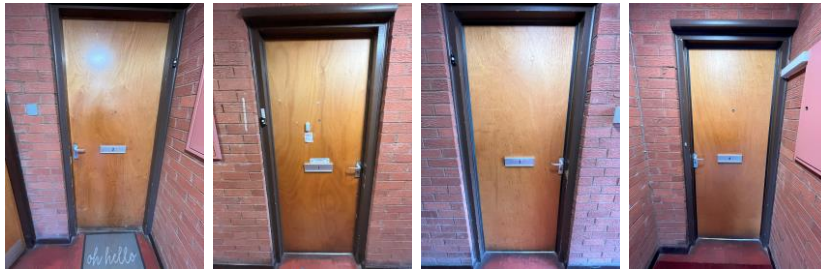
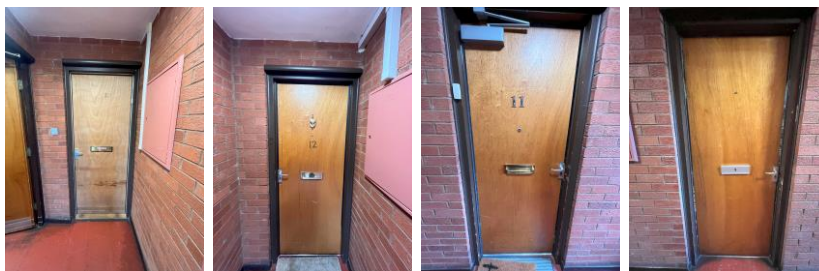
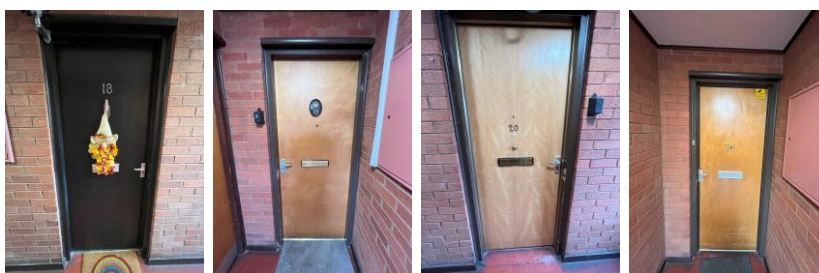
Flats 1-4,9-12,18-21

- 4) A variety of methods and materials have been used to achieve fire-stopping including Rockwool and intumescent pillows where needed.
- 5) All individual flats are installed with notional FD30 timber doors. It has been recommended that on the next refurbishment to the building that the FD30 timber doors be upgraded to certified FD30s fire rated doors.

Ground floor flats 1,2,3,4

1<sup>st</sup> floor flats 9,10,11,12

2<sup>nd</sup> floor flats 18,19,20,21

It is recommended that for future renovations of the block that the notional FD30 timber fire doors be replaced with FD30s certified fire rated doors.

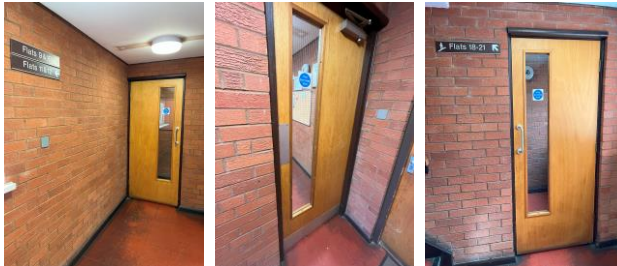
- 8) The building has sufficient compartmentation between the communal areas, staircases, landing corridors by the means of FD30s fire doors with door closures, all communal doors were checked to see if self-closing device worked as should, no issues were found.

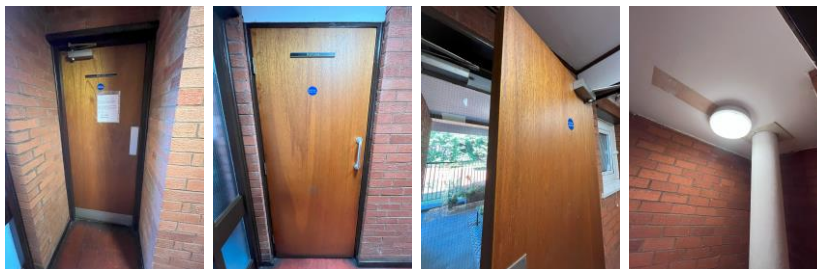
Internal Refuse cupboards

- 9) All refuse waste cupboards located on each communal landing are secured with timber FD30s fire doors. The compartmentation within these refuse cupboards was inspected, and no issues were identified. The cleaners' storage cupboard on the ground floor is also fitted with a timber FD30s fire door. This door is secured with a 54-mortice lock and is accessible only to authorised personnel.

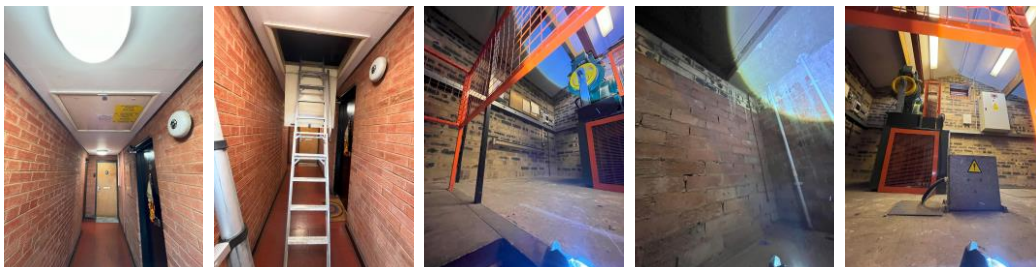
- 10) Lift motor room on the 2<sup>nd</sup> floor for flats 1-4,9-12,18-21 was accessed to check compartmentation and fire stopping, no issues found

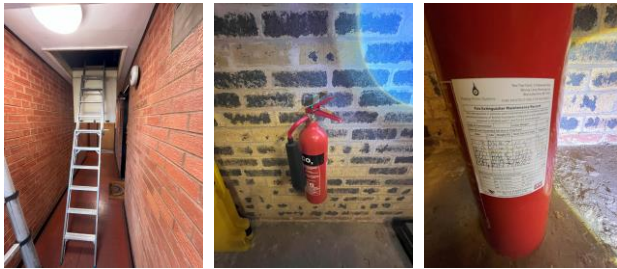
- 1) There is a CO2 fire extinguisher located in the lift motor room, which is on the second floor, accessed through a roof hatch. Next service date is due for Oct 2025.

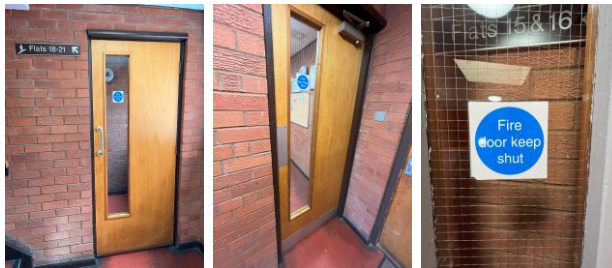
- 1) Fire door keep shut signs are displayed where appropriate. All resident meter cupboards display "Fire Door Keep Shut/Locked" sign.

Communal fire doors have signage of keeping door closed

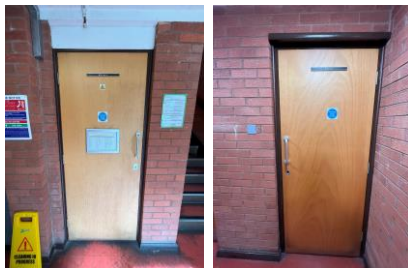
Electrical cupboard and storeroom have signage of keeping door locked.

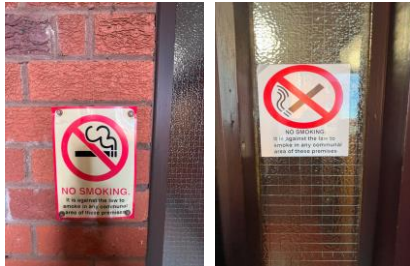
- 4) Smoking is prohibited within any communal parts of the building in line with Smoke Free England legislation. Signage is also displayed in the external refuse cupboard located next to the entrance doors.

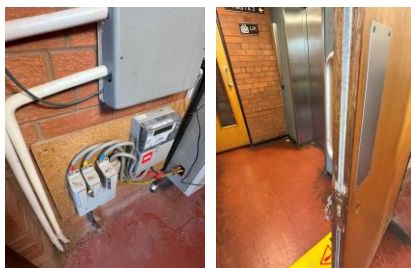
- 7) Electrical service cupboard on the ground floor is secured behind a FD30s fire rated door. Cupboard is free from any combustibles.

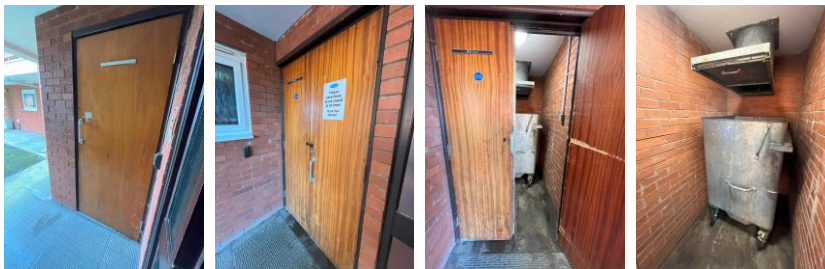
- 2) Refuse bins are stored in 2 refuse cupboards that are located next to the front entrances of the building. Bins Are regularly emptied by site services.

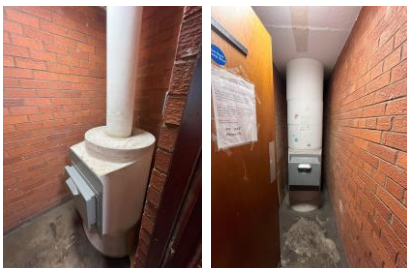
- 3) All internal refuse Shute rooms are clear of any rubbish.

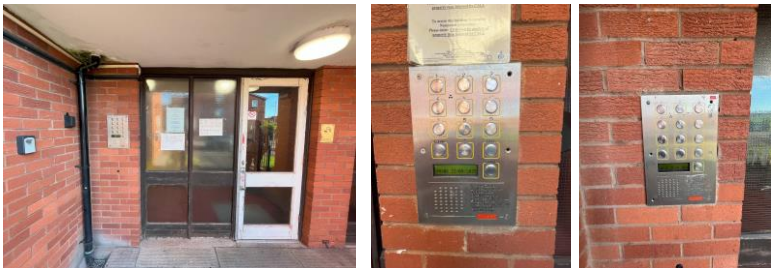
- 1) Regular checks are undertaken by Caretakers / Cleaning Team(s) 365 days per year which helps reduce the risk of arson.
- 2) Both blocks have restricted access, this is via a key lock, each resident has their own key to gain access. There is an intercom system that can allow visitors and contractors in.

Entrance doors and intercom access system.

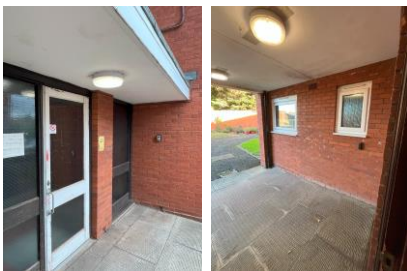
- 3) There is no current evidence of arson.
- 4) The perimeter of the premises is well illuminated.

Front External lighting

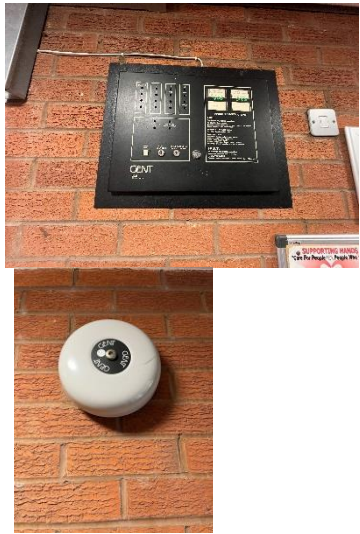
4) A communal fire alarm system that was previously installed in the building has since been decommissioned. Although the system is no longer active, key components—such as the alarm sounders located within the corridors and the main control panel situated in the ground floor communal lobby—remain in place. According to available records, the system has been inactive since 2020. However, there is currently no signage or labelling on the control panel to clearly indicate that it is out of service. This could potentially cause confusion in the event of an emergency or for visiting contractors and should be addressed to ensure clarity and compliance with best practice.

| 8/4 | Decommissioned alarm panel and sounders still present within the building. Need labelling on panel to indicate that it is not in use. | | P2 | 1-3 Months<br>Community Alarms | |

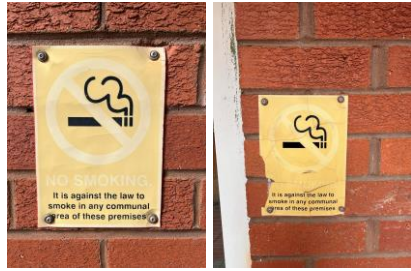
- 5) External No Smoking signs need replacing due to fading and damage.

| 12/5 | External No Smoking signs need replacing due to fading and damage | | P2 | 1-3 Months<br>Fire Rapid Response | |
