# Fire Risk Assessment

**7 – 12 Willow Close  
Cradley Heath,  
B64 6LJ**

**Date Completed: 6<sup>th</sup> October 2025**

**Current Risk Rating = Tolerable**

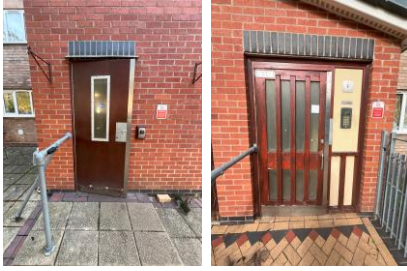
The main entrance to the building is through a porch, with both front and rear doors secured by fob readers. Tradespeople and visitors use an intercom system for access. For emergencies, a firefighter manual override switch is located above the door intercom panel. However, during the assessment, the firefighter switch did not grant access to the building. This issue is noted in Section 7, Means of Escape.

Front and rear entrances to block

The issue of the firefighter override switch failing to provide emergency access has been reported to the contractor for repair.

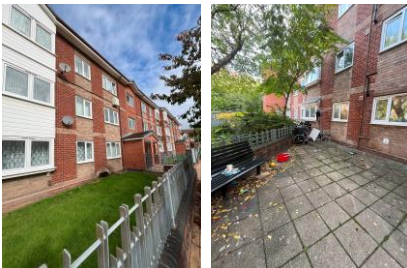
Metal railing fencing perimeter and courtyard at the rear.

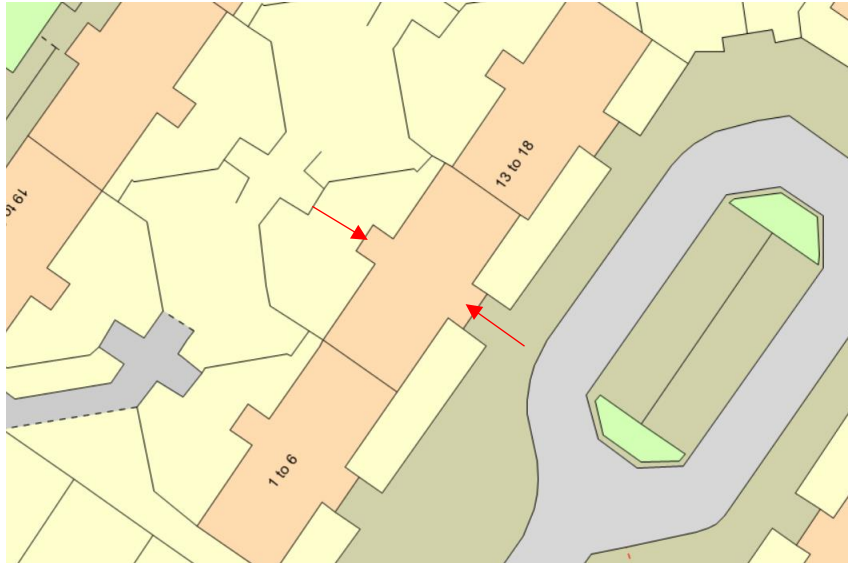
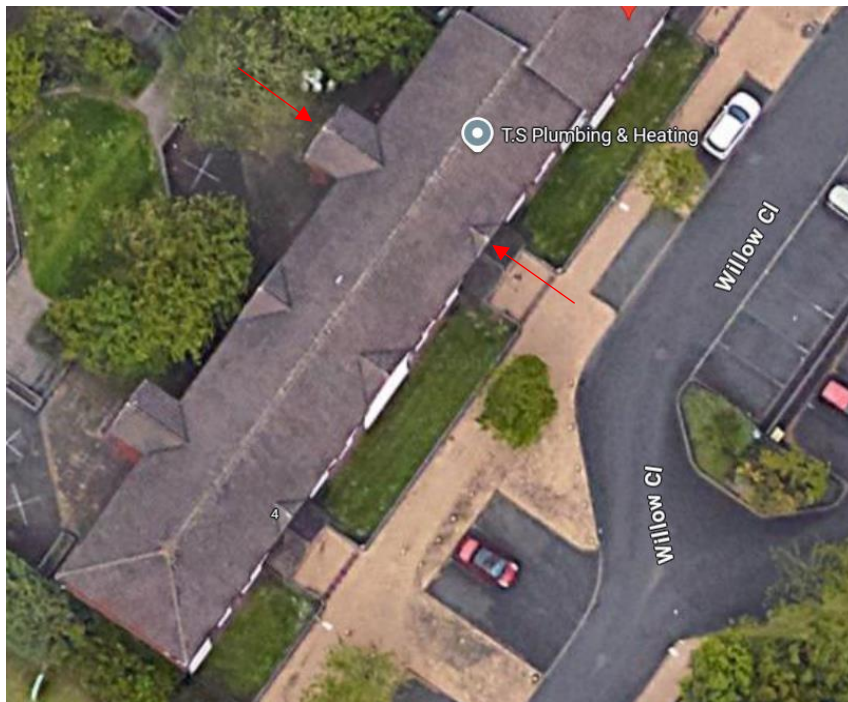
Front and rear entrance as indicated by the red arrows.

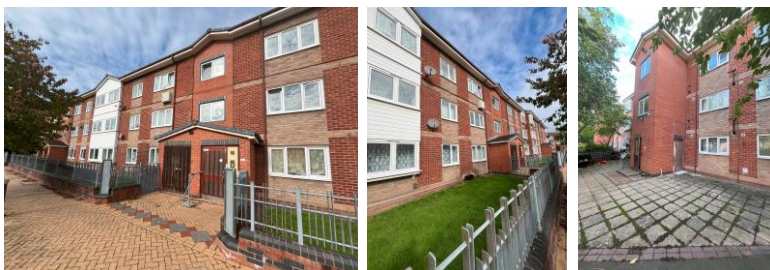
Front Elevation & rear Elevation

- 1) The exterior of the building is primarily traditional brick construction with a pitched roof design. The roof features concrete tiles and UPVC fascia boards along the roofline. The front entrance is accessed via a brick-built porch with a pitched roof, which includes UPVC dry verge end caps, fascia boards, and attached drainage.

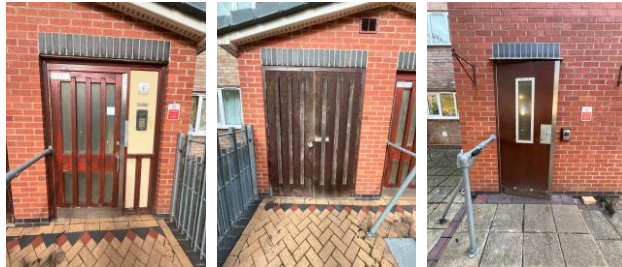
- 2) Both the front and rear doors are constructed from timber. The front door features glazed inserts and spandrel panelling to the side, while the rear door includes a single pane of glass with aluminium trim. Adjacent to the front entrance on the front elevation, there is a set of timber doors enclosing the residents' refuse bins.

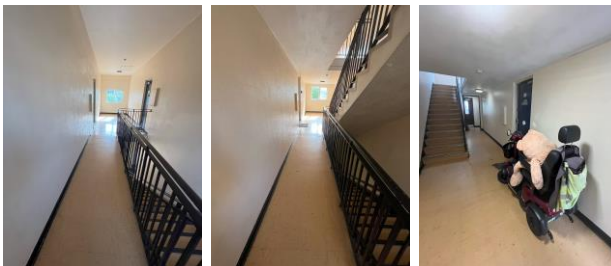
- 4) All corridors, landing and staircase are of adequate width and are kept clear to maintain safe exit in an event of fire. A mobility scooter stored outside flat 8 was noted.

| Question/<br>Ref No | Required Action | Supporting photograph | Priority | Timescale<br>and Person<br>Responsible | Date<br>Completed |
|---|---|---|---|---|---|
| 7/5 | Mobility scooter stored outside flat 8. Need removing. | | P2 | 1 -3 Months<br>Housing<br>Manager | |

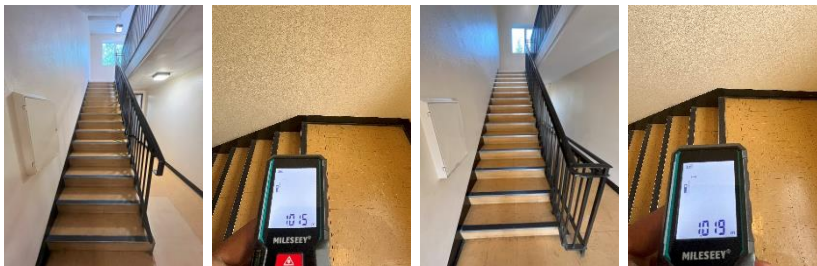
Ground to 1<sup>st</sup> & 2<sup>nd</sup> floor staircase.

- 7) Willow Close 7-12 features a single staircase, positioned at the entrance of each block, which provides an adequate means of escape. The width of the staircases, measured from handrail to wall, is 1015mm and 1019mm respectively. These staircases are kept clear to ensure a safe means of escape.

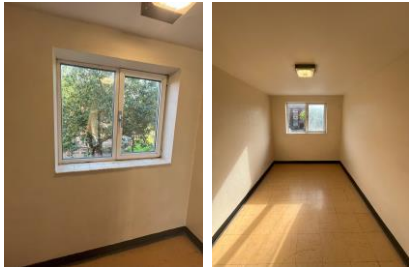
- 8) UPVC window units have been installed on the staircase landings and within the corridors leading to the flats. These windows can be opened without a key to provide adequate airflow into the corridors and stairwells. However, there is no automatic smoke ventilation system installed on the premises.

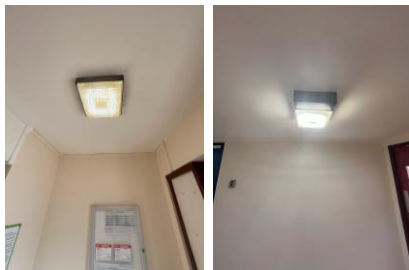
- 9) Emergency lighting is installed throughout the building, these are installed near final exit doors, communal staircase, landing and the corridors for flat entrances.

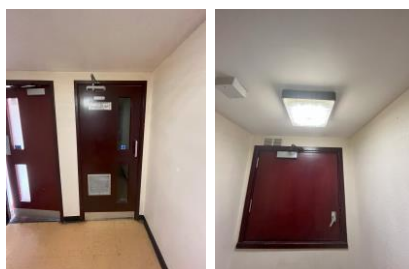
- 10) On the ground floor communal hallway there is access to a bin refuse room which is located behind a FD30s fire door.

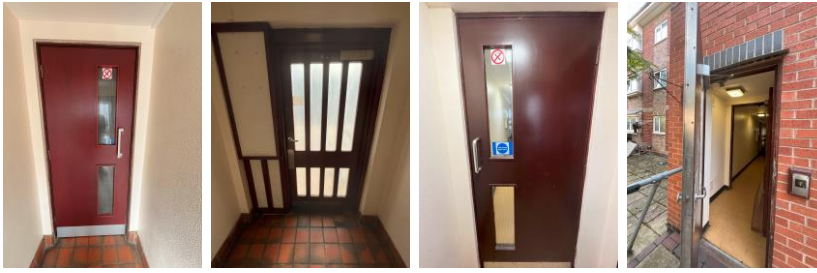
Communal doors before front and rear final exits doors.

- 11) A communal fire door separates the front and rear final exit doors from the main communal area. The final exit doors are equipped with a levered handle operated exit system. These doors are regularly inspected by the Caretaking Teams as part of their routine checks. Any defective closing devices are replaced either by the Caretaking Teams or the in-house Repairs Teams

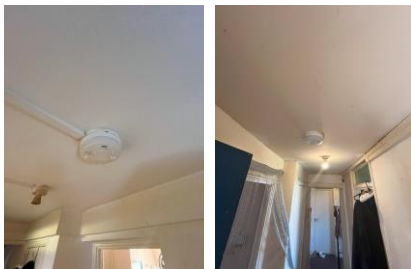
Flat 8 & 11 detection.

Flat 8 – detection in hallway and lounge – LD2

Flat 11- detection in hallway, lounge and bedroom – LD1

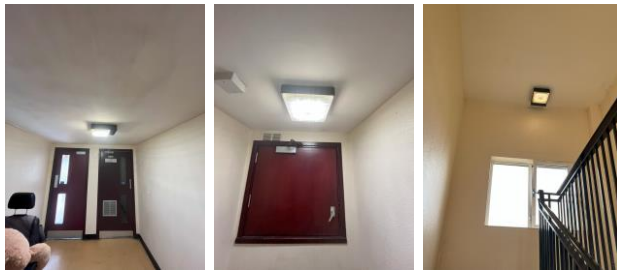
Communal area, stairwell refuse cupboard emergency lighting

- 3) Emergency lighting is installed throughout the building, including communal areas such as stairways, corridors, and lobbies. Additional units are also present within the electrical cupboard, refuse cupboards, and storage areas."

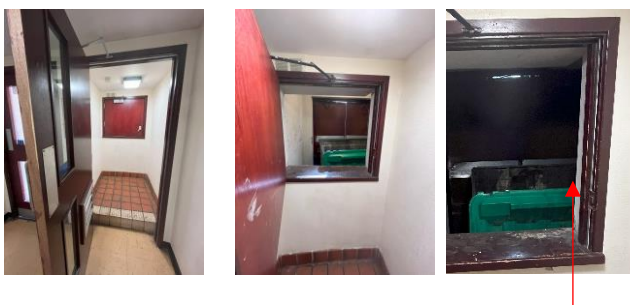
Bin store enclosure and smoke seals

7)The building has adequate compartmentation between the refuse bin room and the communal hallway. This is achieved through an FD30s timber fire door equipped with an automatic self-closing device. The refuse bin hatch is also fitted with a timber fire door that includes smoke seals. These seals were inspected for damage, and no issues were identified.

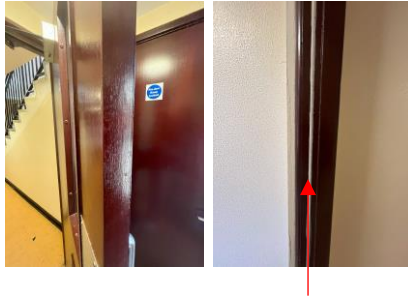
Fd30s and intumescent strip

- 8) Additional FD30s timber fire doors with self closing device and intumescent seals have been installed separating the final exit doors from the communal areas.

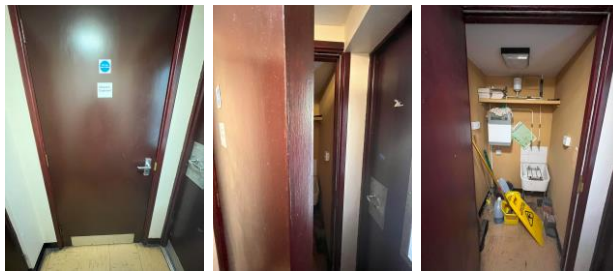
- 9) Cleaners storage cupboard on the ground floor is installed with timber FD30s fire door with smoke seals. This door is locked by a 54 morice key and only held by authorised staff.

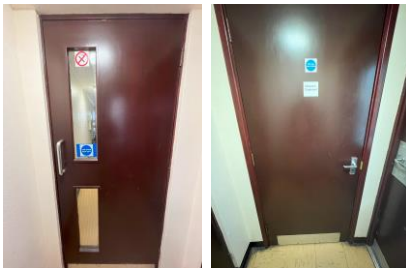
- 1) Fire door keep shut signs are displayed where appropriate, on external electrical cupboard and communal fire doors display Fire Door Keep Shut/Locked” sign.

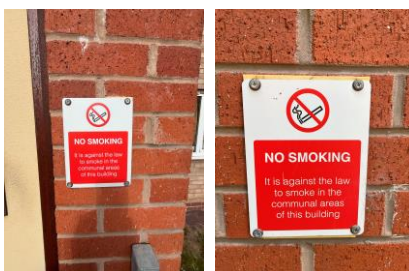
- 2) Yellow LPG warning signs are not displayed within the block. [refer to section 18](#).
- 3) Smoking is prohibited within any communal parts of the building in line with Smoke Free England legislation.

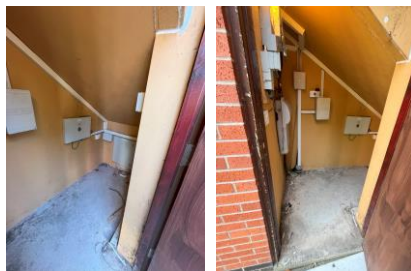
- 7) Electrical service cupboard on the ground floor which is located externally on the rear of the building is secured behind a FD30s fire rated door. Cupboard is free from any combustibles.

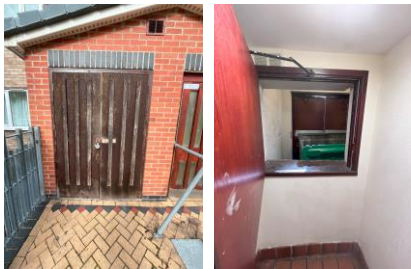
- 1) There is a regular Cleaning Service to the premises.
- 2) Refuse bin is stored in a secured bin room that is located next to the front entrance of the building. This can be accessed from both internal and externally and is kept secure. Bins Are regularly emptied by site services.

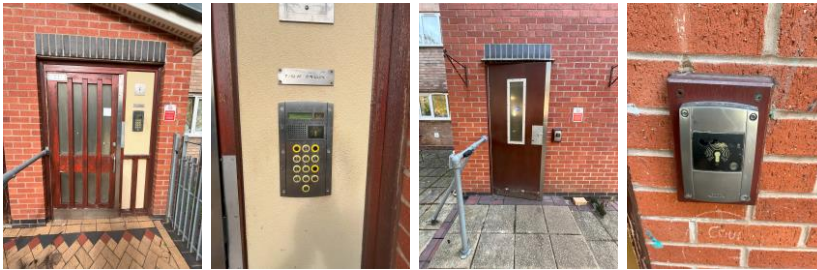
Front and rear entrance doors with access system.

- 1) Regular checks are undertaken by Caretakers / Cleaning Team(s) 365 days per year which helps reduce the risk of arson.
- 2) Both blocks have restricted access, this is via a key lock, each resident has their own fob to gain access. There is an intercom system that can allow visitors and contractors in.

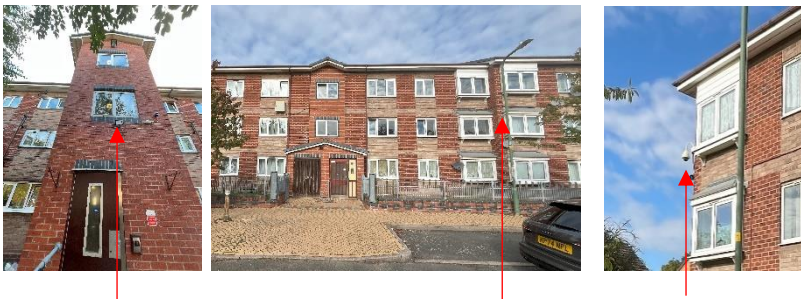
Rear external lighting, Street lighting & CCTV

- 3) There is no current evidence of arson.
- 4) The perimeter of the premises is well illuminated. Although there is no external lighting installed at the front of the building, the area benefits from adequate street lighting. Additionally, a CCTV camera located at the corner of 1–6 is monitored by concierge staff.

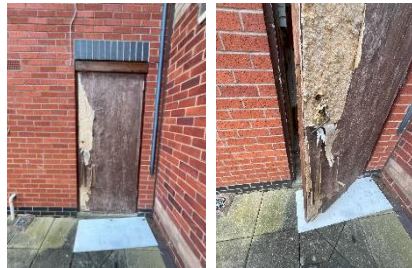
- 4) The external door leaf to the electrical cupboard has sustained significant weather damage, requires replacement.**

| 10/4 | The external door slab to the electrical cupboard has sustained damage due to prolonged exposure to rain. Needs replacing. | | P2 | 1 -3 Months<br>Fire<br>Rapid<br>Response | |

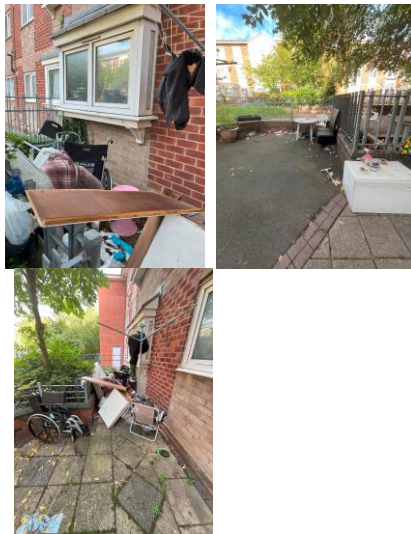
- 6) Discarded combustible items were noted against the building in the rear courtyard, present an unnecessary risk.

| 15/6 | All combustible materials discarded / stored in court yard against the building to be removed. | | P2 | 1 -3 Months<br>Housing<br>Manager | |

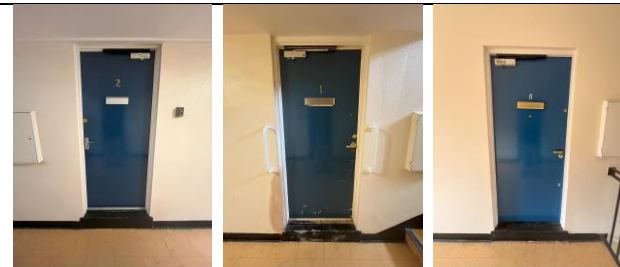
- 5) All individual flats are installed with of notional FD30s fire rated timber doors. It has been recommended that on the next refurbishment to the building that the FD30s timber doors be upgraded to certified FD30s fire rated doors.

It is recommended that for future renovations of the block that the notional FD30s timber fire doors be replaced with certified FD30s fire rated doors.

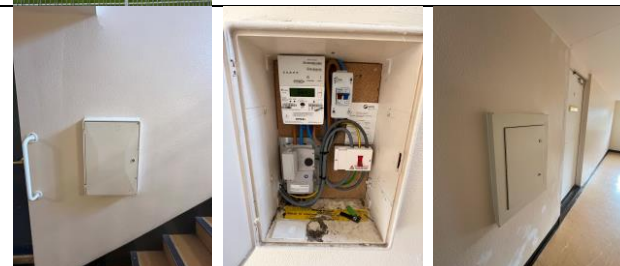
- 10) Resident electrical cupboards are located next to residents flats. The cupboards inset into the block work with over units as a closure. It is recommended that on any future refurbishment of the block that the electrical cupboards are to be relocated within the residents flat at housed within the required compartmentation.

It is recommended that the residents' electrical cupboards be relocated to within the residents' flats and housed within the required compartmentation on any future refurbishment of the block.
