# Fire Risk Assessment

**19-24**

**Peartree Lane,  
Cradley Heath,  
B64 6EH**

**Date Completed: 11/11/2025**

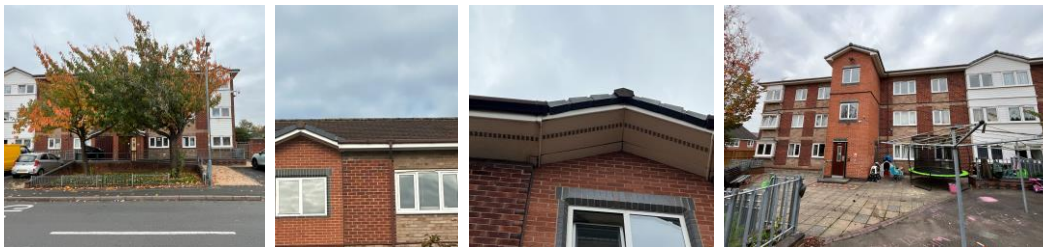
- 1) The external surface of the building is predominantly brick structure with uPVC soffits and fascia. The roof is pitched and fitted with flat concrete interlocking roof tiles on the roof.

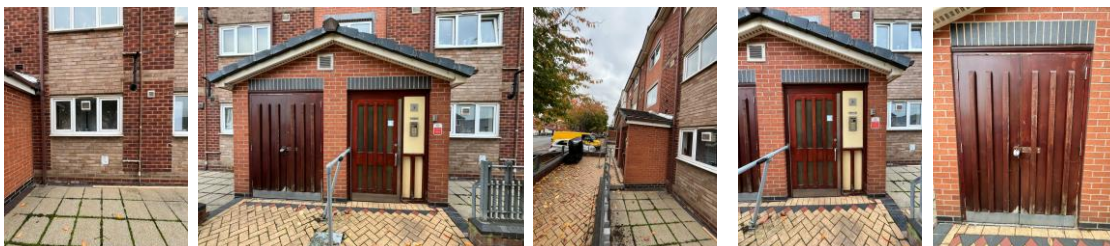
- 2) uPVC double glazed units have been installed to each flat and communal stairway. There is a porched entrance to the block. The canopy roof is a pitched roof with flat interlocking roof tiles. There are uPVC fascia and soffits installed around the porch front. Entrance & rear door are timber and glass units, with small section of spandrel panelling to the side. The bin room door is of timber construction.

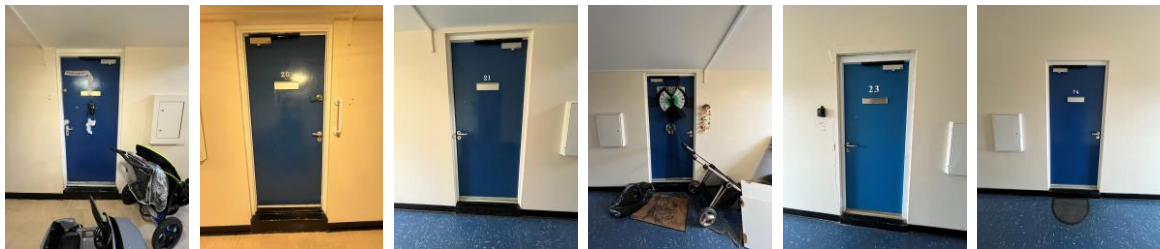
- 1) Each property is fitted with a minimum of an LD3 detection system within the flat. [See Section 8](#)
- 2) Each property has the protection of a minimum of a notional FD30s rated door; self-closers are fitted, some to the external face of the door, some internally.

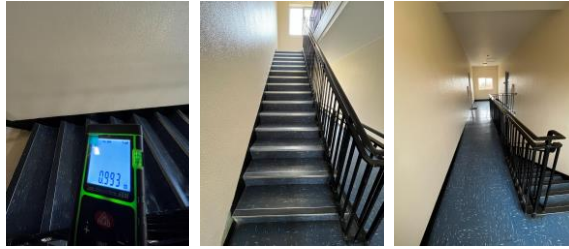
- 5) Within the block each floor is accessed via a single staircase that provides a means of escape and has a width of a minimum of 990mm between the handrails, this includes the minimum width of the landings.

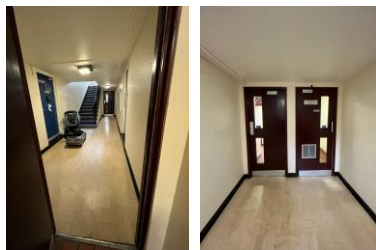
- 6) Corridors and landings are at least 1050mm in width and are kept clear.

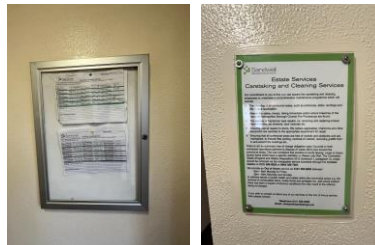
- 10) Communal areas are kept free of flammable items. The communal areas are checked on a regular basis by Caretaking / Cleaning teams 365 days per year and all items of rubbish are immediately removed. There is also an out of hour's service that allows combustible items of furniture / rubbish to be removed.

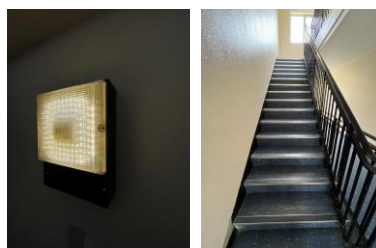
- 11) Emergency lighting is provided to communal landings and stairs as this is required under 3.41 of Approved Document B Volume 1.  
[\(Refer to section 9\)](#) Landing windows and standard lighting units also supply light within the communal areas.

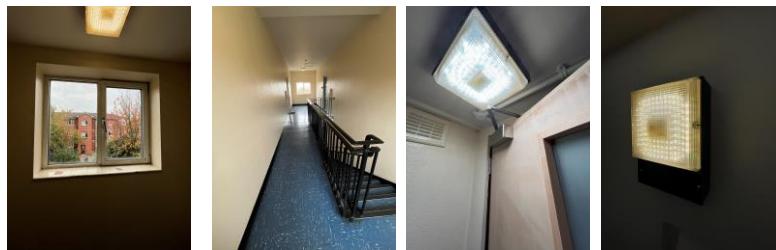
- 1) These premises have been fitted with emergency lighting at the head of the stairways.
- 2) As well as emergency lighting fitted there is also standard lighting and windows to assist in lighting of the communal areas

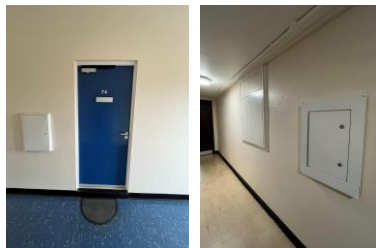
- 11) Outside each flat is situated a fire rated electric meter overbox. These are locked with a budget key.

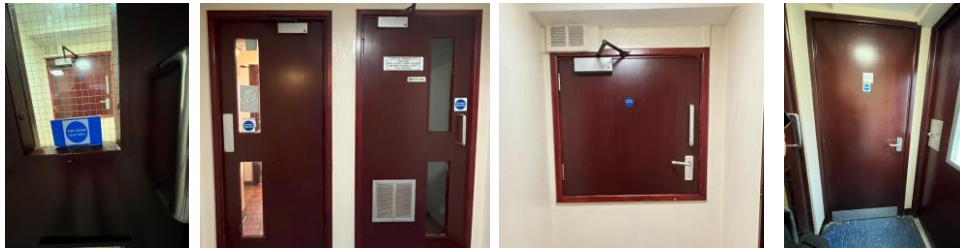
- 1) 'Fire door keep shut' signs are displayed on the entrance and exit doors.

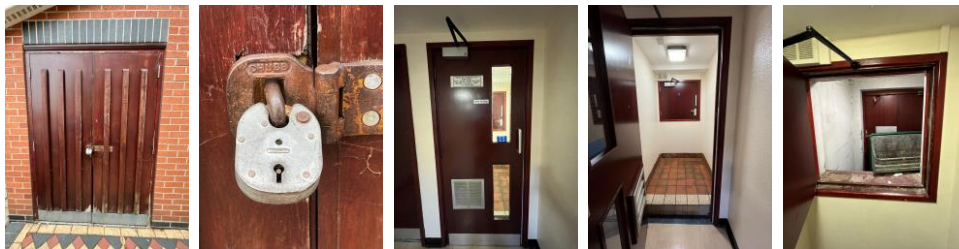
- 1) There is a regular Cleaning Service to the premises.
- 2) The refuse bin is located at the front of the block within a room next to the blocks front entrance. Rubbish is disposed of via a bin chute from within the block, the bin is kept in its own room.

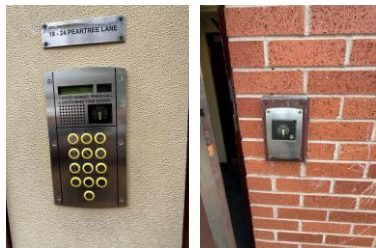
- 1) Regular checks are undertaken by Caretakers / Cleaning Team(s) 365 days per year which helps reduce the risk of arson.
- 2) Restricted access to the premises by means of a fob and door entry system to the front and the rear.

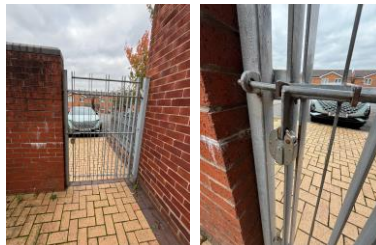
- 3) There is access to the rear via a side gate. This is always padlocked preventing unofficial access
