# Fire Risk Assessment

**1-6 Elm Tree Way  
Cradley Heath,  
B64 6EN**

**Date Completed: 3rd November 2025**

**Current Risk Rating = Tolerable**

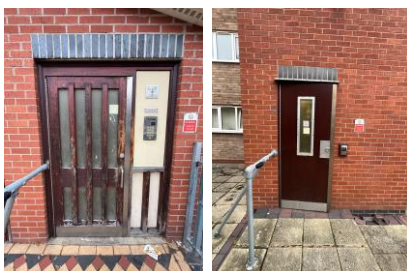
Front and rear entrances to block.

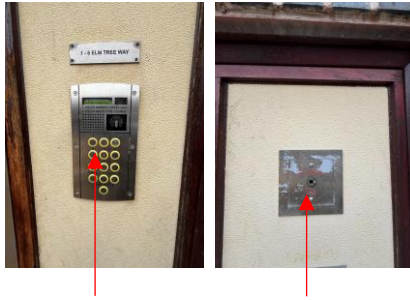
Intercom access and firefighter's switch

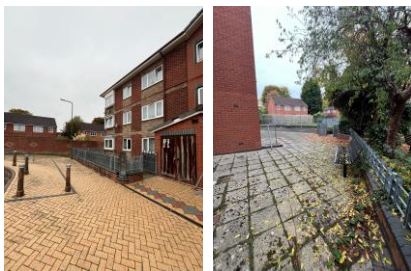
Metal railing fencing perimeter and courtyard at the rear.

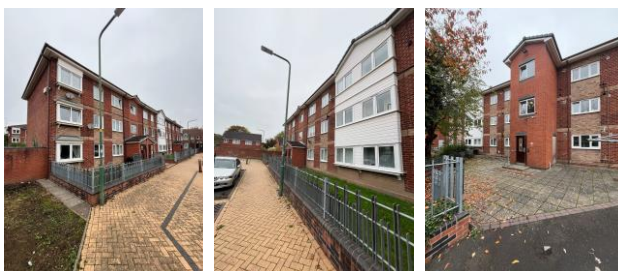
- 1) The exterior of the building is primarily traditional brick construction with a pitched roof design. The roof features concrete tiles and UPVC fascia boards along the roofline. The front entrance is accessed via a brick-built porch with a pitched roof, which includes UPVC dry verge end caps, fascia boards, and attached drainage.

Front Elevation & rear Elevation

UPVC Dry Verge End caps and drainage.

The materials used within the external construction at 1 - 6 Elm Tree Way present an acceptable level of risk to fire. However, the risk could be further mitigated by replacing the existing UPVC shiplap cladding with a non-combustible material. This option may be worth considering as part of any future refurbishment programme. At the time of writing, the use of UPVC cladding on residential building facades under 11 metres in height remains compliant with Approved Document B: Fire Safety, provided the building is set back at least 1000mm from the relevant boundary.

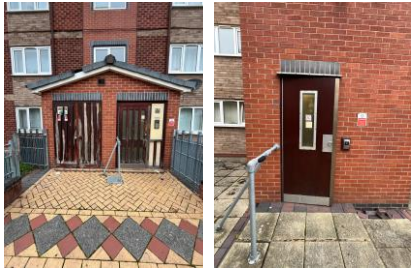
- 2) Both the front and rear doors are constructed from timber. The front door features glazed inserts and spandrel panelling to the side, while the rear door includes a single pane of glass with aluminium trim. Adjacent to the front entrance on the front elevation, there is a set of timber doors enclosing the residents' refuse bins.

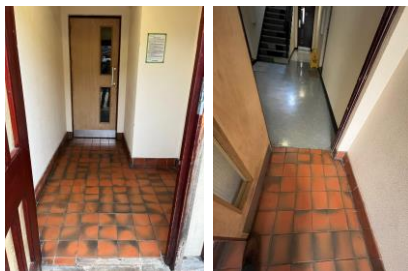
- 3) Front entrance doors to residents' flats have floor mats placed in communal area, they are of a suitable size and in acceptable condition, the fire rating for these mats is not known, but deemed to be sufficiently low risk.

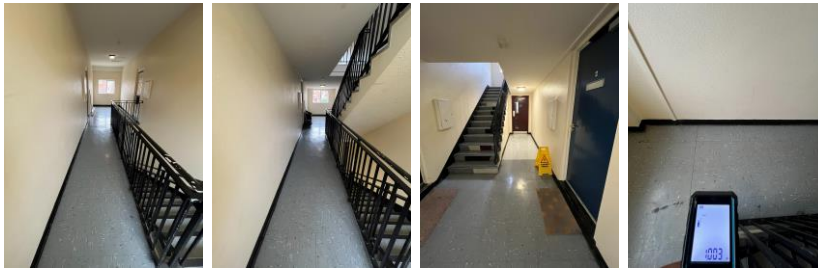
- 5) All corridors, landing and staircase are of adequate width of 1003mm and are kept clear to promote maintain safe exit in an event of fire.

2<sup>nd</sup> floor.

1<sup>st</sup> floor.

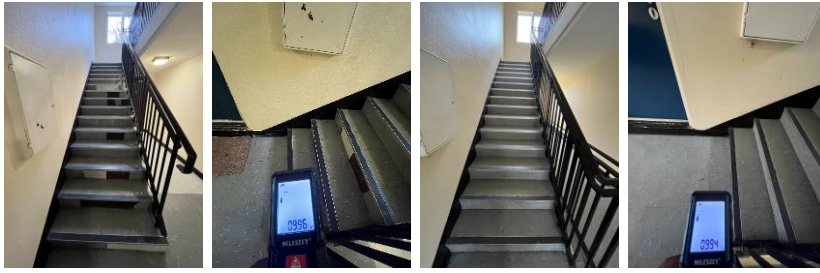
- 7) Elm Tree Way 1 -6 features a single staircase, positioned at the entrance of each block, which provides an adequate means of escape. The width of the staircases, measured from handrail to wall, is 996mm and 994 mm respectively. These staircases are kept clear to ensure a safe means of escape.

Ground to 1<sup>st</sup> & 2<sup>nd</sup> floor staircase.

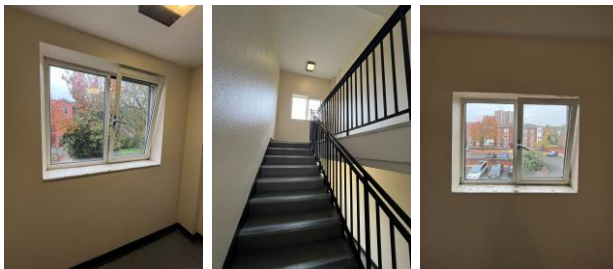
- 8) UPVC window units have been installed on the staircase landings and within the corridors leading to the flats. These windows can be opened without a key to provide adequate airflow into the corridors and stairwells. However, there is no automatic smoke ventilation system installed on the premises.

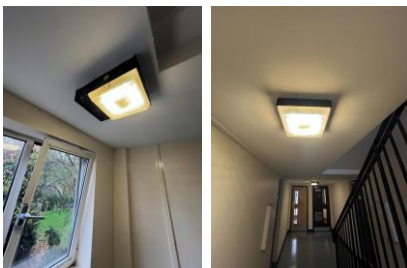
- 9) Emergency lighting is installed throughout the building, these are installed near final exit doors, communal staircase, landing and the corridors for flat entrances.

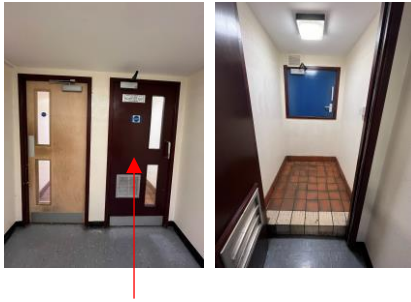
Refuse bin room

- 10) On the ground floor communal hallway there is access to a bin refuse room which is located behind a FD3s fire door.

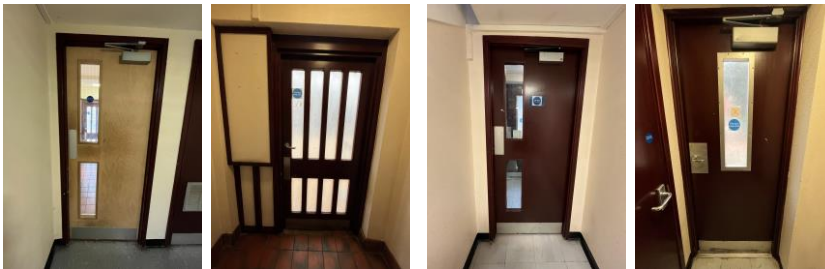
- 11) A communal fire door separates the front and rear final exit doors from the main communal area. The final exit doors are equipped with handle-operated exit systems. These doors are regularly inspected by the Caretaking Teams as part of their routine checks. Any defective closing devices are replaced either by the Caretaking Teams or the in-house Repairs Teams

Communal doors with front and rear final exits doors.

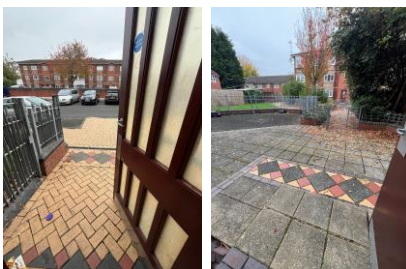
- 12) There are 2 sufficient final exit doors which lead to a place of ultimate safety.

Front final & Rear final exits.

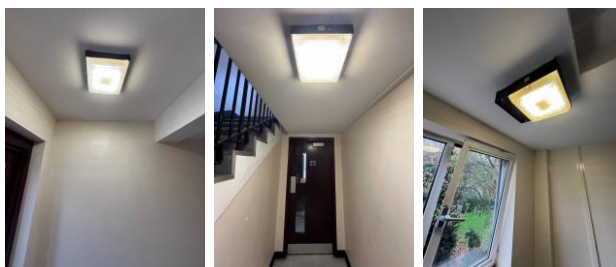
- 3) Emergency lighting is installed throughout the building, including communal areas such as stairways, corridors, and lobbies.

Communal area, stairwell emergency lighting

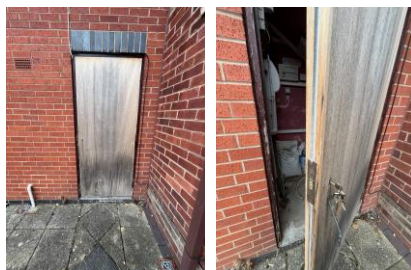
- 3) Electrical Service cupboard on ground floor is located outside to the rear of the block, this is behind an FD30s timber fire door, this secured by 054 mortice lock key; this is only held by authorised staff.

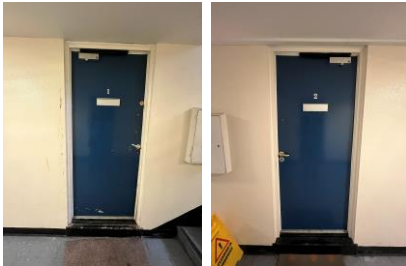
Ground floor flats 1,2,

- 5) All individual flats are installed with of notional FD30s rated timber doors. It has been recommended that on the next refurbishment to the
-

building that the FD30s timber doors be upgraded to FD30s certified fire rated doors. Flat 2 self-closing device inspected and tested on the required 15-degree closure test, door closed into the frame as required.

It is recommended that for future renovations of the block that the notional FD30s timber fire doors are to be replaced with FD30s certified fire doors.

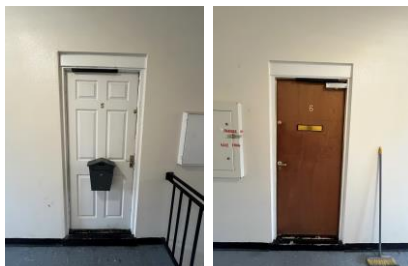
2<sup>nd</sup> floor flats 5,6

**6) Flat 5 has a missing self-closure device, no access was gained to inspect the door.** *Door previously deemed unacceptable 10/11/2023.*

| Question/<br>Ref No | Required Action | Supporting photograph | Priority | Timescale<br>and Person<br>Responsible | Date<br>Completed |
|---|---|---|---|---|---|
| 10/6 | Flat 5 front entrance door missing self-closing device. Reinstallation of door device required.<br><i>Door previously deemed unacceptable 10/11/2023.</i> | | P3 | 3-6 Months<br>Leasehold<br>Manager | |

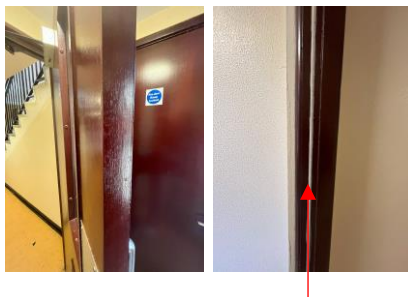
8) Additional FD30s timber fire doors with self closing devices and intumescent seals have been installed separating the final exit doors from the communal areas.

Fd30s and intumescent strip

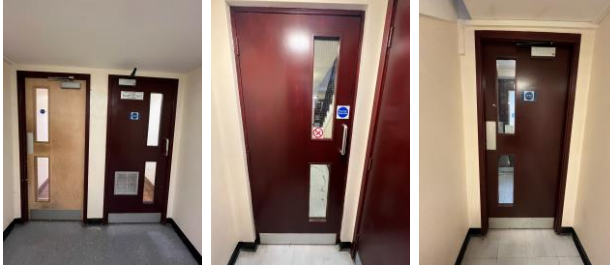
- 1) Fire door keep shut signs are displayed where appropriate, on communal fire doors, refuse bin stores and cleaners cupboard display Fire Door Keep Shut/Locked” sign.

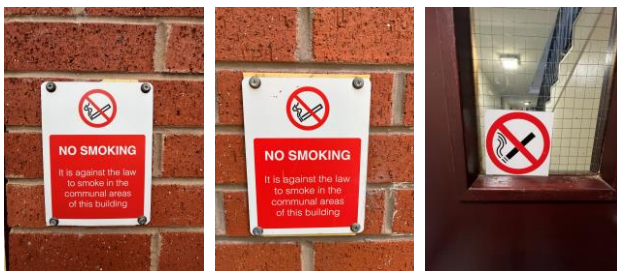
- 2) Yellow LPG warning signs are not displayed within the block. [refer to section 18](#).
- 3) Smoking is prohibited within any communal parts of the building in line with Smoke Free England legislation.

External and internal No Smoking signs.

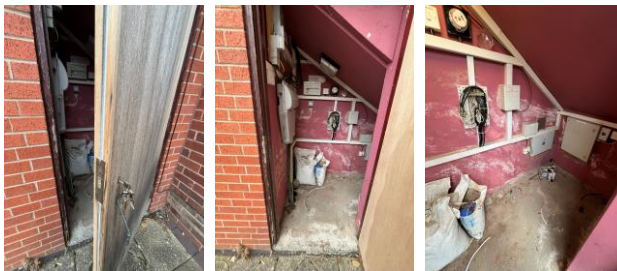
- 1) Smoking is prohibited on entrance and within any communal parts of the building in line with Smoke Free England legislation.
- 2) Hot working is not normally carried out. If essential maintenance requires the use of hot work processes, then corporate policies and procedures are to be followed.
- 3) Portable electrical equipment used as part of the Caretaking / Cleaning regime is subject to annual PAT Testing. This information is held by the Estate Services Manager.
- 4) The fixed electrical installation shall be tested every 5 years. No evidence of EICR for the block. Email has been sent to the electrical team on the 21/10/2025. This has now been scheduled.
- 5) Electrical service cupboard on the ground floor which is located externally on the rear of the building is secured behind a FD30s fire rated door. Cupboard is free from any combustibles.

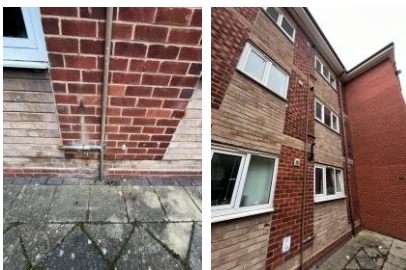
- 6) Gas appliances and pipework (where installed) are subject to annual testing and certification. This contract is managed by the in-house Gas team. Gas supply to these premises is external.

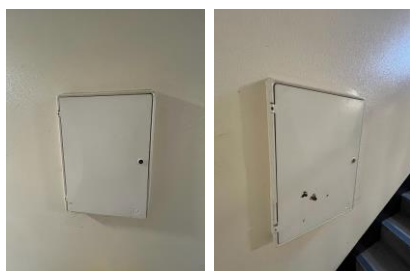
- 7) Residents' electrical meters are housed within secured units apart from electrical cupboard for flat 6 which has been noted in section 10, Compartmentation.

| 10/11 | Flat 6 resident electrical cupboard door locks will not secure unit. Locks are defective, locks need replacing. | | P2 | 1 -3 Months<br>Electrical<br>Manager | |

It is recommended that the residents' electrical cupboards be relocated within the residents' flats and housed within required compartmentation in any future renovation program.

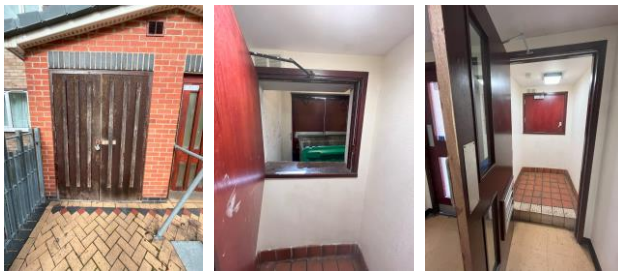
- 2) Refuse bin is stored in a secured bin room that is located next to the front entrance of the building. This can be accessed from both internal and externally and is kept secure. Bins Are regularly emptied by site services. All internal refuse rooms are clear of any rubbish.

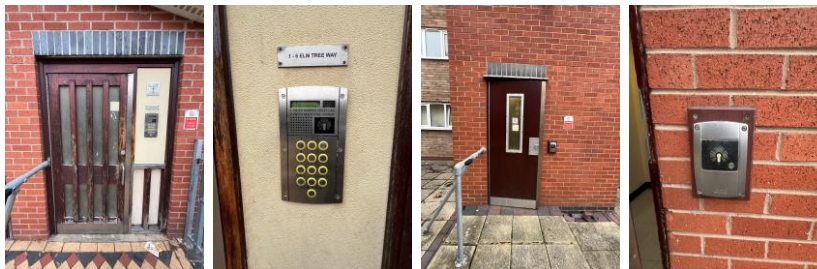
- 1) Regular checks are undertaken by Caretakers / Cleaning Team(s) 365 days per year which helps reduce the risk of arson.
- 2) Both blocks have restricted access, this is via a key lock, each resident has their own fob to gain access. There is an intercom system that can allow visitors and contractors in.

Front and rear entrance doors with access system.

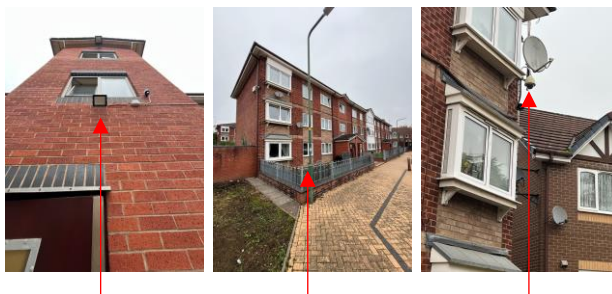
- 3) There is no current evidence of arson.
- 4) The perimeter of the premises is well illuminated. Although there is no external lighting installed at the front of the building, the area benefits from adequate street lighting. Additionally, a CCTV camera located at the corner of 7–12 is monitored by concierge staff.

Rear lighting, Street lighting & CCTV
