# Fire Risk Assessment

**1 -6 Elm Tree Way**

**Cradley Heath,  
B64 6EN**

**Date Completed: 3rd November 2025**

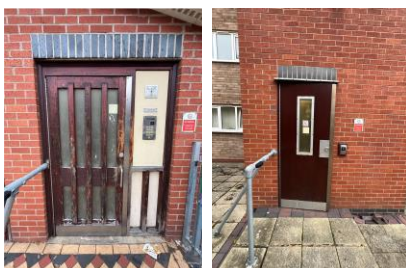
Front and rear entrances to block

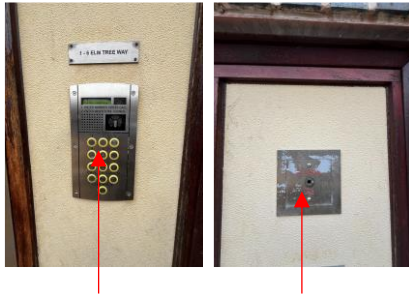
Intercom access and fire-fighter's switch

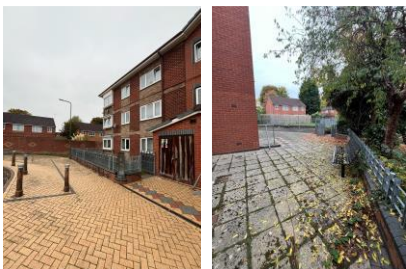
Metal railing fencing perimeter and courtyard at the rear.

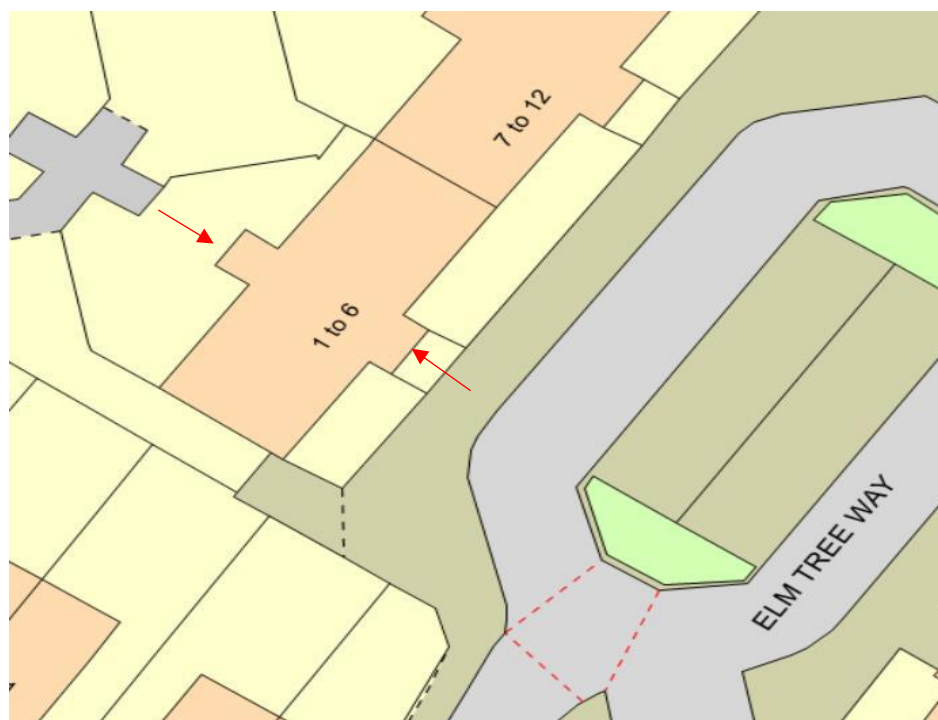
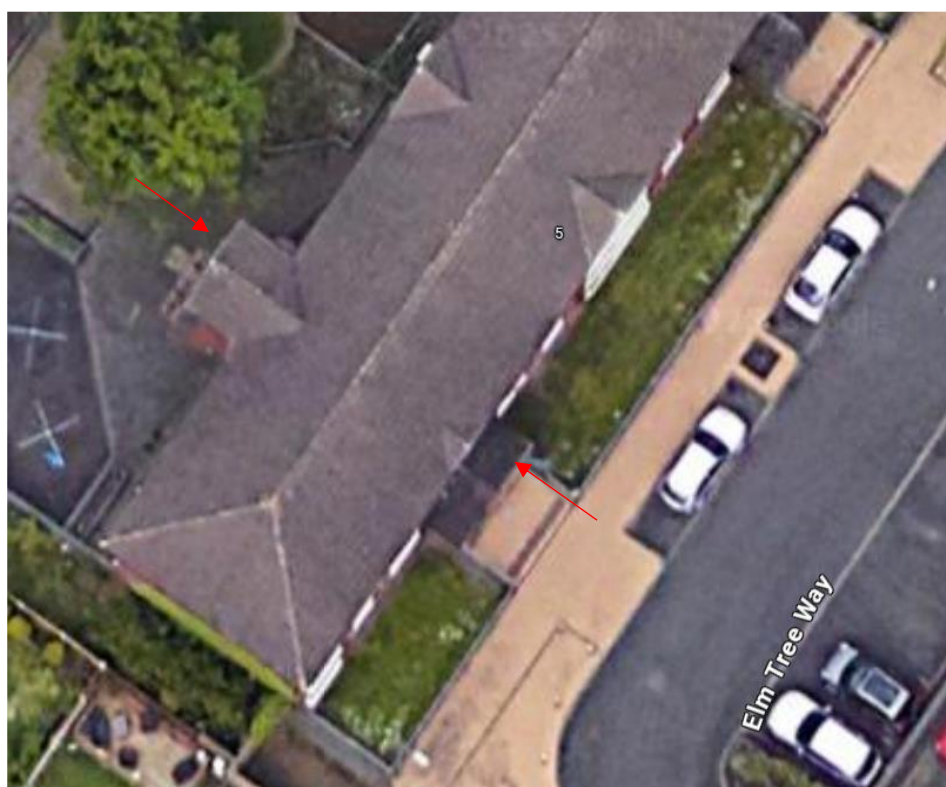
Front and rear entrance as indicated by the red arrows.

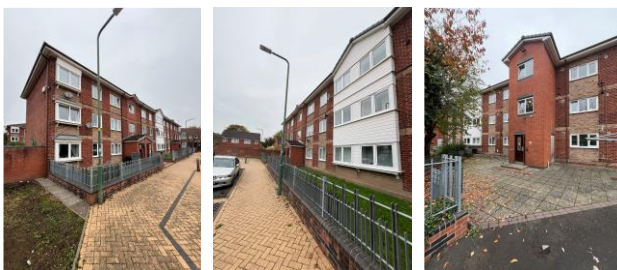
Front Elevation & rear Elevation

The materials used within the external construction at 1 -6 Elm Tree present an acceptable level of risk to fire. However, the risk could be further mitigated by replacing the existing UPVC shiplap cladding with a non-combustible material. This option may be worth considering as part of any future refurbishment programme. At the time of writing, the use of UPVC cladding on residential building facades under 11 metres in height remains compliant with Approved Document B: Fire Safety, provided the building is set back at least 1000mm from the relevant boundary.

- 1) The exterior of the building is primarily traditional brick construction with a pitched roof design. The roof features concrete tiles and UPVC fascia boards along the roofline. The front entrance is accessed via a brick-built porch with a pitched roof, which includes UPVC dry verge end caps, fascia boards, and attached drainage.

It is recommended that the UPVC cladding be considered for removal on any future renovation to the building.

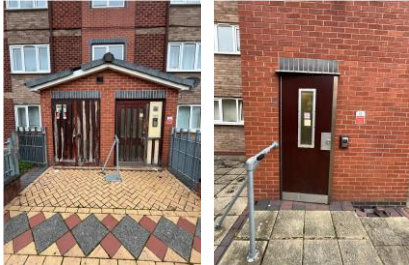
- 2) Both the front and rear doors are constructed from timber. The front door features glazed inserts and spandrel panelling to the side, while the rear door includes a single pane of glass with aluminium trim. Adjacent to the front entrance on the front elevation, there is a set of timber doors enclosing the residents' refuse bins.

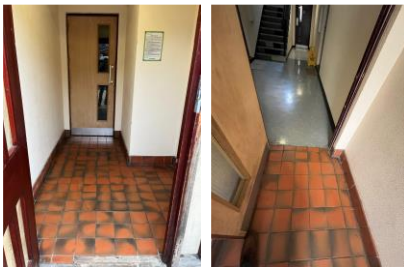
- 3) Front entrance doors to residents' flats have floor mats placed in communal area, they are of a suitable size and in acceptable condition, the fire rating for these mats is not known, but deemed to be sufficiently low risk.

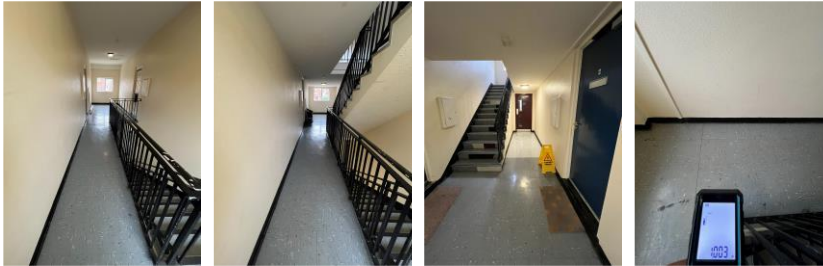
- 4) All corridors, landing and staircase are of adequate width of 1003mm and are kept clear to promote maintain safe exit in an event of fire.

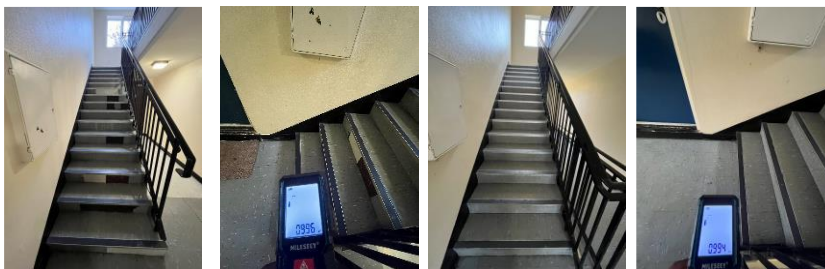
Ground to 1<sup>st</sup> & 2<sup>nd</sup> floor staircase.

- 6) Elm Tree 1 - 6 features a single staircase, positioned at the entrance of each block, which provides an adequate means of escape. The width of the staircases, measured from handrail to wall, is 996 mm and 994 mm respectively. These staircases are kept clear to ensure a safe means of escape.

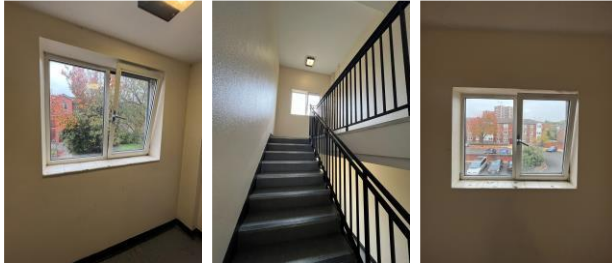
- 7) UPVC window units have been installed on the staircase landings and within the corridors leading to the flats. These windows can be opened without a key to provide adequate airflow into the corridors and stairwells. However, there is no automatic smoke ventilation system installed on the premises.

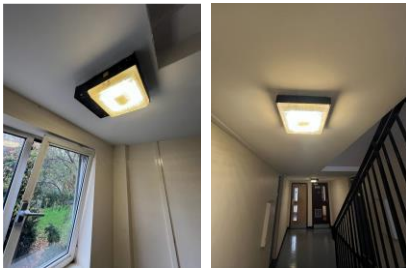
- 8) Emergency lighting is installed throughout the building, these are installed near final exit doors, communal staircase, landing and the corridors for flat entrances.

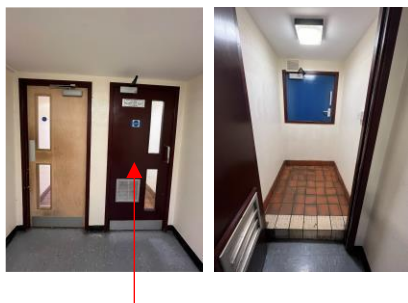
Refuse bin room

- 9) On the ground floor communal hallway there is access to a bin refuse room which is located behind a FD30s fire door.

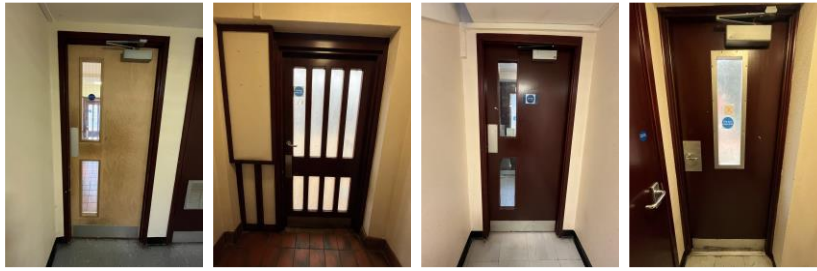
- 10) A communal fire door separates the front and rear final exit doors from the main communal area. The final exit doors are equipped with levered handle-operated exit system. These doors are regularly inspected by the Caretaking Teams as part of their routine checks. Any defective self-closing devices are replaced either by the Caretaking Teams or the in-house Repairs Teams
-

Communal doors with front and rear final exits doors.

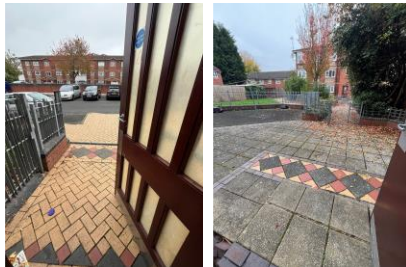
- 11) There are 2 sufficient final exit doors which lead to a place of ultimate safety.

Front final & Rear final exits.

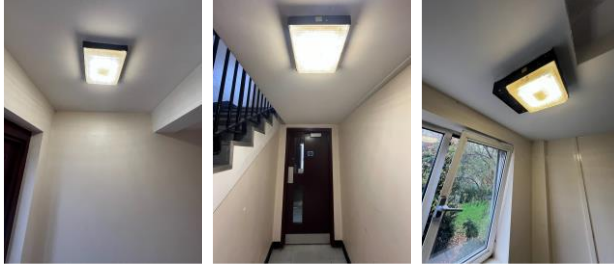
- 4) Emergency lighting is installed throughout the building, including communal areas such as stairways, corridors, and lobbies.

Communal area, stairwell emergency lighting

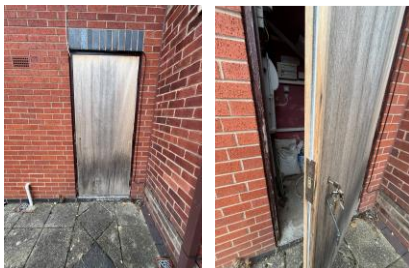
- 3) Electrical Service cupboard on ground floor is located outside to the rear of the block, this is behind an FD30s timber fire door, this secured by 054 mortice lock key; this is only held by authorised staff.

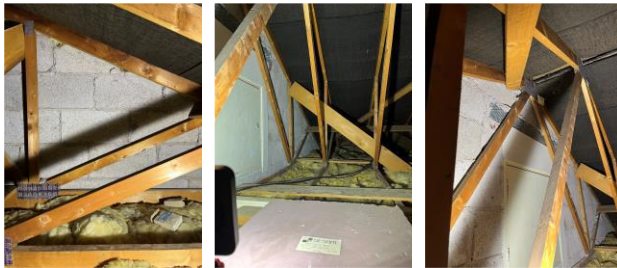
- 4) On the second floor there is a roof hatch that allows access into the roof void, there was acceptable compartmentation between the flats.

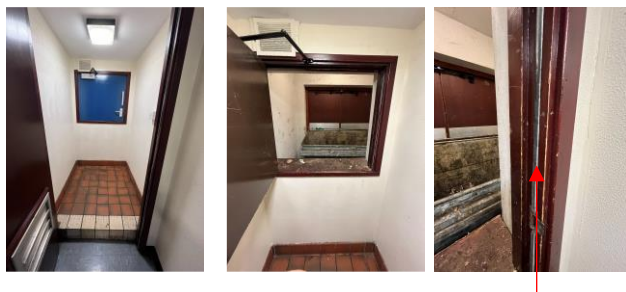
7)The building has adequate compartmentation between the refuse bin room and the communal hallway. This is achieved through an FD30s timber fire door equipped with a self-closing device. The refuse bin hatch is also fitted with a timber fire door that includes smoke seals. These condition of these seals were inspected, and no issues were identified.

Bin store enclosure and smoke seals

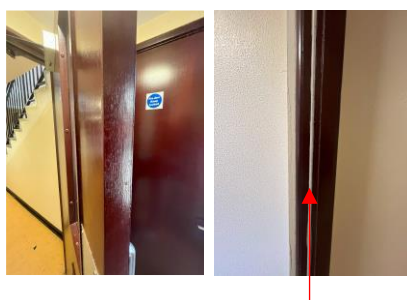
8)Additional FD30s timber fire doors with self closing devices and smoke seals have been installed seperating the final exit doors from the communal areas.

FD30s and smoke seal

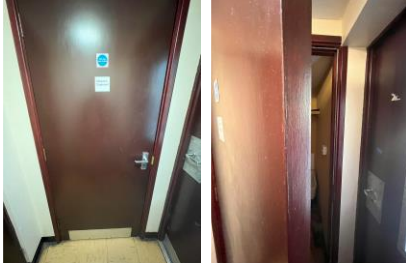
- 9) Cleaners storage cupboard on the ground floor is installed with timber FD30s fire door with smoke seals. This door is locked by a 54 morice key and only held by authorised staff.

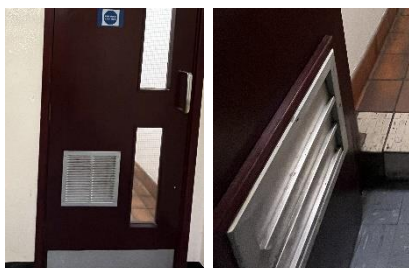
- 11) The fire door to the refuse cupboard on the ground floor within the communal corridor is equipped with a vision panel and an acceptable ventilation intumescent grill.

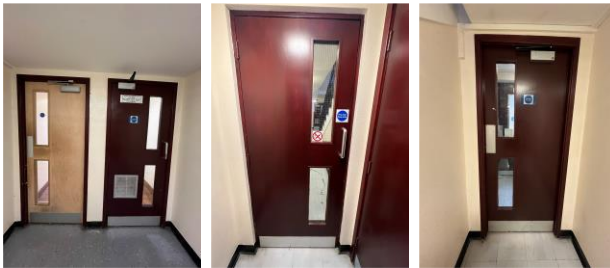
- 1) Fire door keep shut signs are displayed where appropriate, on communal fire doors, refuse bin stores and cleaners cupboard display Fire Door Keep Shut/Locked” sign.

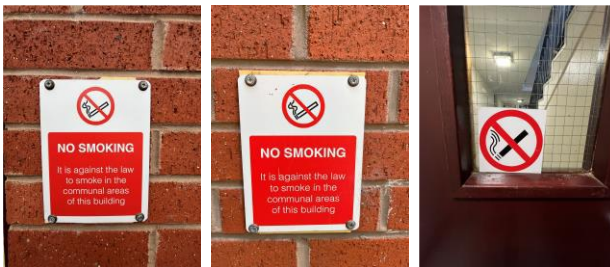
- 3) Smoking is prohibited within any communal parts of the building in line with Smoke Free England legislation.

External and internal No Smoking signs.

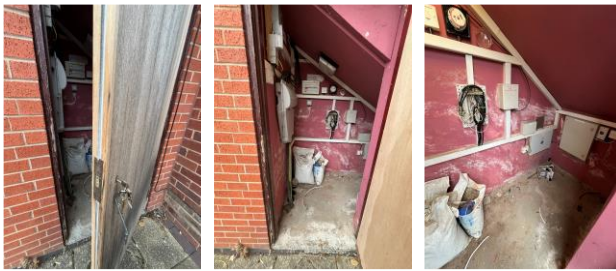
- 2) Hot working is not normally carried out. If essential maintenance requires the use of hot work processes, then corporate policies and procedures are to be followed.
- 3) Portable electrical equipment used as part of the Caretaking / Cleaning regime is subject to annual PAT Testing. This information is held by the Estate Services Manager.
- 4) The fixed electrical installation shall be tested every 5 years. No evidence of EICR for the block. Email has been sent to the electrical team on the 21/10/2025. This has now been scheduled.
- 5) Electrical service cupboard on the ground floor which is located externally on the rear of the building is secured behind a FD30s fire rated door. Cupboard is free from any combustibles.

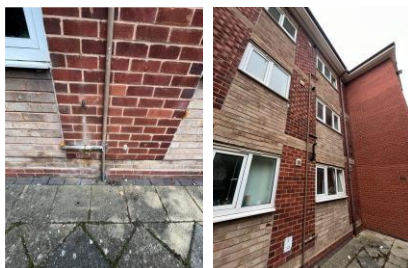
- 6) Gas appliances and pipework (where installed) are subject to annual testing and certification. This contract is managed by the in-house Gas team. Gas supply to these premises is external.

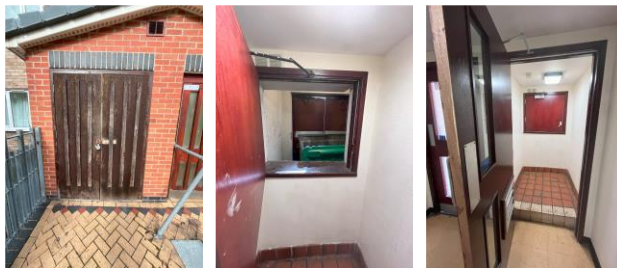
- 2) Refuse bin is stored in a secured bin room that is located next to the front entrance of the building. This can be accessed from both internal and externally and is kept secure. Bins Are regularly emptied by site services. All internal refuse rooms are clear of any rubbish.

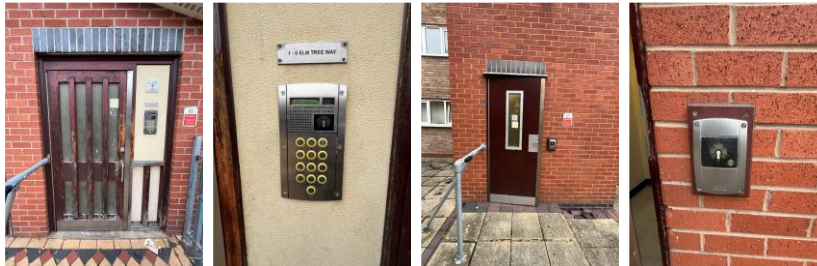
- 2) Both blocks have restricted access, this is via a key lock, each resident has their own fob to gain access. There is an intercom system that can allow visitors and contractors in.

Front and rear entrance doors with access system.

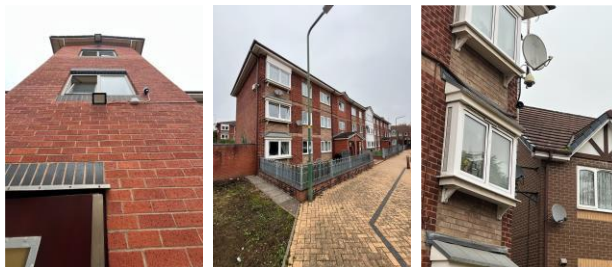
- 3) There is no current evidence of arson.
- 4) The perimeter of the premises is well illuminated. Although there is no external lighting installed at the front of the building, the area benefits from adequate street lighting. Additionally, a CCTV camera system is located at the corner of 7–12 which is monitored by concierge staff.

Rear lighting, & CCTV
