Fire Risk Assessment

**25 - 30 Elm Tree Way
Cradley Heath,
B64 6EN**

**Date Completed: 4th November 2025
Officer: M Zafeer Fire Risk Assessor
Checked By: C. Hill Building Safety Manager**

Current Risk Rating = Tolerable

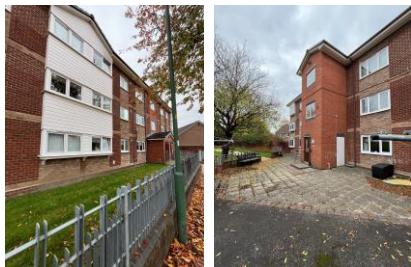
Metal railing fencing perimeter and courtyard at the rear.

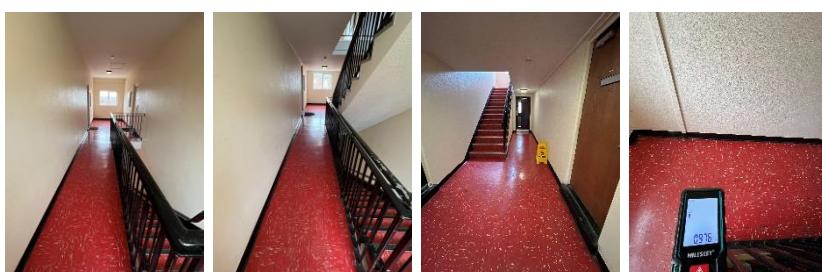
- 3) All corridors, landing and staircase are of adequate width of 976mm and are kept clear to promote maintain safe exit in an event of fire.

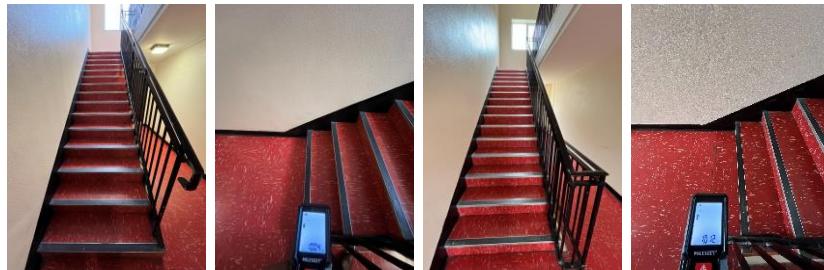
7) Elm Tree Way 25 – 30 features a single staircase, positioned at the entrance of each block, which provides an adequate means of escape. The width of the staircases, measured from handrail to wall, is 1004 mm and 1012 mm respectively. These staircases are kept clear to ensure a safe means of escape.

Ground to 1st & 2nd floor staircase.

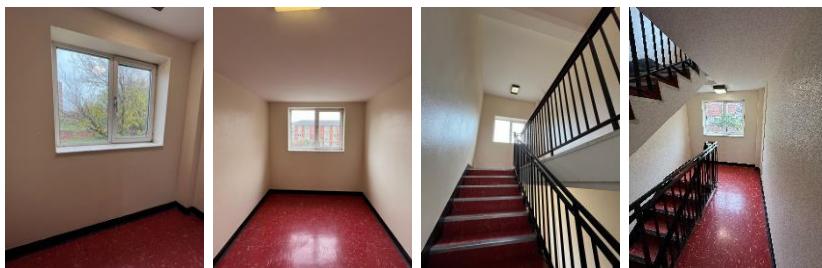
8) UPVC window units have been installed on the staircase landings and within the corridors leading to the flats. These windows can be opened without a key to provide adequate airflow into the corridors and stairwells. However, there is no automatic smoke ventilation system installed on the premises.

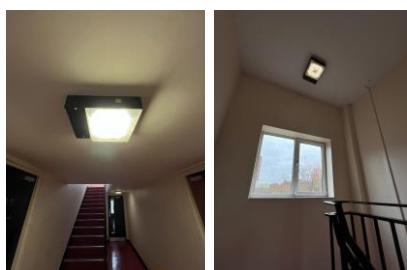
9) Emergency lighting is installed throughout the building, these are installed near final exit doors, communal staircase, landing and the corridors for flat entrances.

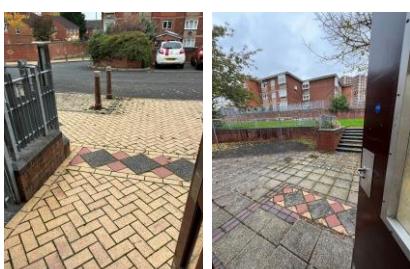
12) There is a clear and safe exit out of the building via the two-ground floor exits.

Front final & Rear final exits.

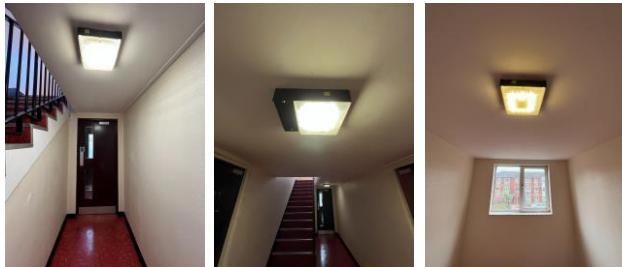
- 4) Emergency lighting is installed throughout the building, including communal areas such as stairways, corridors, and lobbies.

Communal area, stairwell emergency lights.

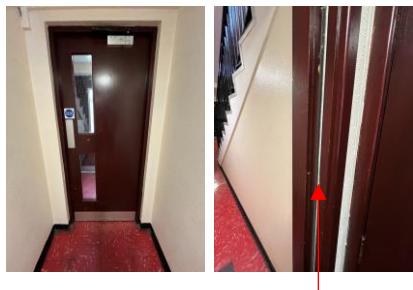
8) Additional FD30s timber fire doors with self closing devices and smoke seals have been installed, these door separate the communal area from the final, exit doors.

FD30s and smoke seals.

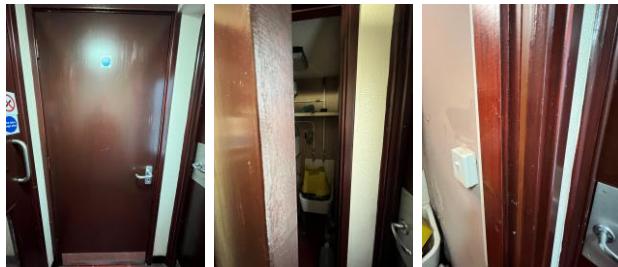
9) Cleaners storage cupboard on the ground floor is installed with timber FD30s fire door with smoke seals. This door is locked by a 54 morice key and only held by authorised staff.

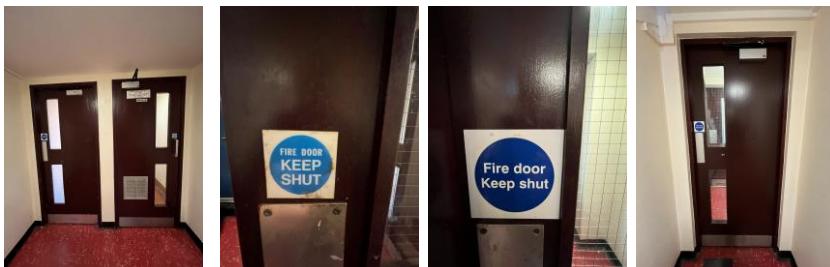
- 1) Fire door keep shut signs are displayed where appropriate, on communal fire doors, refuse bin stores and cleaners cupboard display Fire Door Keep Shut/Locked" sign.

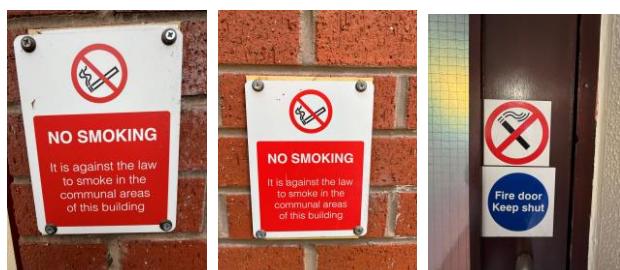
External and internal No Smoking signs.

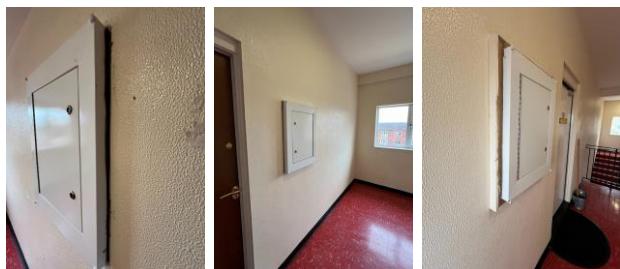
5) Resident electrical cupboards are currently located adjacent to individual flats. These cupboards are installed within secure units integrated into the block's structure. It is recommended that, during any future refurbishment works, the electrical cupboards be relocated inside each resident's flat and enclosed within the appropriate fire-rated compartmentation

7) Residents' electrical meters are housed within metal secured units.

It is recommended that the residents' electrical cupboards be relocated within the residents' flats and housed within required compartmentation in any future renovation program.

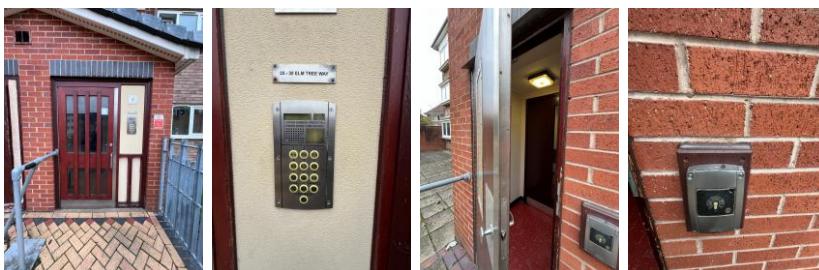
- 1) Regular checks are undertaken by Caretakers / Cleaning Team(s) 365 days per year which helps reduce the risk of arson.
- 2) Both blocks have restricted access, each resident has their own fob to gain access. There is an intercom system that will facilitate visitors and contractors access.

Front and rear entrance doors with access system.
