# Fire Risk Assessment

**19 – 24 Elm Tree Way  
Cradley Heath,  
B64 6EN**

**Date Completed: 4th November 2025**

**Current Risk Rating = Tolerable**

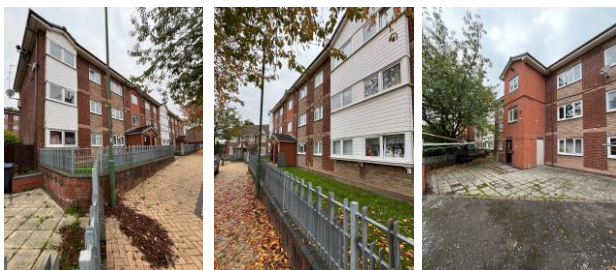
Front Elevation & rear Elevation

- 1)The exterior of the building is primarily traditional brick construction with a pitched roof design. The roof features concrete tiles and UPVC fascia boards along the roofline. The front entrance is accessed via a brick-built porch with a pitched roof, which includes UPVC dry verge end caps, fascia boards, and attached drainage.

The materials used within the external construction at 19 -24 Elm Tree Way present an acceptable level of risk to fire. However, the risk could be further mitigated by replacing the existing UPVC shiplap cladding with a non-combustible material. This option should be considered as part of any future refurbishment programme. At the time of writing, the use of UPVC cladding on residential building facades under 11 metres in height remains compliant with Approved Document B: Fire Safety, provided the building is set back at least 1000mm from the relevant boundary.

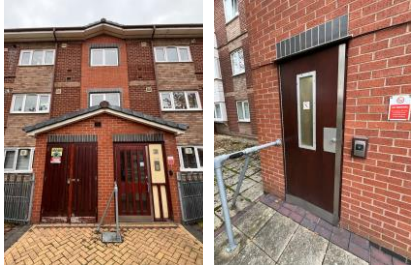
- 2) Both the front and rear doors are constructed from timber. The front door features glazed inserts and spandrel panelling to the side, while the rear door includes a single pane of glass with aluminium trim. Adjacent to the front entrance on the front elevation, there is a set of timber doors enclosing the residents' refuse bins.

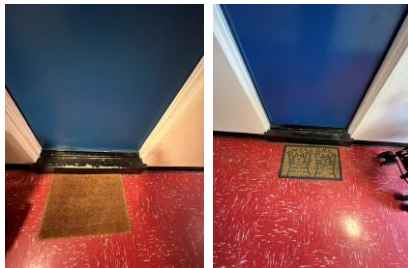
- 3) Front entrance doors to residents' flats have floor mats placed in communal area, they are of a suitable size and in acceptable condition, the fire rating for these mats is not known, but deemed to be sufficiently low risk.

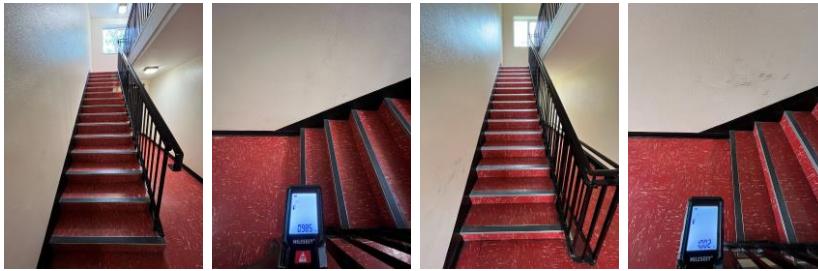
Ground to 1<sup>st</sup> & 2<sup>nd</sup> floor staircase.

- 8) Elm Tree Way 19 - 24 has a single staircase, positioned at the entrance of each block, which provides an adequate means of escape. The width of the staircases, measured from handrail to wall, is 985 mm and 1002 mm respectively. These staircases are kept clear to ensure a safe means of escape.

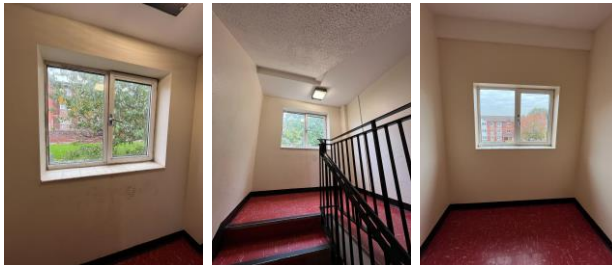
- 9) UPVC window units have been installed on the staircase landings and within the corridors leading to the flats. These windows can be opened without a key to provide adequate airflow into the corridors and stairwells. However, there is no automatic smoke ventilation system installed on the premises.

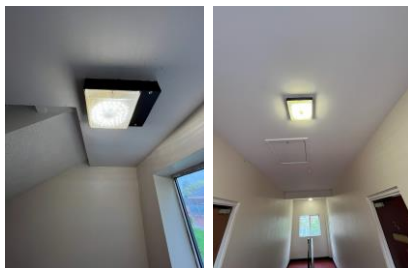
- 10) Emergency lighting is installed throughout the building, these are installed near final exit doors, communal staircase, landing and the corridors for flat entrances.

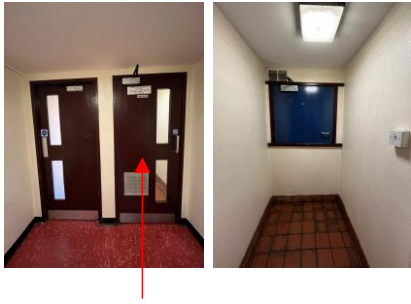
Refuse bin room

- 11) On the ground floor communal hallway there is access to a bin refuse room which is located behind a FD30s fire door.

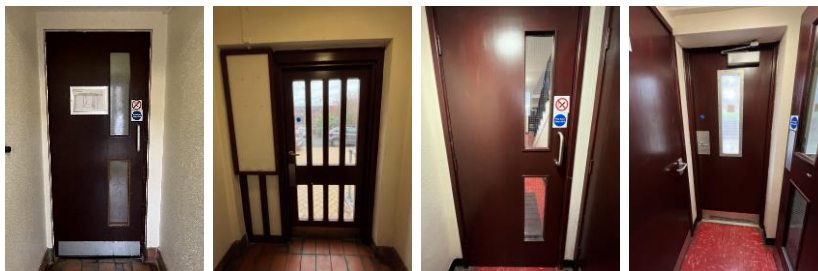
Communal doors with front and rear final exits doors

- 12) A communal fire door separates the front and rear final exit doors from the main communal area. The final exit doors are equipped with levered handle-operated exit system. These doors are regularly inspected by the Caretaking Teams as part of their routine checks. Any defective self-closing devices are replaced either by the Caretaking Teams or the in-house Repairs Teams

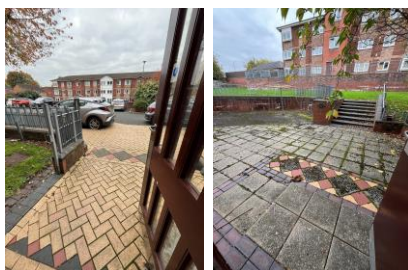
Front final & Rear final exits.

- 13) There are 2 sufficient final exit doors which lead to a place of ultimate safety.

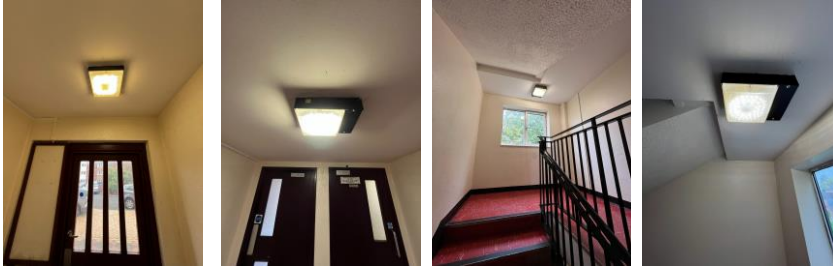
Communal area, stairwell emergency lighting

- 3) Emergency lighting is installed throughout the building, including communal areas such as stairways, corridors, and lobbies.

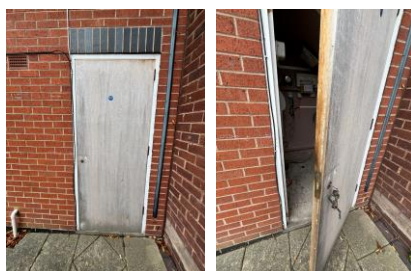
- 3) Electrical Service cupboard on ground floor is located outside to the rear of the block, this is behind an FD30s timber fire door, this secured by 054 mortice lock key; this is only held by authorised staff.

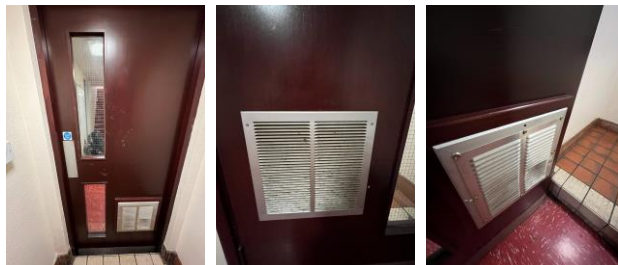
- 7) The fire door to the refuse cupboard on the ground floor within the communal corridor is equipped with a vision panel and an intumescent ventilation grill.

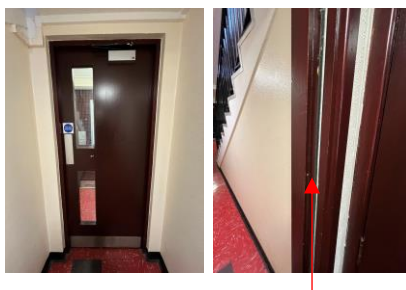
FD30s and smoke seal

- 9) Additional FD30s timber fire doors with self closing devices and smoke seals have been installed separating the final exit doors from the communal areas.

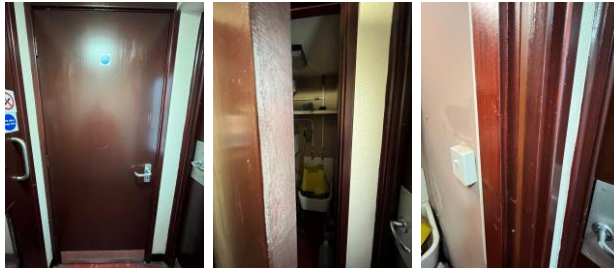
- 10) Cleaners storage cupboard on the ground floor is installed with timber FD30s fire door with smoke seals. This door is locked by a 54 morice key and only held by authorised staff.

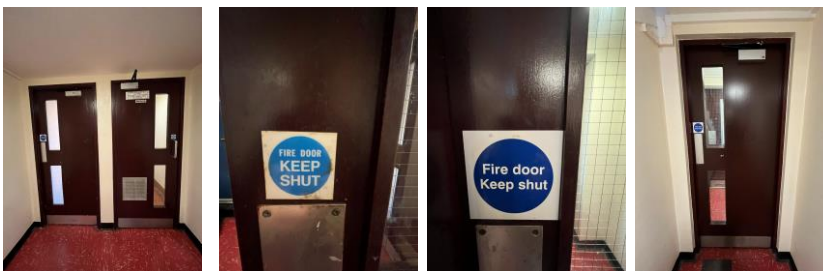
- 1) Fire door keep shut signs are displayed where appropriate, on communal fire doors, refuse bin stores and cleaners cupboard display Fire Door Keep Shut/Locked” sign.

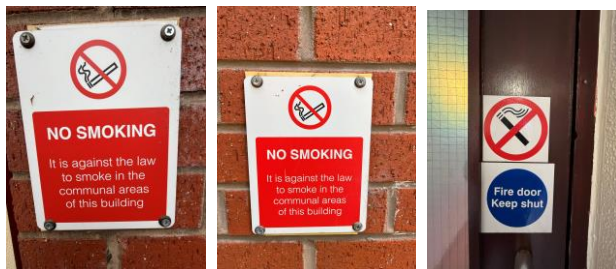
External and internal No Smoking signs.

- 2) Yellow LPG warning signs are not displayed within the block. [refer to section 18.](#)
- 3) Smoking is prohibited within any communal parts of the building in line with Smoke Free England legislation.

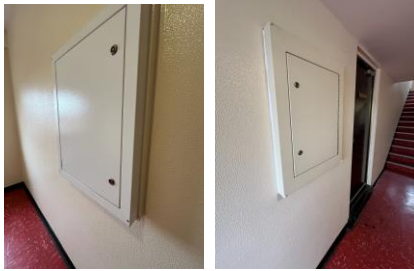
7) Residents' electrical meters are housed within secured units.

It is recommended that the residents' electrical cupboards be relocated within the residents' flats and housed within required compartmentation in any future renovation program.

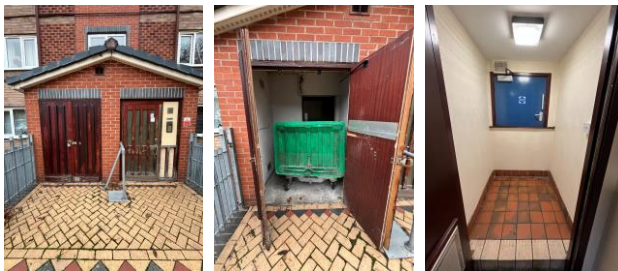
- 2) Refuse bin is stored in a secured bin room that is located next to the front entrance of the building. This can be accessed from both internal and externally and is kept secure. Bins Are regularly emptied by site services. All internal refuse rooms are clear of any rubbish.
