Fire Risk Assessment

7-12

**Applewood Grove,
Cradley Heath,
B64 6EG.**

Date Completed: 11/11/2025

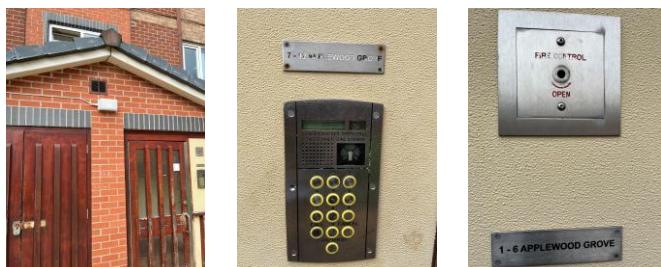
The block has a front entrance, that has a door entry system with a fob reader installed. There is a rear access door, leading to a rear courtyard area has a fob reader to enter the building. Both escape routes lead to an ultimate place of safety. The front final exit door has a firefighter override switch operated by drop-latch key.

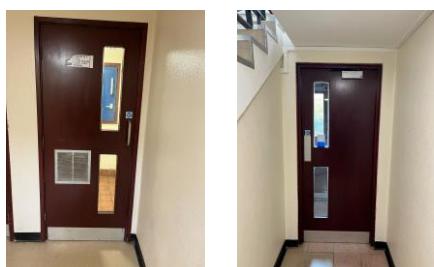
All entrances lead through a further door which is an FD30S with vision panel before entering the ground floor lobby area.

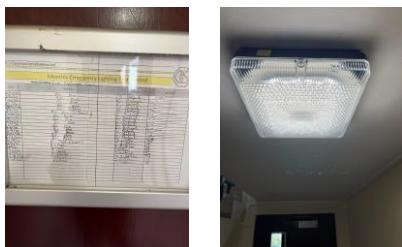
17) Emergency lighting is provided to communal landings and stairs. Checks are done monthly by Sandwell MBC in house electrical team or approved contractor.

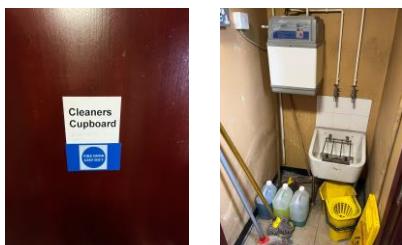
18) The cleaners store cupboard is protected by an FD30 fire door. The door is secured by a suited type 54 mortice lock and key.

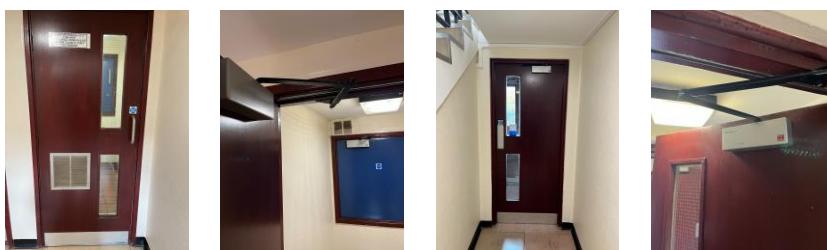
19) All communal doors are fitted with self closing devices that are checked on a regular basis by caretaking teams as part of their check. Defective closing devices are replaced either by the caretaking team or in house repair team.

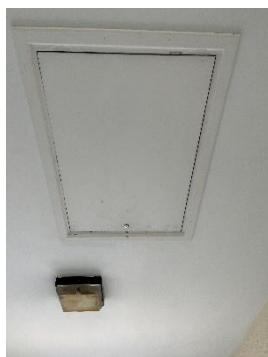
12) The block has a pitched roof with a loft access panel on the second-floor landing. Access was not possible during this survey; however, the assessor will return once suitable access equipment is available. This FRA will then be reviewed.

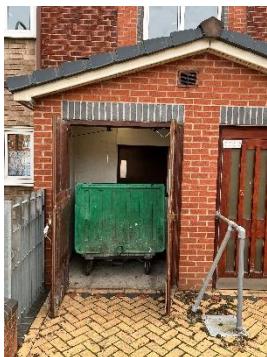
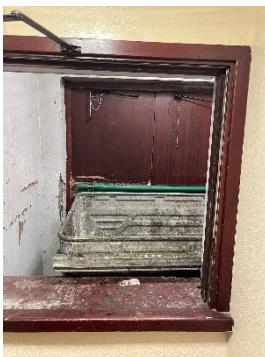
- 1) There is a regular Cleaning Service to the premises.
- 2) Refuse bins are stored to the front of the building in a purpose-built store. Bins Are regularly emptied.
