Fire Risk Assessment

Kenrick House

**Green Street, West Bromwich,
B70 6DN.**

Date Completed: 1st December 2025

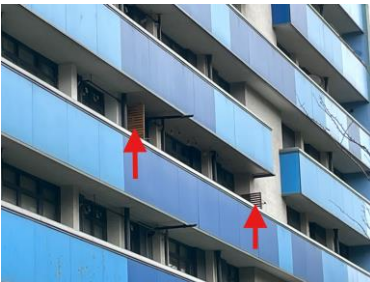
14. Flat 20 timber screening panels installed to balcony.

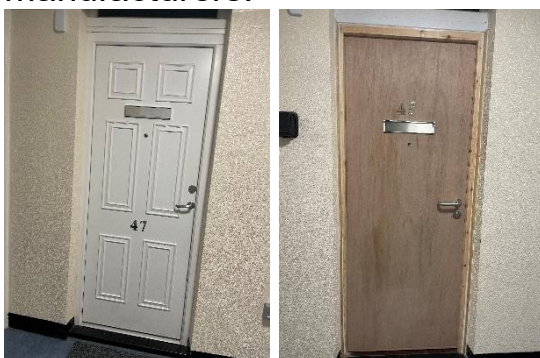
- 1) Individual flat entrance doors are predominantly nominal FD30s Premdor fire doors. The remainder of the doors are a combination of composite fire doors and timber fire doors from other manufacturers.

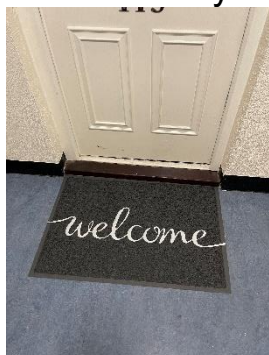
- 2) All flat entrance doors within Kendrick House are scheduled for inspection in December 2025 on a best endeavour basis. The inspections and where necessary any subsequent repairs or adjustments will be carried out by SMBC inhouse fire door inspectors.
- 3) A number of flat entrance doors have door mats on the communal corridor side. The fire rating of the mats is unknown but deemed to be sufficiently low risk.

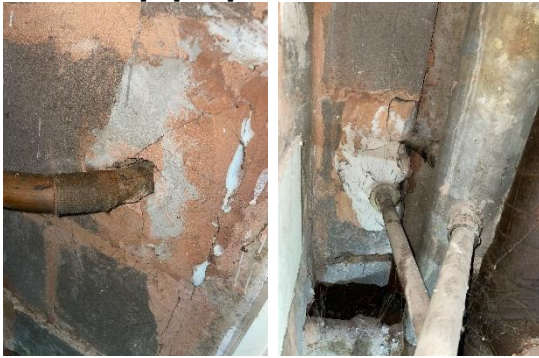
- 20) 15th floor - Gas riser cupboard near chute room – fire stop around pipe penetration and behind soil stack.

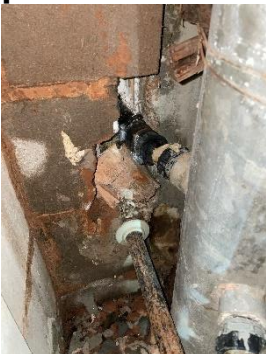
- 21) 14th floor- Gas riser cupboard near chute room – fire stop penetration behind soil stack.

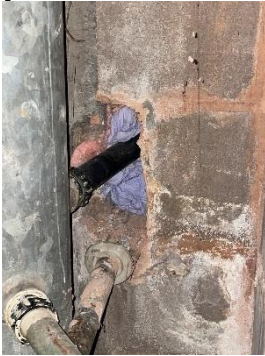
- 23) 13th floor- Gas riser cupboard near chute room – fire stop penetration behind soil stack.**

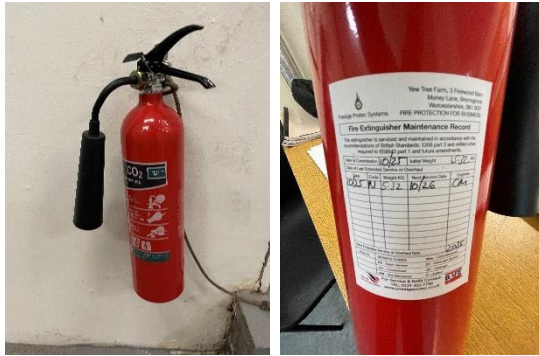
- 5) The portable Co2 extinguisher in the community room should be repositioned beside the exit door.

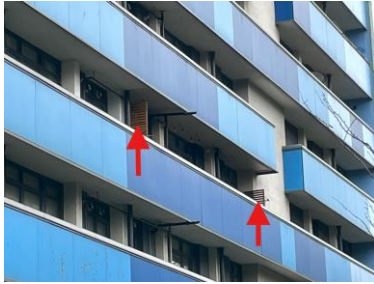
6/14	Flat 20 – Remove timber screening panels installed to balcony.

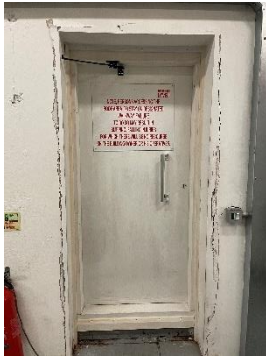
- 21) The door leaf providing access to the external roof is damaged, difficult to open and requires attention.**

P3	Within 3-6 Months Housing Manager	
7/21	Lift motor room – door leaf to roof is split / difficult to open requires repair.

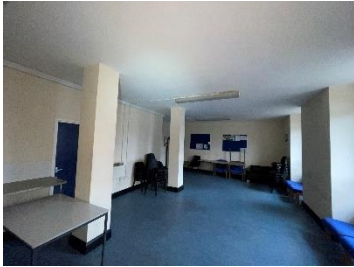
- 3) There is no effective means for detecting an outbreak of fire to communal areas. The reason for this are:
 - I. Such systems may get vandalised.
 - II. False alarms would occur.
 - III. A Stay Put - Unless policy is in place.
 - 4) A deluge system is provided to the refuse chute bin store. An approved contractor maintains the system. The frequency for the maintenance checks are twice per year (April and October) of each calendar year.
 - 5) Suitable hardwired smoke alarms to be installed to the community room.**
-

P2	Within 1-3 Months Fire rapid Response	
8/5	Install hardwired smoke alarms to the community room.

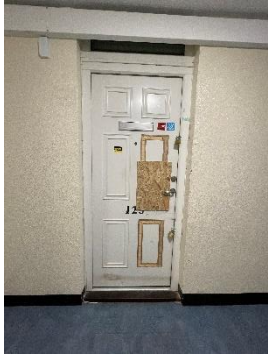
- 15) Flat 125 entrance door noted as damaged due to forced entry. Replacement required.**

10/15	Flat 125 FD30s entrance door to be replaced.

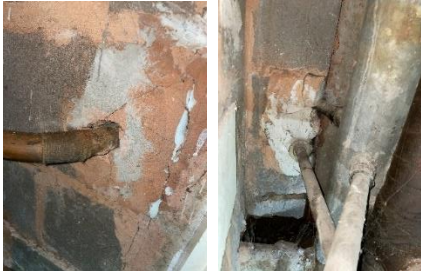
P3	Within 3-6 Months Fire Door Contract	
10/19	15 th floor - Communal door by flat 120 excessive gap to head adjustment required.	n/a	P2	Within 1-3 Months Fire rapid Response	
10/20	15 th floor - Gas riser cupboard near chute room – fire stop around pipe penetration and behind soil stack.

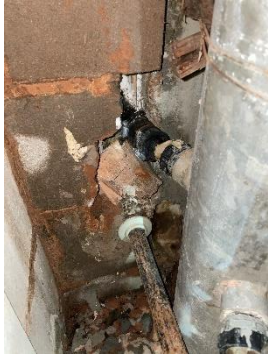
10/21	14th floor- Gas riser cupboard near chute room – fire stop penetration behind soil stack.

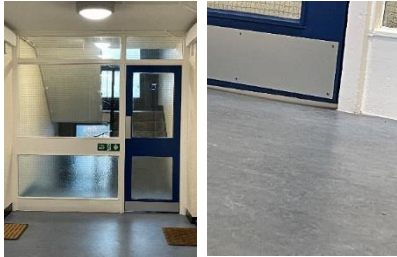
P2	Within 1-3 Months Fire rapid Response	
10/22	14 th floor - Communal door by flat 111 excessive gap to threshold adjustment required.

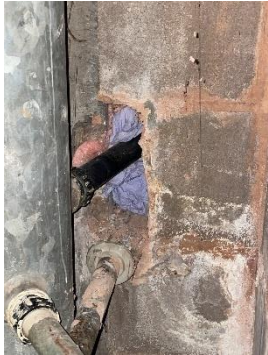
P2	Within 1-3 Months Fire rapid Response	
10/23	13th floor- Gas riser cupboard near chute room – fire stop penetration behind soil stack.

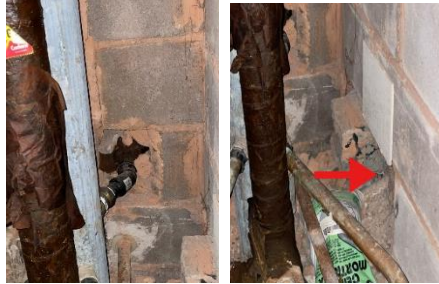
10/24	12 th floor - Communal door by flat 95 excessive gap to head adjustment required.	n/a	P2	Within 1-3 Months Fire rapid Response	
10/25	8th floor - Gas riser cupboard near chute room – fire stop penetration behind soil stack. Also, to right hand side of soil stack if necessary.

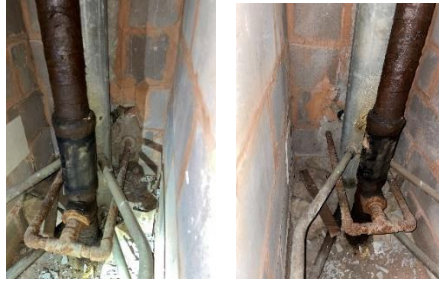
P2	Within 1-3 Months Fire rapid Response	
10/26	7th floor - Gas riser cupboard near chute room –fire stop x 2 penetrations behind soil stack.

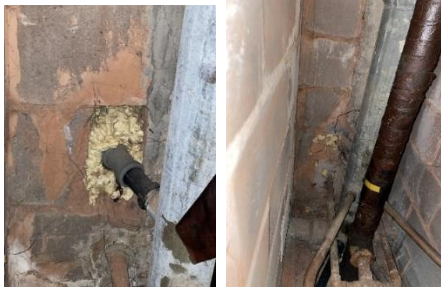
10/27	6th floor - Gas riser cupboard near chute room – remove expanding foam and fire stop x 2 penetrations behind soil stack.

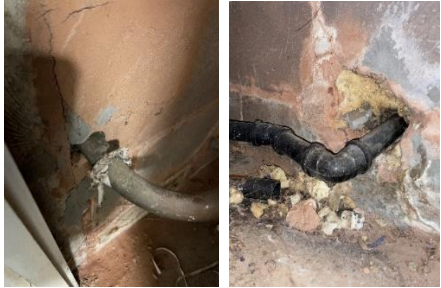
P2	Within 1-3 Months Fire rapid Response	
10/28	5th floor - Gas riser cupboard near chute room – fire stop where intumescent mastic has come away from l/h waste pipe penetration and remove foam and fire stop waste pipe penetration on r/h side.

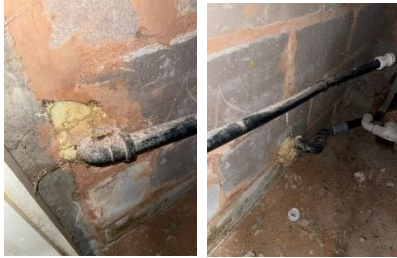
10/31	4th floor - Gas riser cupboard near chute room – remove expanding foam and fire stop x 2 waste pipe penetrations.

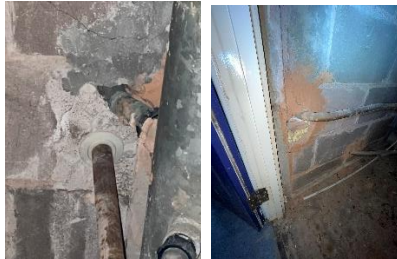
P2	Within 1-3 Months Fire rapid Response	
10/32	3rd floor - Gas riser cupboard near chute room – remove expanding foam and fire stop on l/h side waste pipe penetration. Also, fire stop penetration behind soil stack.

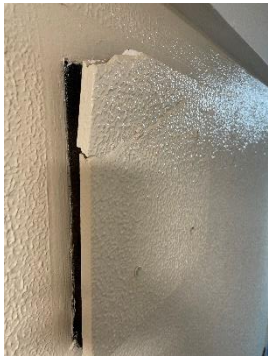
- 33) 3rd floor – replace broken stop tap panel in communal corridor for like or with suitable alternative maintaining compartmentation.**

P2	Within 1-3 Months Fire rapid Response	
10/33	3rd floor – replace broken stop tap panel in communal corridor for like or with suitable alternative maintaining compartmentation.

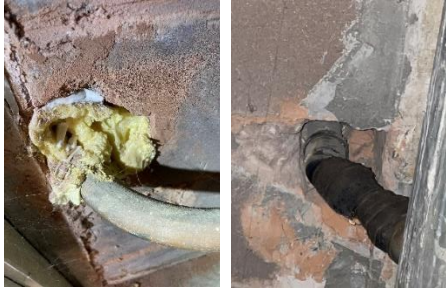
10/34	2nd floor - Gas riser cupboard near chute room – Remove expanding foam from waste pipe penetration , and fire stop around this one plus one other.

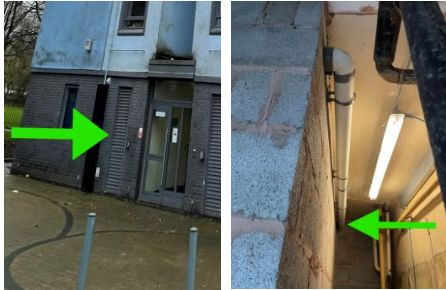
P2	Within 1-3 Months Fire rapid Response	
10/35	Ground floor service void behind roller shutter, left of side entrance door – Fit intumescent collar around extraction pipe rear of bathroom compartment wall.

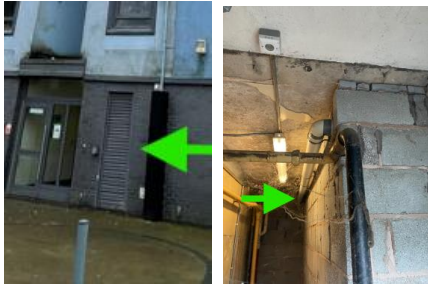
P2	Within 1-3 Months Fire rapid Response	
10/36	Ground floor service void behind roller shutter, right of side entrance door – Fit intumescent collar around extraction pipe rear of bathroom compartment wall.
