Fire Risk Assessment

Kenrick House

**Green Street, West Bromwich,
B70 6DN.**

Date Completed: 1st December 2025

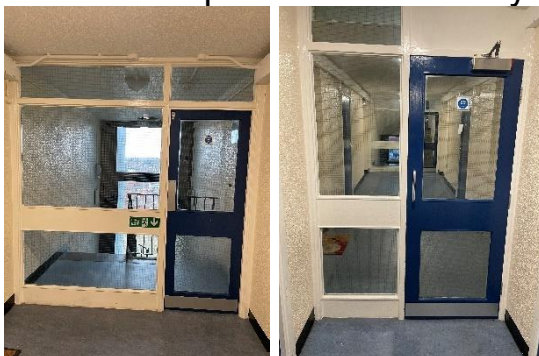
- 9) Cross corridor fire doors to all floors from the 1st to the 16th are 44mm notional 30 minute timber doors with vision panels.

Notional fire doors were installed at the time of the buildings construction and will not have been tested as per today's benchmark for a certified FD30s fire door. However, current guidance recognises that notional fire doors are acceptable providing they are a good fit within the frame and satisfy the standard applicable to fire resisting doors at the time of construction.

It has been recognised that all of the cross corridor notional doors in this building have been upgraded with combined intumescent strips & cold smoke seals to enhance their original design and minimise departures from today's standards.

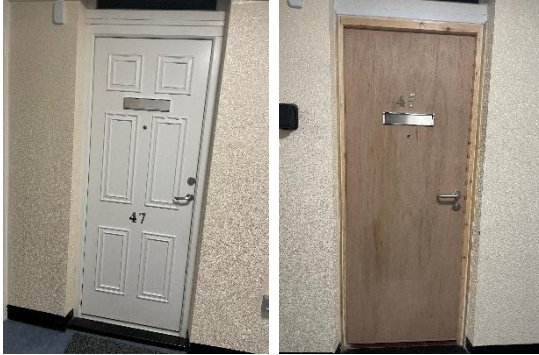
- 14) Individual flat entrance doors are predominantly nominal FD30s Premdor fire doors. The remainder of the doors are a combination of composite fire doors and timber fire doors from other manufacturers.

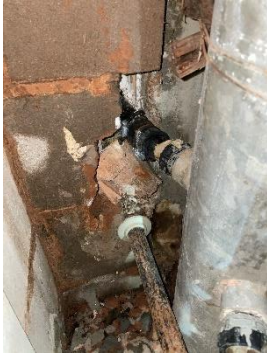
- 22) 14th floor- Gas riser cupboard near chute room – fire stop penetration behind soil stack.

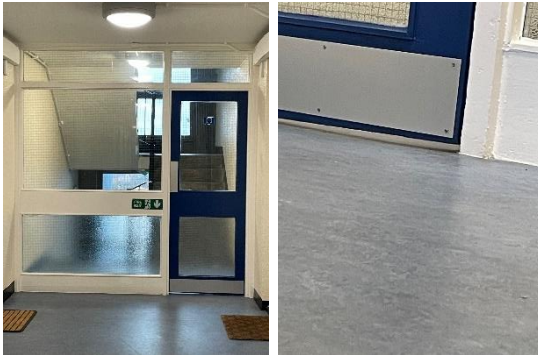
- 23) 14th floor communal door near flat 111 – excessive gap to threshold to be reduced.**

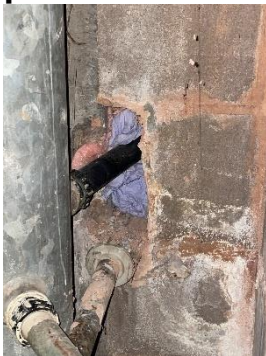
- 24) 13th floor- Gas riser cupboard near chute room – fire stop penetration behind soil stack.**

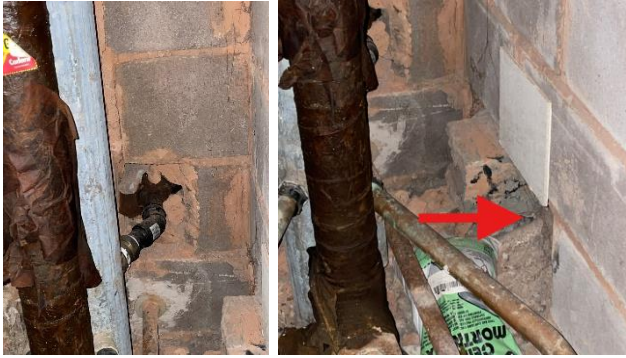
- 26) 8th floor - Gas riser cupboard near chute room – fire stop penetration behind soil stack. Also, to right hand side of soil stack if necessary.**
-

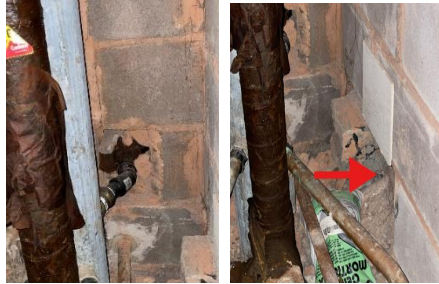
10/25	12 th floor - Communal door by flat 95 excessive gap to head adjustment required.	n/a	P2	Within 1-3 Months Fire rapid Response	
10/26	8th floor - Gas riser cupboard near chute room – fire stop penetration behind soil stack. Also, to right hand side of soil stack if necessary.

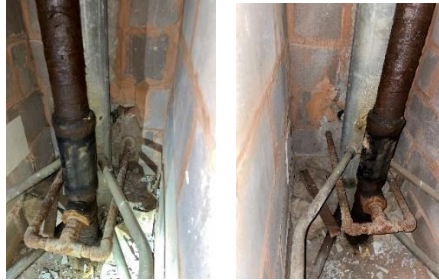
P2	Within 1-3 Months Fire rapid Response	
10/27	7th floor - Gas riser cupboard near chute room –fire stop x 2 penetrations behind soil stack.

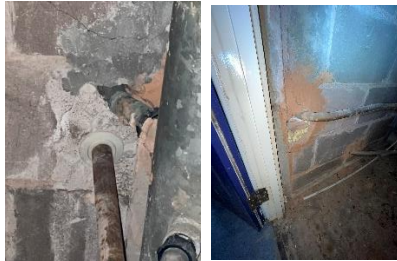
P2	Within 1-3 Months Fire rapid Response	
10/33	3rd floor - Gas riser cupboard near chute room – remove expanding foam and fire stop on l/h side waste pipe penetration. Also, fire stop penetration behind soil stack.

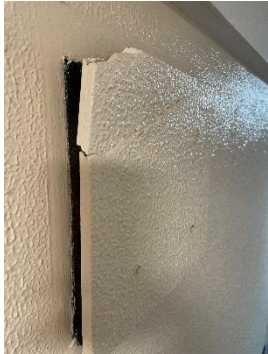
- 34) 3rd floor – replace broken stop tap panel in communal corridor for like or with suitable alternative maintaining compartmentation.**

P2	Within 1-3 Months Fire rapid Response	
10/34	3rd floor – replace broken stop tap panel in communal corridor for like or with suitable alternative maintaining compartmentation.

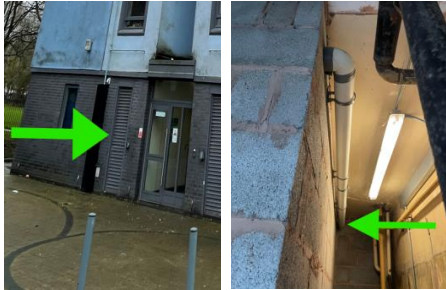
P2	Within 1-3 Months Fire rapid Response	
10/36	Ground floor service void behind roller shutter, left of side entrance door – Fit intumescent collar around extraction pipe rear of bathroom compartment wall.

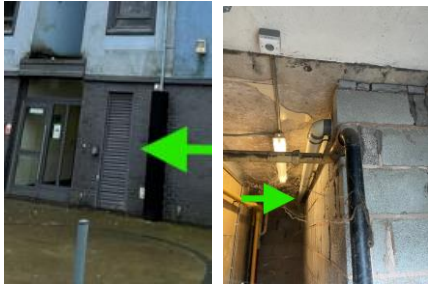
P2	Within 1-3 Months Fire rapid Response	
10/37	Ground floor service void behind roller shutter, right of side entrance door – Fit intumescent collar around extraction pipe rear of bathroom compartment wall.
