Fire Risk Assessment

1-6 Sherwood House

**Southbank Road,
Cradley Heath, B64 6EW**

Date Completed: 4th December 2025

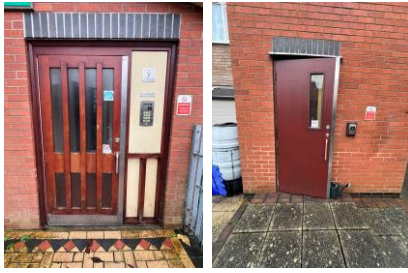
Front and rear entrances to block

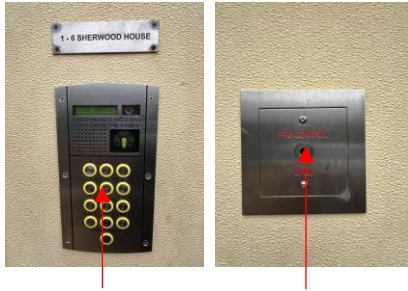
Intercom access and firefighter's switch

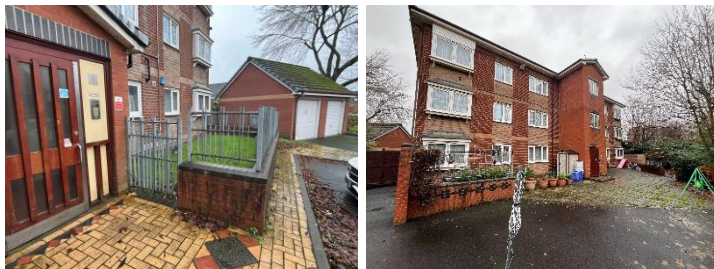
Metal railing fencing perimeter and courtyard at the rear.

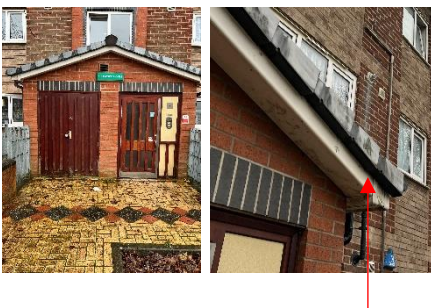
- 1) The exterior of the building is primarily traditional brick construction with a pitched roof design. The roof features concrete tiles and UPVC fascia boards along the roofline. The front entrance is accessed via a brick-built porch with a pitched roof, which includes UPVC dry verge end caps, fascia boards, and attached drainage.

UPVC Dry Verge End caps and drainage.

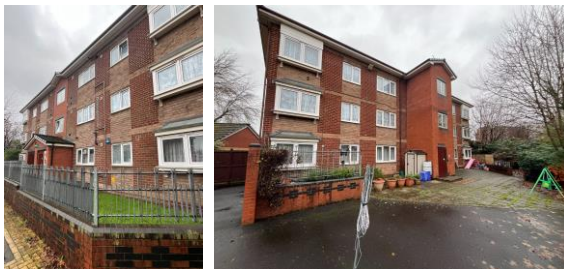
- 3) UPVC double-glazed window units have been installed in each flat and in the communal areas within the block.

Front and rear and UPVC window units

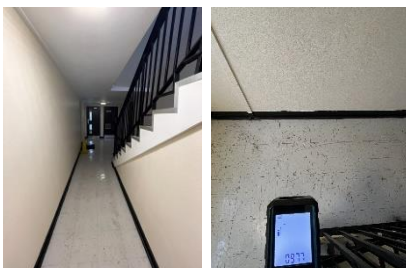
Ground floor.

- 4) All corridors, landing and staircase are of adequate width of 1144mm(G) 977mm(1st) and 938mm(2nd)

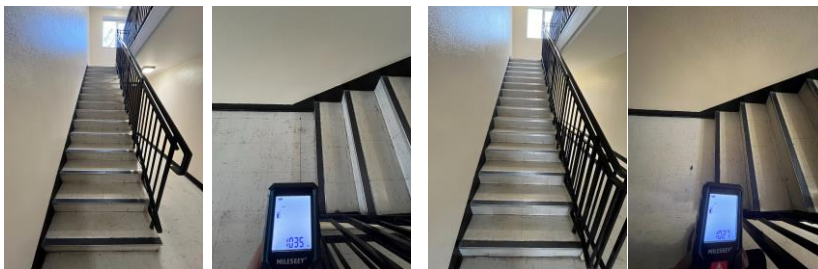
- 9) 1-6 Sherwood House features a single staircase, positioned at the entrance of each block, which provides an adequate means of escape. The width of the staircases, measured from handrail to the wall, is 1004 mm and 1027mm respectively. These staircases are kept clear to ensure a safe means of escape.

Ground to 1st & 2nd floor staircase.

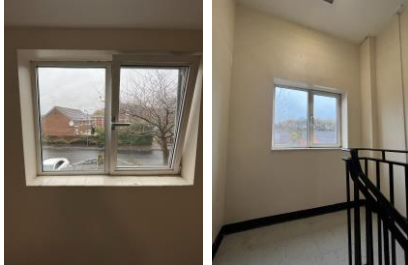
- 10) UPVC window units have been installed on the staircase landings and within the corridors leading to the flats. These windows can be opened without a key to provide adequate airflow into the corridors and stairwells. However, there is no automatic smoke ventilation system installed on the premises.

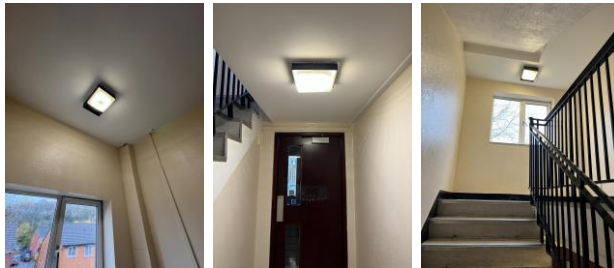
- 11) Emergency lighting is installed throughout the building, these are installed near final exit doors, communal staircase, landing and the corridors for flat entrances.

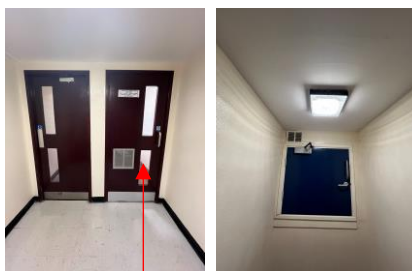
- 12) On the ground floor communal hallway there is access to a bin refuse room which is located behind a FD30s fire door.

Refuse bin room

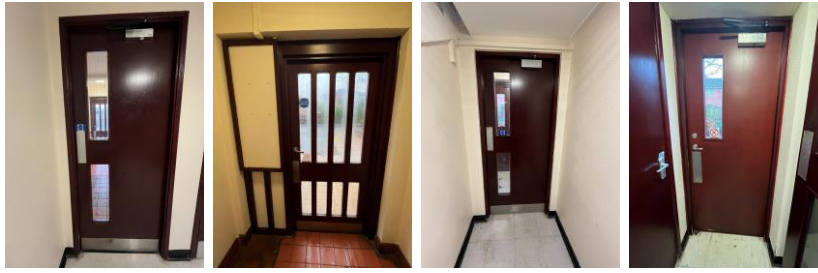
- 13) A communal fire door separates the front and rear final exit doors from the main communal area. The final exit doors are equipped with levered handle-operated exit system. These doors are regularly inspected by the Caretaking Teams as part of their routine checks. Any defective self-closing devices are replaced either by the Caretaking Teams or the in-house Repairs Team.
-

Communal doors with front and rear final exits doors with levered handles.

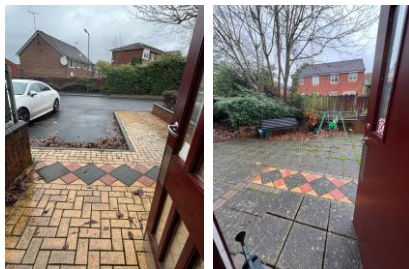
- 15) There are 2 sufficient final exit doors which lead to a place of ultimate safety.

Front final & Rear final exits.

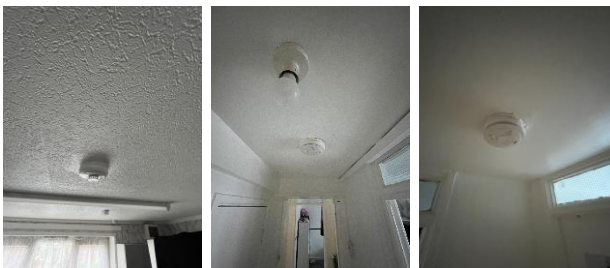
Flat 3 – LD1, Hallway (*escape route*) Bedrooms, Kitchen & Lounge
(*risk areas*)

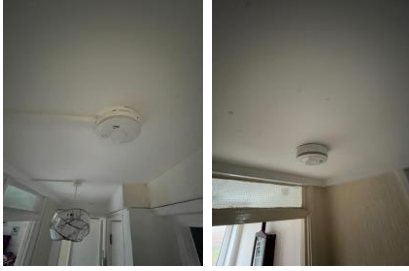
Flat 4 – LD1, Hallway (*escape route*) Bedrooms, Kitchen& Lounge
(*risk areas*)

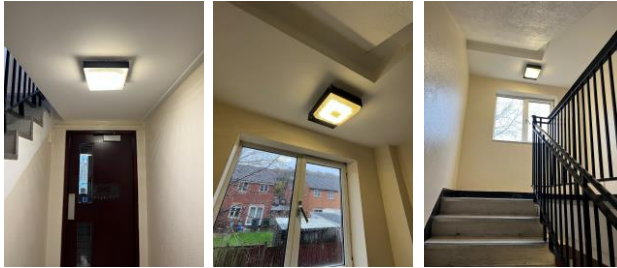
- 4) Emergency lighting is installed throughout the building, including communal areas such as stairways, corridors, and lobbies.

Communal area, stairwell emergency lighting

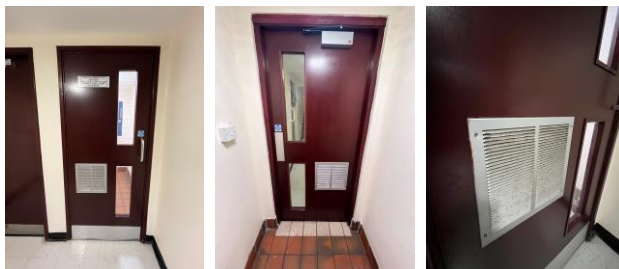
- 10) The fire door to the refuse cupboard on the ground floor within the communal corridor is equipped with a vision panel, self-closing device and an intumescent ventilation grill.

Refuse bin room door and ventilation grill.

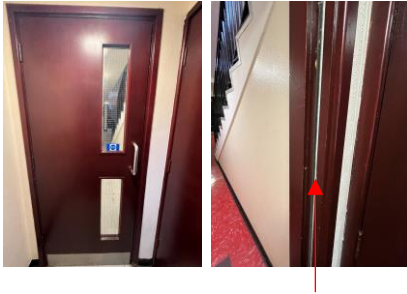
- 12) Additional FD30s timber fire doors with self closing devices and smoke seals have been installed, these door separate the communal area from the final, exit doors.

FD30s and smoke seal

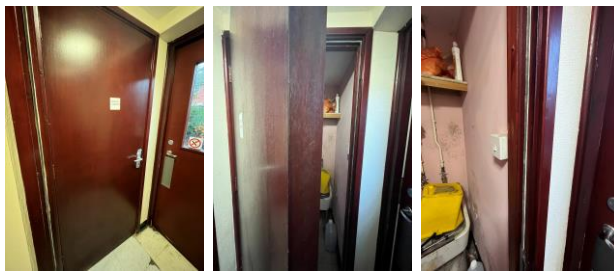
- 13) Cleaners storage cupboard on the ground floor is installed with timber FD30s fire door with smoke seals. This door is locked by a 54 mortice key and only held by authorised staff.

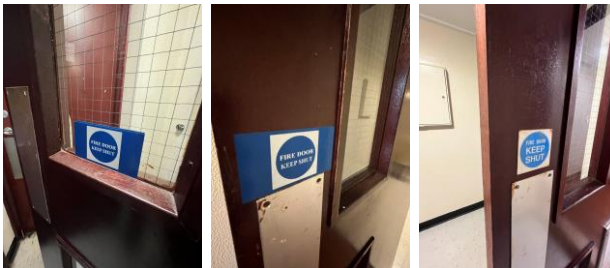
- 1) Fire door keep shut signs are displayed where appropriate, on communal fire doors, refuse bin stores and cleaners cupboard display Fire Door Keep Shut/Locked” sign.

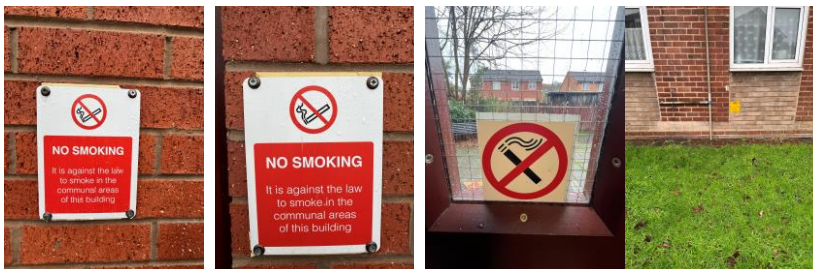
- 2) Yellow LPG warning signs are not displayed within the block. [refer to section 18](#).
- 3) Smoking is prohibited within any communal parts of the building in line with Smoke Free England legislation.

External and internal No Smoking signs.

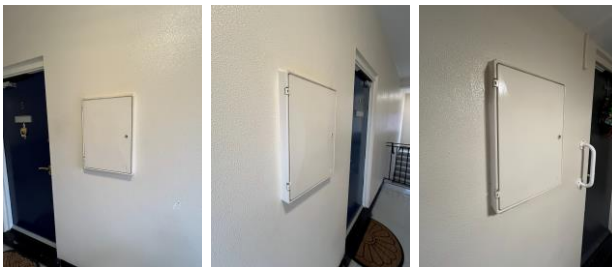
- 7) Residents' electrical cupboards are located next to each flat front entrance doors in the communal area. The electric meters are within an over cupboard that are inset into the block work. it is recommended that on any future refurbishment of the block that the electrical meters to be relocated to within the residents flat and housed within the required compartmentation.

It is recommended that the residents' electrical cupboards be relocated within the residents' flats and housed within required compartmentation in any future renovation program.

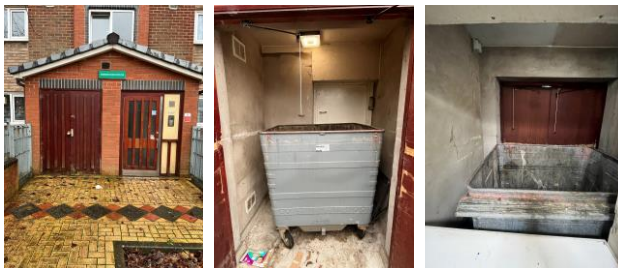
- 2) Refuse bin is stored in a secured bin room that is located next to the front entrance of the building. This can be accessed from both internal and externally and is kept secure. Bins Are regularly emptied by site services. All internal refuse rooms are clear of any rubbish.

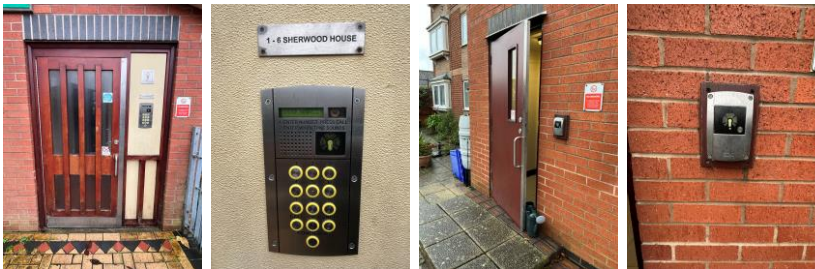
- 1) Regular checks are undertaken by Caretakers / Cleaning Team(s) 365 days per year which helps reduce the risk of arson
- 2) Both blocks have restricted access, this is via a key lock, each resident has their own fob to gain access. There is an intercom system that can allow visitors and contractors in.

Front and rear entrance doors with access system.
