Fire Risk Assessment

2 – 24

Shepherds Fold,

Current Risk Rating = Tolerable

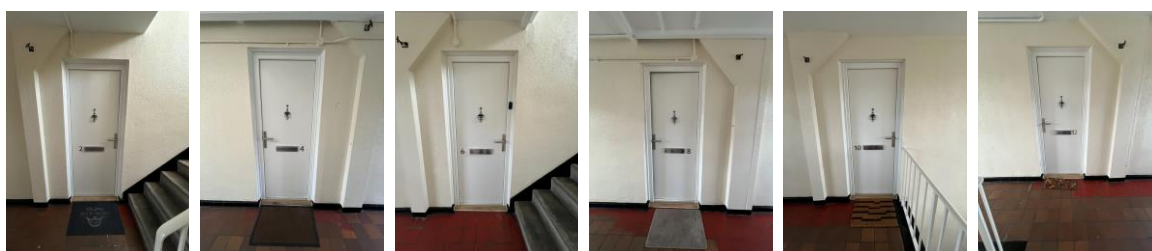
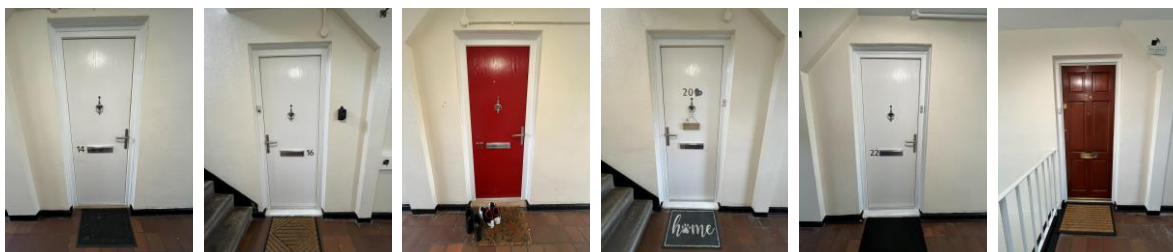
- 1) Each property is fitted with a minimum of an LD3 detection system within the flat. See Section 8
- 2) Non leasehold flats have had new doors fitted within the last two years. These doors are FD30 composite doors with no glass installed.

- a) **Flat 24: Entrance door is a none fire door: Email sent to leasehold manager 20/11/25 who replied to say that the door should have been replaced during the last contract but were let down. Will add this door to the actions of this FRA.**

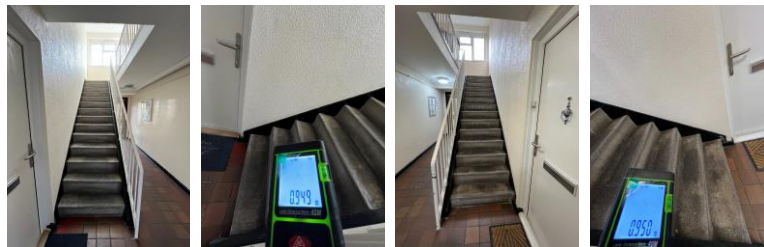
8) Within both blocks each floor is accessed via a single staircase that provides a means of escape and has a width of a minimum of 950mm between the handrails.

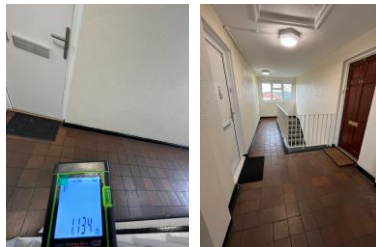
9) All corridors are of adequate width (at least 1100mm) and will be maintained clear to that width as a minimum.

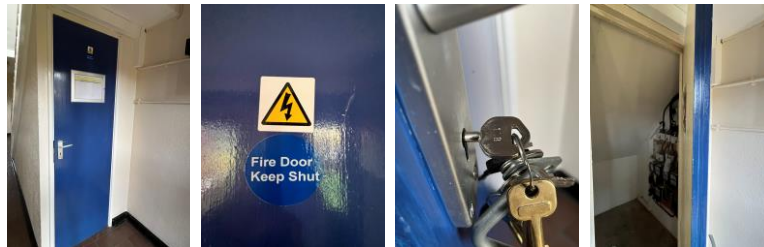
12) The means of escape are protected to prevent the spread of fire and smoke. All service cupboards to communal landings are upgraded timber notional doors with an added intumescent strip (this has been painted over and requires replacement – see section 10/6), they are lockable with 138 lock and include a fire door Keep locked signage.

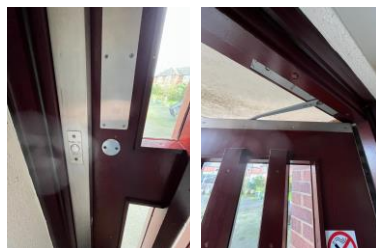
13) The final exit doors are fitted with automatic closing devices. To exit the doors, you do so by using a push button. These are checked on a regular basis by caretaking teams as part of their checks. Defective closing devices are replaced either by the Caretaking Team(s) or the in-house repairs team(s). These systems are designed to fail safe i.e. door unlocked in the event of a power failure. This prevents residents being locked in or out of the building.

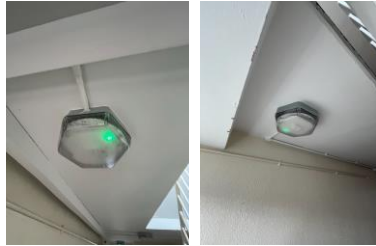
- 1) These premises are fitted with emergency lighting in the communal areas i.e. Hallways and at the top of stairways

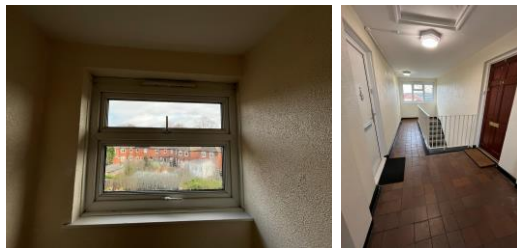
- 2) There is also standard lighting within the hallway also landing windows to assist in lighting the communal areas from outside

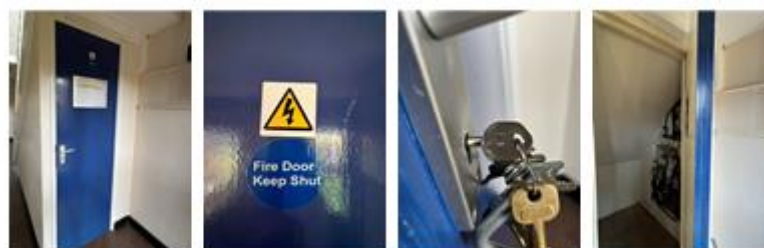
- 5) A variety of methods / materials have been used to achieve fire-stopping such as intumescent mastic around penetrations.
- 6) All service cupboards to communal landings are FD30 rated with intumescent strips fitted and lockable with 138 lock, the door also includes "Fire door Keep locked" signage.

- a) Within block 2-12 the service cupboard located by the front door requires fire stopping. Location: Right hand side wall at the rear, where the plastic trunking is located.

P2	Within 1-3 months Fire Rapid Response JM 18492377	15/01/2026
10/6a	Block 2-12: Fire stop required, right hand side wall at the rear, by trunking.

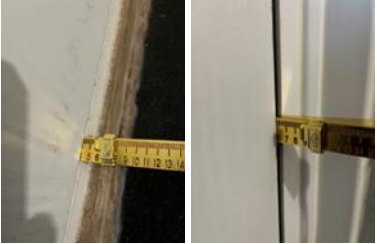
P3	Within 3-6 months Fire Rapid Response jm18523940	Unable to close gaps
7/3c	Flat 4: Close gap between the door as frame. See section 7/3c for more details

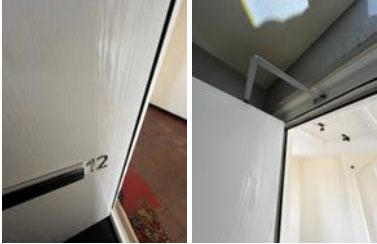
P3	Within 3-6 months Fire Rapid Response JM18726033	04/02/2026
7/3h	Flat 12: adjust self closer due to door not self closing.

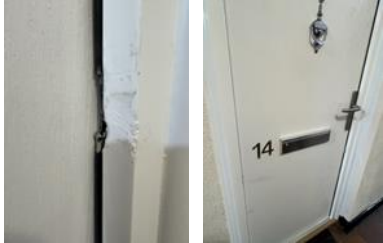
- i) **Flat 14: Did not get access to the flat. External section of the frame on the right-hand side halfway down is damaged. May need replacement.**

P2	Within 1-3 months Fire Rapid Response JM 18542841	15/01/2026
7/3i	Flat 14: Entrance door frame damaged. Also, signs of surface damage to the door. Assess and make fire safe. New door set required / ordered

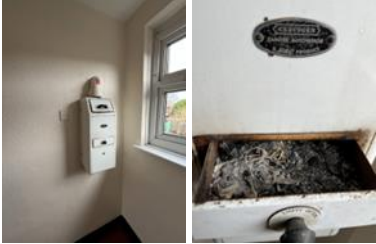
- 5) Upon the 1st floor landings there is small incinerator unit. In block 1-12 there is evidence that this unit is being used to burn items. The units within blocks 2-12 & 14-24 need to be removed or sealed up. *Email sent to Building and Fire Safety Team Manager and Assistant Building Surveyor 20/11/2025 who are looking to get the incinerators removed.*

P2	Within 1-3 months Fire Rapid Response JM:18724327	04/02/2026
7/5	Block 2-12 and 12-24: Incinerators situated on the 1 st floor of each block are to be removed. Email sent to Building and Fire Safety Team Manager and Assistant Building Surveyor 20/11/2025. Contract given to Bradleys

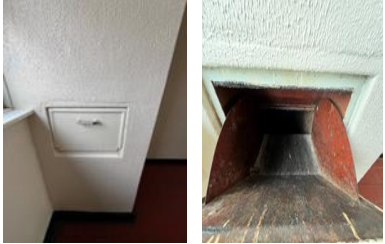
P3	Within 3-6 Bradleys	<i>Resolved</i>
7/6	Block 2-12 and 14-24: Upgrade bin chutes due to not being fitted with suitable fire seals.

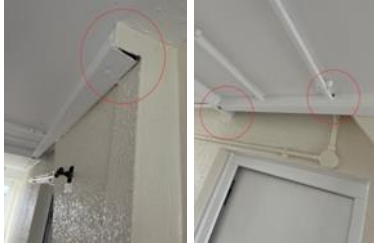
7/7d	Block 2-12: Fire stopping to trunking required by flat 8. See photos for locations
