# Fire Risk Assessment

**Shepherds Fold,  
Rowley Regis,  
B65 8BG**

**Date Completed: 05/12/2025**

**Current Risk Rating = Tolerable**

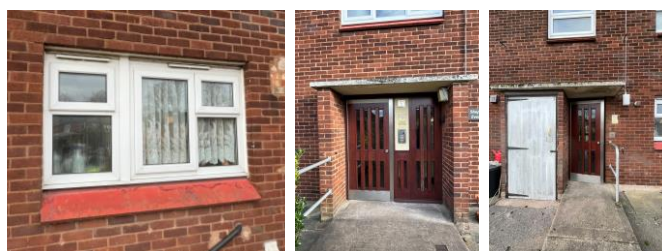
- 2) uPVC double-glazed units have been installed in each flat and on the communal stairway. The building features a canopied entrance, with a flat concrete canopy roof. A security/safety light is fitted within the porch area. The entrance and rear doors are primarily made of timber and glass, with a small section of spandrel panelling. Adjacent to the rear door is a brick-built cupboard housing the bin chute and waste bin; this cupboard is enclosed with a timber door.

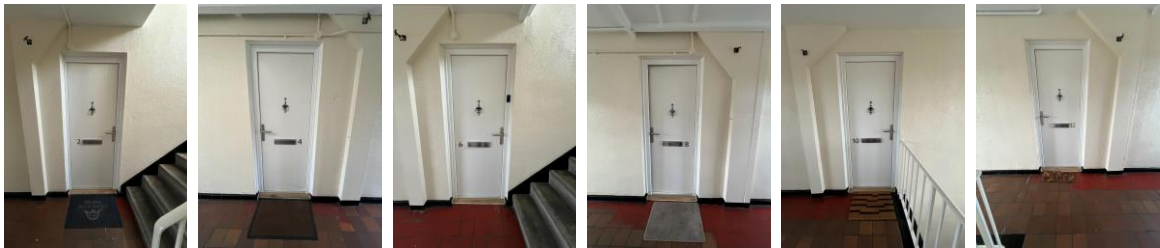
Block 2-12

- 1) Each property is fitted with a minimum of an LD3 detection system within the flat. See Section 8
- 2) Non leasehold flats have had new doors fitted within the last two years. These doors are FD30 composite doors with no glass installed.

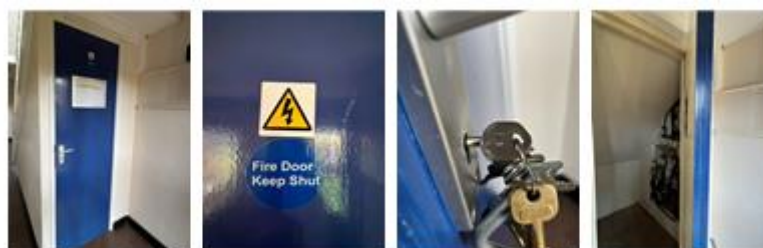
- 5) A variety of methods / materials have been used to achieve fire-stopping such as intumescent mastic around penetrations.
- 6) All service cupboards to communal landings are FD30 rated with intumescent strips fitted and lockable with 138 lock, the door also includes "Fire door Keep locked" signage.

- a) Within block 2-12 the service cupboard located by the front door requires fire stopping. Location: Right hand side wall at the rear, where the plastic trunking is located.

| 10/6a | Block 2-12: Fire stop required, right hand side wall at the rear, by trunking. | | P2 | Within 1-3 months<br>Fire Rapid Response | |

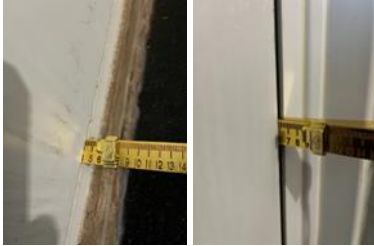
| 7/3c | Flat 4: Close gap between the door as frame. See section 7/3c for more details | | P3 | Within 3-6 months<br>Fire Rapid Response | |

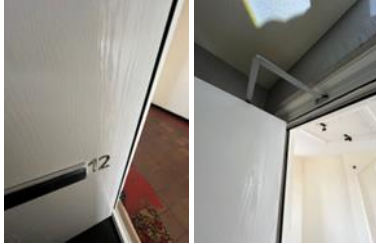
| 7/3h | Flat 12: adjust self closer due to door not self closing. | | P2 | Within 1-3 months<br>Fire Rapid Response | |

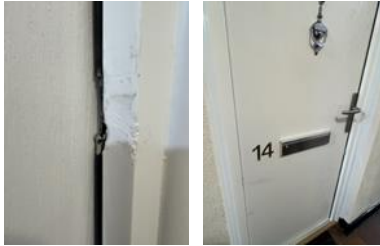
- i) **Flat 14: Did not get access to the flat. External section of the frame on the right-hand side halfway down is damaged. May need replacement.**

| 7/3i | Flat 14: Entrance door frame damaged. Also, signs of surface damage to the door. Assess and make fire safe. | | P2 | Within 1-3 months<br>Fire Rapid Response | |

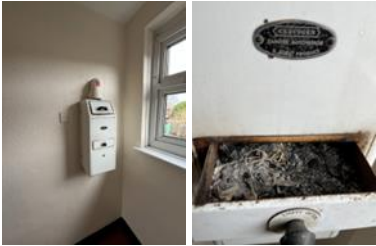
- 5) Upon the 1<sup>st</sup> floor landings there is small incinerator unit. In block 1-12 there is evidence that this unit is being used to burn items. The units within blocks 2-12 & 14-24 need to be removed or sealed up. *Email sent to Building and Fire Safety Team Manager and Assistant Building Surveyor 20/11/2025 who are looking to get the incinerators removed.*

| 7/5 | Block 2-12 and 12-24: Incinerators situated on the 1 <sup>st</sup> floor of each block are to be removed. Email sent to Building and Fire Safety Team Manager and Assistant Building Surveyor 20/11/2025. Contract given to Bradleys | | P3 | Within 3-6 months<br>Bradleys | <i>Resolved</i> |

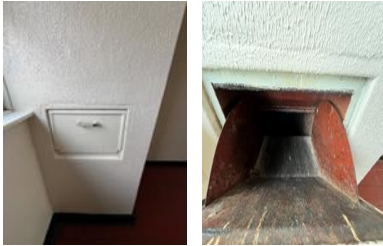
| 7/6 | Block 2-12 and 14-24: Upgrade bion chutes due to not being fitted with suitable fire seals. | | P3 | Within 3-6 months<br>Repairs | |
