Fire Risk Assessment

1-11

**Shepherds Fold,
Cradley Heath,
B65 8BG.**

Date Completed:01/12/2025

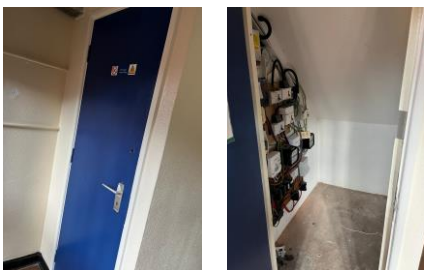
The service cupboard housing electrical intakes is situated at the rear of the building behind the staircase, these are notional FD30s doors, secured with a type 138 suited mortice lock. Residents have been provided with a key for access to their electricity meters.

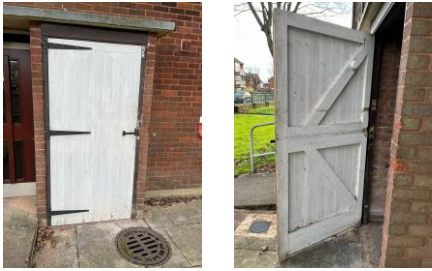
- 7) The bin storage rooms have a ledged and braced door that is of timber construction.

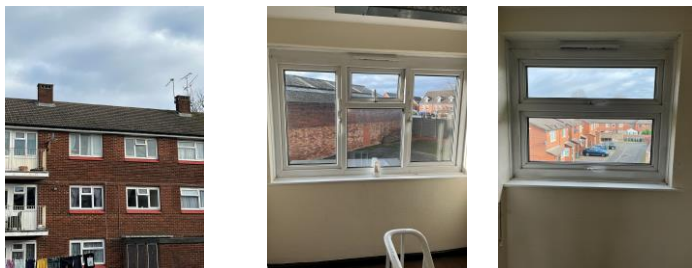
- 10) In the building the 1st and 2ⁿ floor communal landings, have a set of UPVC windows, these windows can be opened without the use of a key, these also allow sufficient ventilation. There is no automatic smoke ventilation system installed in this premises.

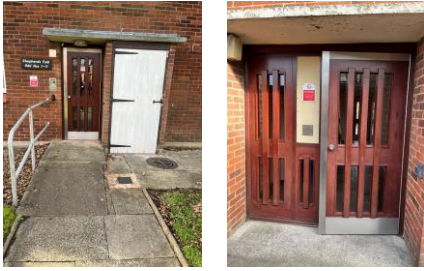
Both access doors are solid timber with glass vision panels and have a Fob access system.

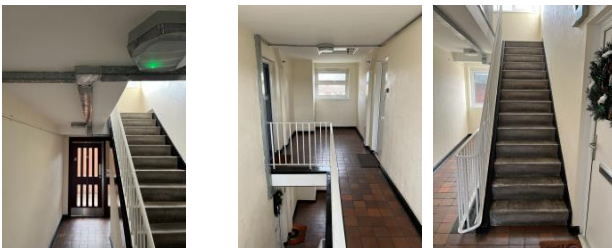
- 12) The landings are kept clear to maintain safe means of escape.

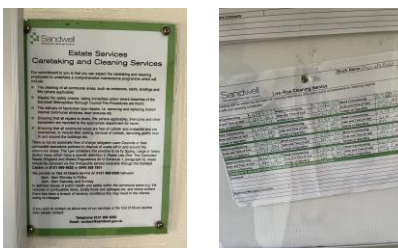
- 14) The communal area is kept free of flammable items. The communal areas should be checked on a regular basis by Caretaking / Cleaning teams and all items of rubbish removed.

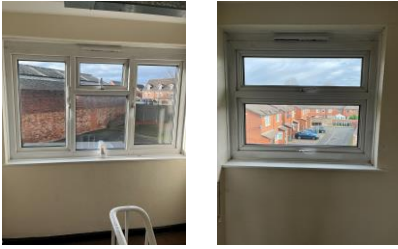
- 15) Ventilation of the common area is facilitated by openable windows in the stairwell. There is no automatic smoke ventilation system installed in this premises.
-
