Fire Risk Assessment

1 -3 Warren Drive

Rowley Regis, B65 8PS

Date Completed: 5th December 2025

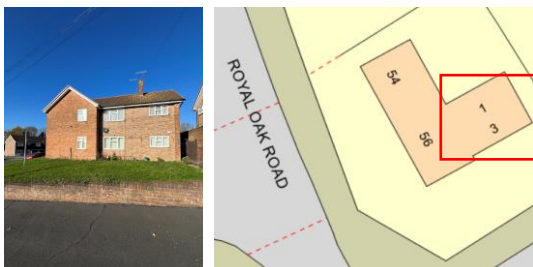
It is also noted that the block at Warren Drive is physically attached to an adjacent residential building, which is accessed separately via Royal Oak Road. Although conjoined, the neighbouring block is served by its own independent entrance and access arrangements and does not share internal common areas with 1 & 3 Warren Drive.

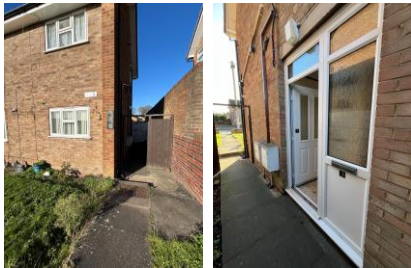
The main entrance to the building is through a timber gate on the side elevation which leads to the entrance to the block.
