# Fire Risk Assessment

## 2 - 4 Warren Drive

**Rowley Regis, B65 8PS**

**Date Completed: 5<sup>th</sup> December 2025**

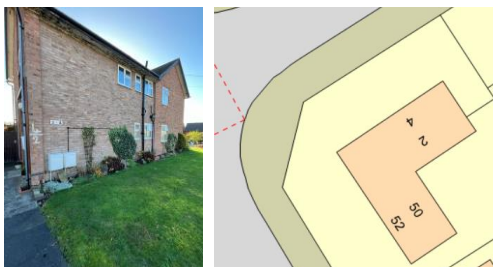
It is also noted that the block at Warren Drive is physically attached to an adjacent residential building, which is accessed separately via Royal Oak Road. Although conjoined, the neighbouring block is served by its own independent entrance and access arrangements and does not share internal common areas with 2 - 4 Warren Drive.

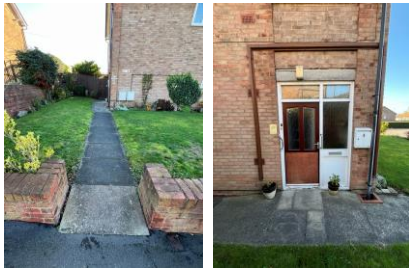
The main entrance to the building is set back and up a walkway, the entrance is located to the side elevation to the block.
