Fire Risk Assessment

5 -7 Warren Drive

Rowley Regis, B65 8PS

Date Completed: 8th December 2025

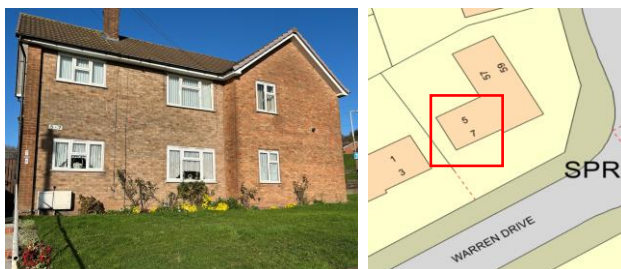
It is also noted that the block at Warren Drive is physically attached to an adjacent residential building, which is accessed separately via Cromwell Close. Although conjoined, the neighbouring block is served by its own independent entrance and access arrangements and does not share internal common areas with 5 -7 Warren Drive.

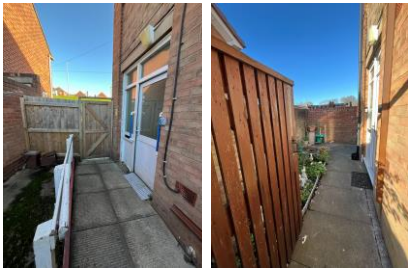
The main entrance to the building is through a timber gate on the side elevation which leads to a UPVC double glazed entrance to the block.
